**BAT SURVEY AT -
7 TIMBRILLS CLOSE
SABDEN**

DATE AND TIME OF VISIT
18th Jan 2022 9.20 am

REFERENCE NO. 6417

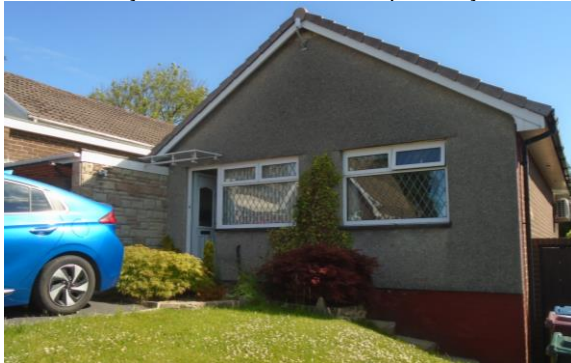
South west front elevation

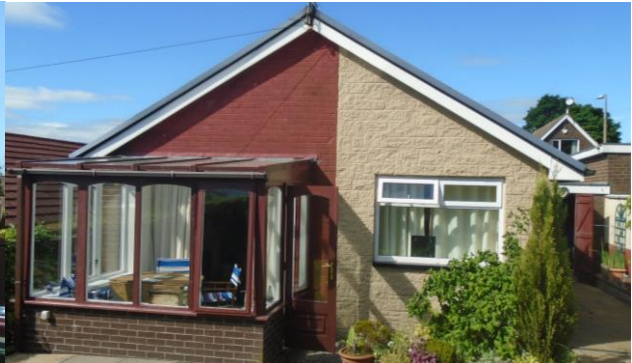
North east rear elevation

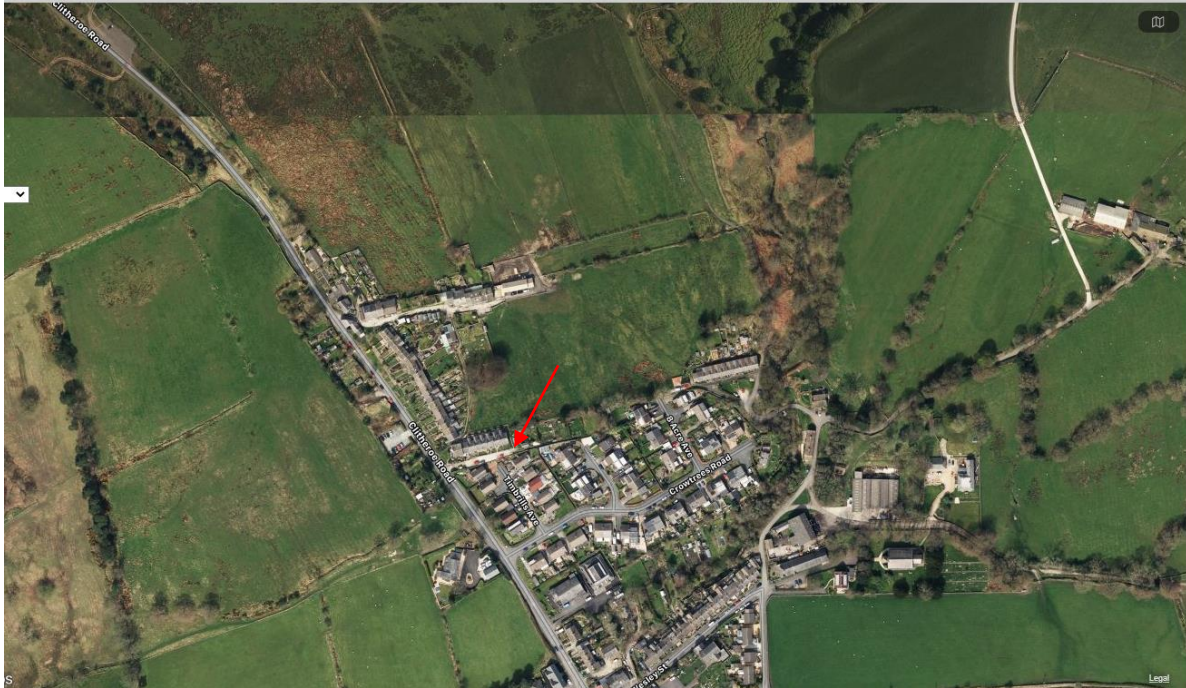
The property is located on the western edge of Sabden settlement area in an elevated position 46.5 m to the east of Clitheroe Road. On a large estate surrounded by houses of a similar age and type.

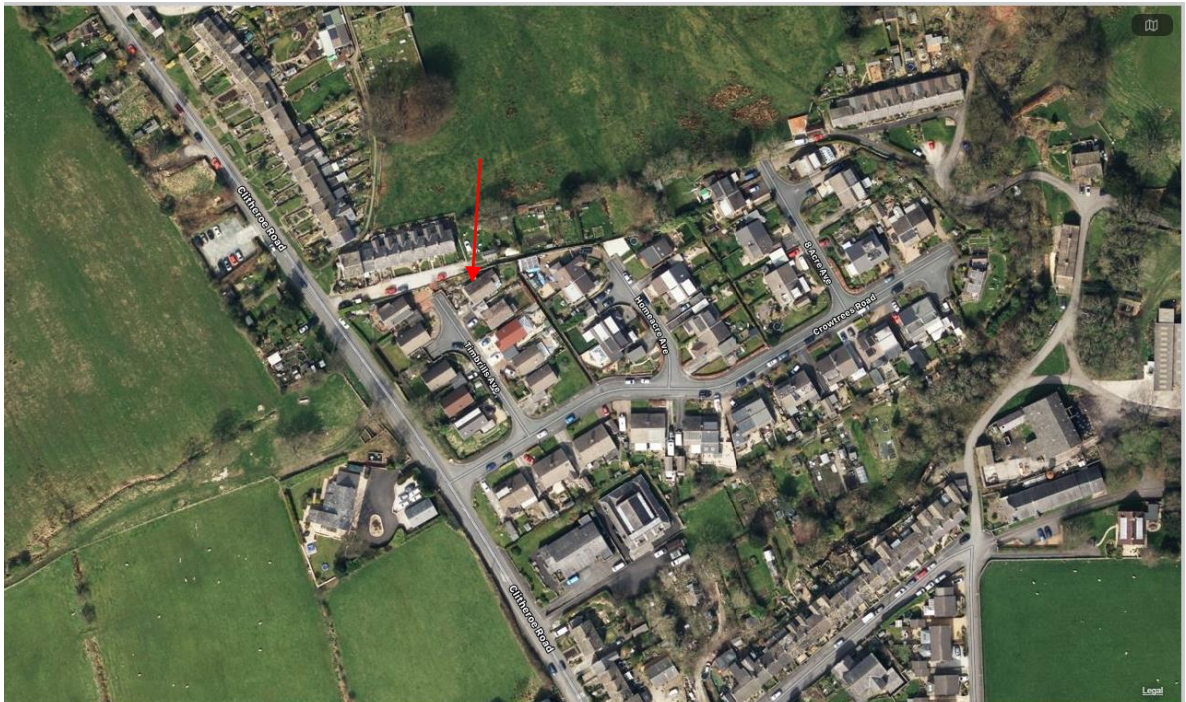
The houses are all located in small gardens with domestic planting. The immediate locality is not considered to provide high value forage potential, however open country side is at 38m to the north and 72m to the west. The nearest water course is Badgerwell Water at 209m to the east, the trees lining the stream are the nearest significant area of trees however the connectivity from the house via tree lines (forage / commute routes for bats) is broken and generally not considered high value.

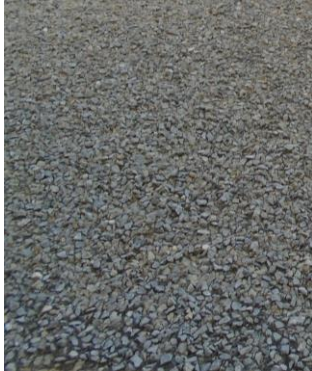
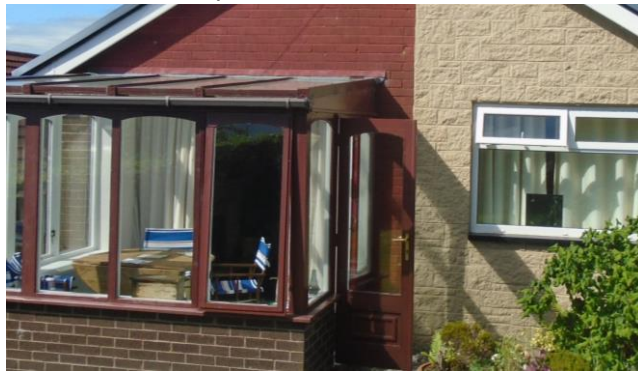
The bungalow has, brick , artificial stone and pebble dash render walls.

All the walls are in good condition and do not provide any access points, cracks or crevices suitable for bat ingress.

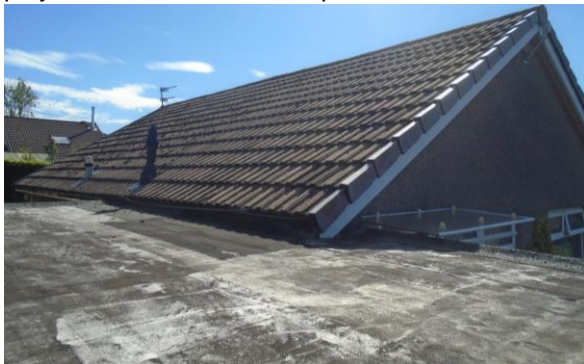
Tile pitched and felt flat roofs.

The roof tiles are in very good condition tight fitting with no cracked or loose tiles. The ridge tiles are well pointed. The soffits, barge boards and fascia's are tight fitting and in good condition with no access points. The conservatory roof and flashing was in good condition and tight fitting it did not provide any potential bat habitat..

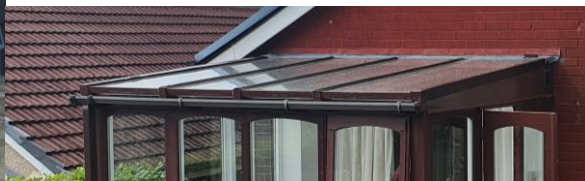
Conservatory roof

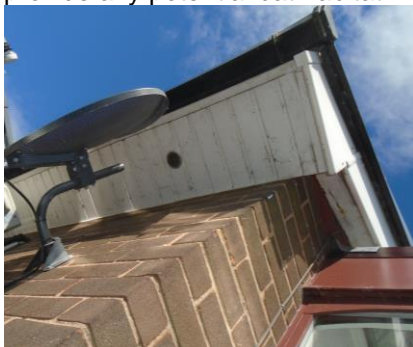
Soffits

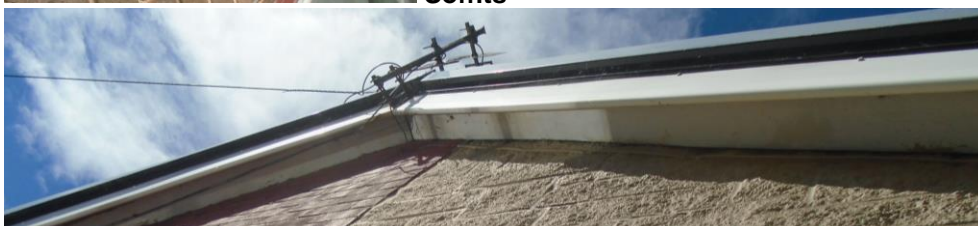
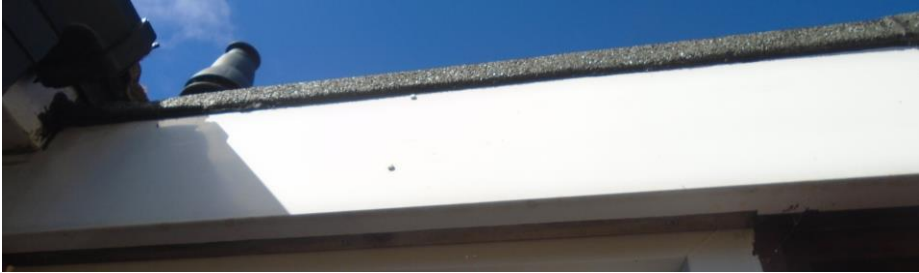
The garage roof is in good condition with no rips or tears in the felt, the verges are tight fitting to the fascia's no access points were noted.

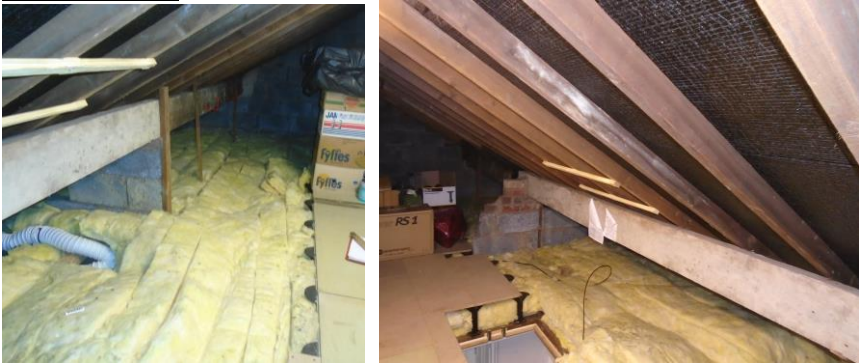
ROOF SPACE

The structure is timber rafters and purlins with felt underlay. Insulation quilt is present, all the surfaces were clean and free from any dropping or feeding evidence. The timbers were in good condition as was the felt underlay, the space did not provide any roost potential for bats.

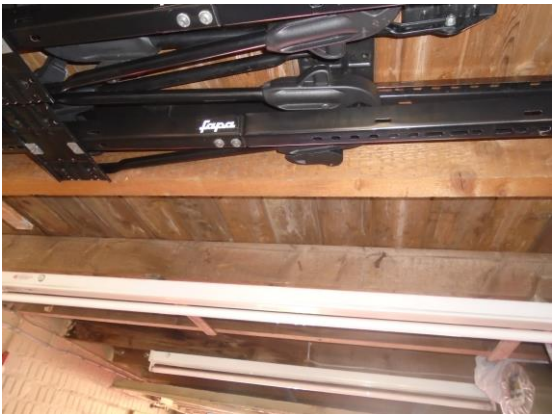
Garage roof is timber t and g boarding over timber joists, all in reasonable condition with no rot, cracks or crevices with the potential to provide bat roost habitat.
