# Outbuildings at Higher Chipping House, Forest of Bowland

## Bat Survey Report

1<sup>st</sup> September 2022

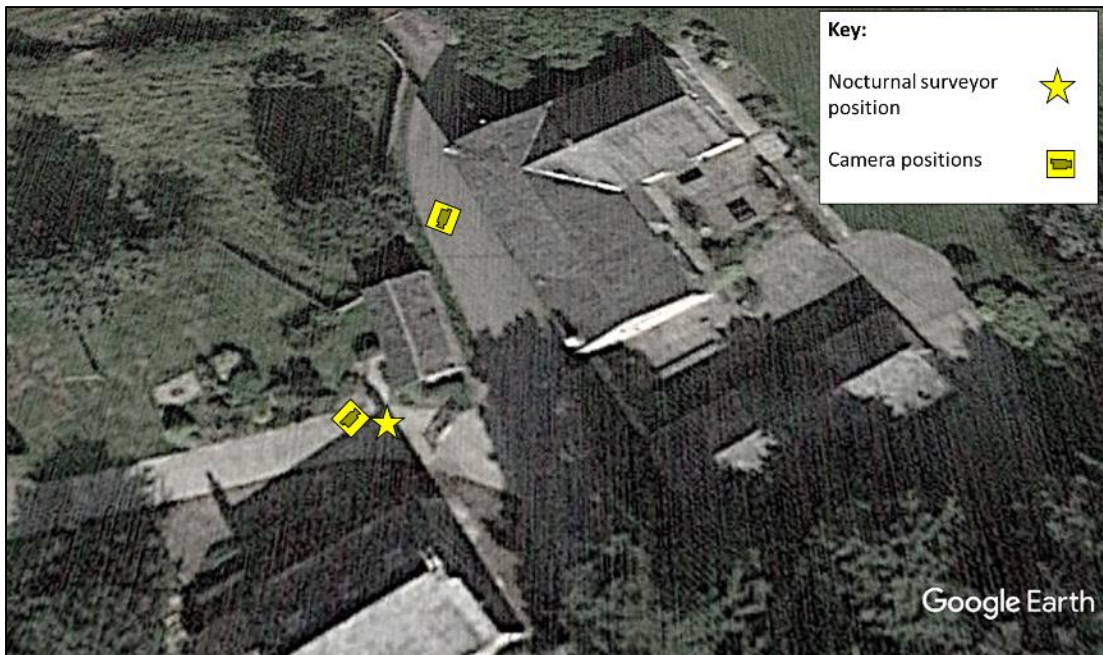
**Figure 2. Nocturnal survey plan**

4.2.7 The dawn return survey continued from 1.5 hours prior to sunrise until 15 minutes after this time. The arrangement of the surveyor and cameras during the nocturnal surveys is shown in Figure 2.

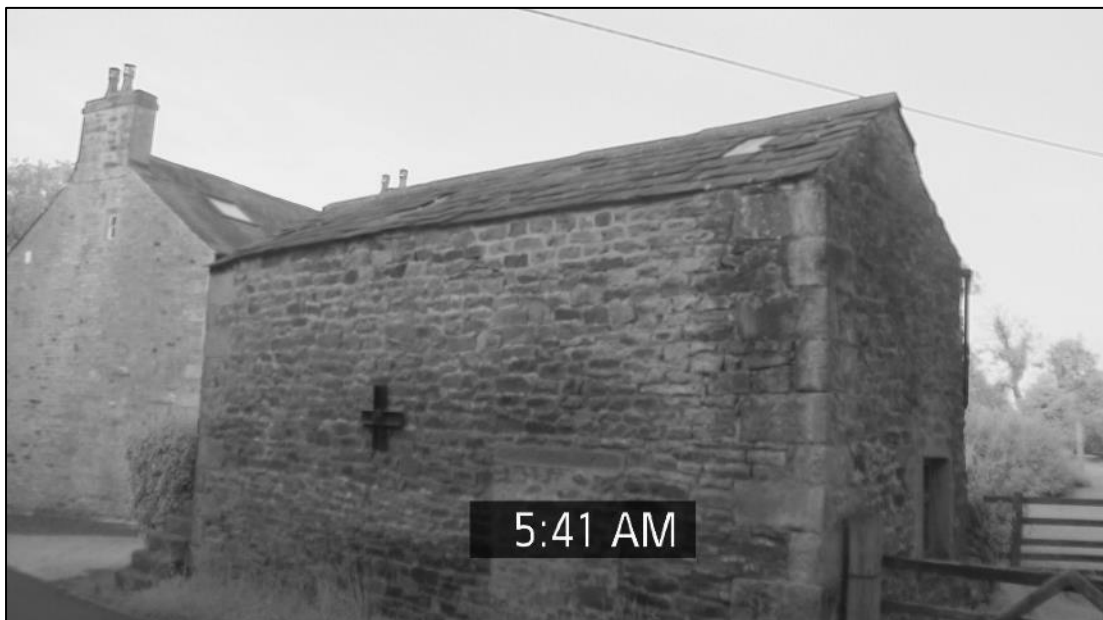
**Plate 1. Image taken from unmanned camera position**

4.2.6 An image taken from the unmanned camera position is shown in Plate 1. The footage from this camera position was watched back in its entirety by the licensed surveyor the following day.

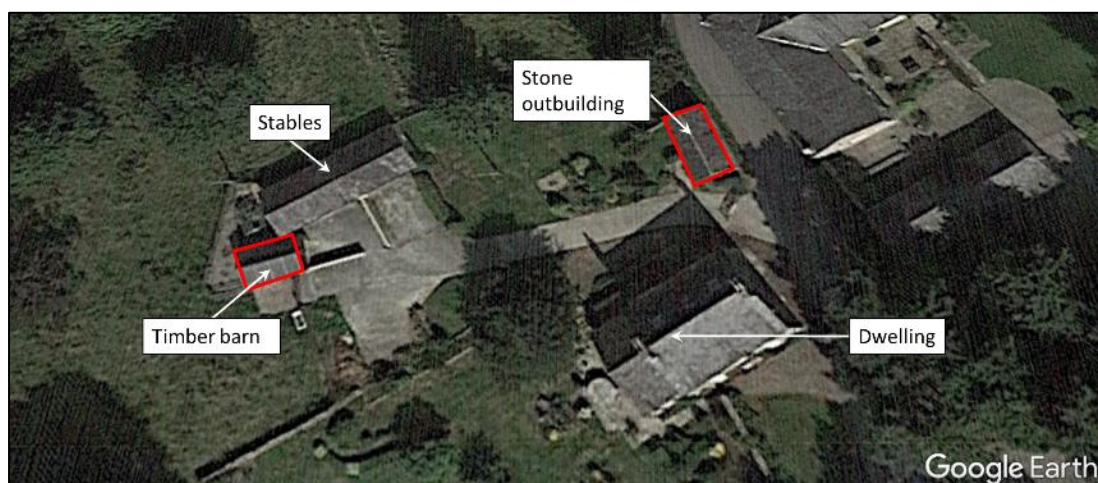
**Figure 3. Building plan, with surveyed buildings in red outline**

- 5.2.1 No signs of bat presence were recorded during the visual inspection of either the stone outbuilding or the timber barn. The location of these buildings is shown on Figure 3.
- 5.2.2 An old disused swallow *Hirundo rustica* nest was recorded from the timber barn.
- 5.2.3 The stone outbuilding was considered to display a low level of bat roost suitability with the timber barn displaying a negligible level of suitability.

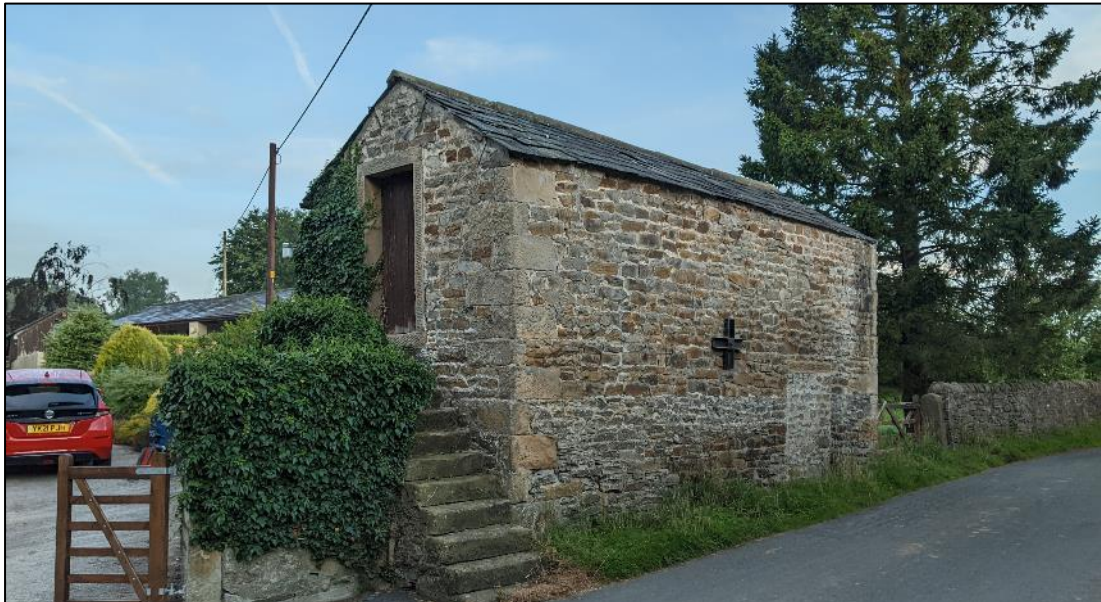
**Plate 2. Eastern corner of stone outbuilding**

- 5.2.4 The stone outbuilding comprises a small 19<sup>th</sup> Century two-storey stone building with a pitched Welsh slate roof, stone ridge tiles and mortar filled verges (Plates 2-4). The building has solid walls. There is a single first-floor wood door in the southeast gable, a wood-framed and single-paned window in the northwest gable and two wood-framed single-paned windows and a single wood door in the southwest elevation. An external

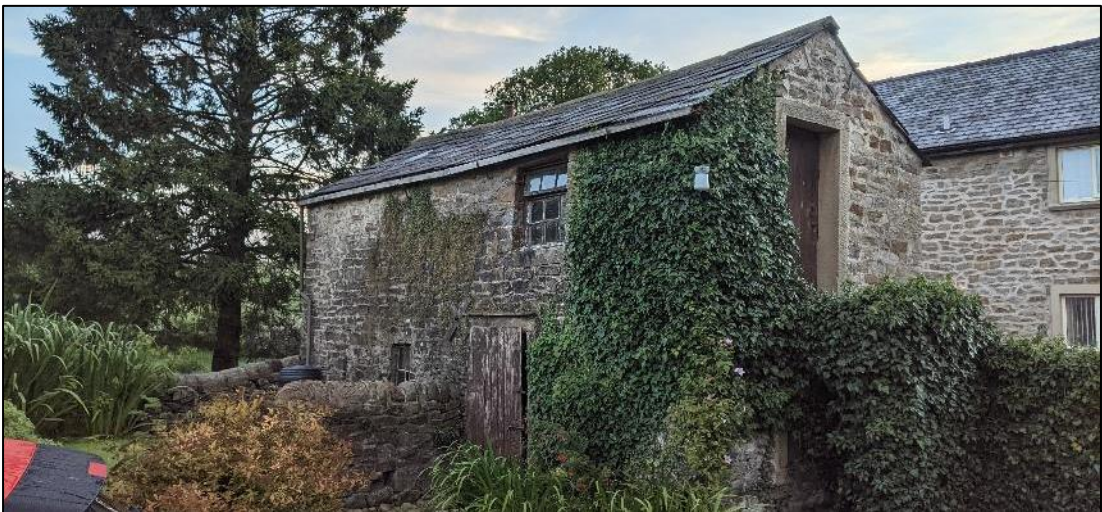
**Plate 4. Southern corner of stone outbuilding**

stone staircase accesses the door in the southeast gable. A steel wall tie is present in the northeast elevation and a wooden gutter with a metal down pipe is present on the southwest elevation. Fairly dense ivy *Hedera helix* cover is present on the southern corner of the building.

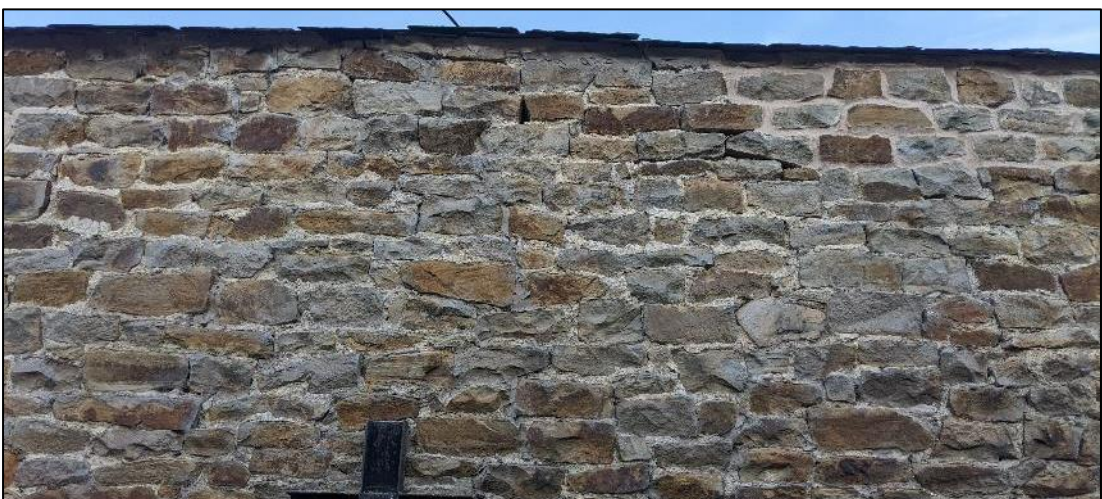
- 5.2.5 The main potential roost feature recorded from the stone outbuilding comprised occasional open joints in the masonry, most notably on the northeast elevation (Plate 5). Bats may also access the wall top in places and occasional slipped roof slates are present, resulting in crevice spaces between slates. A ladder was used to inspect open joints in the masonry.

**Plate 5. Open joints between masonry on northeast elevation of stone outbuilding**

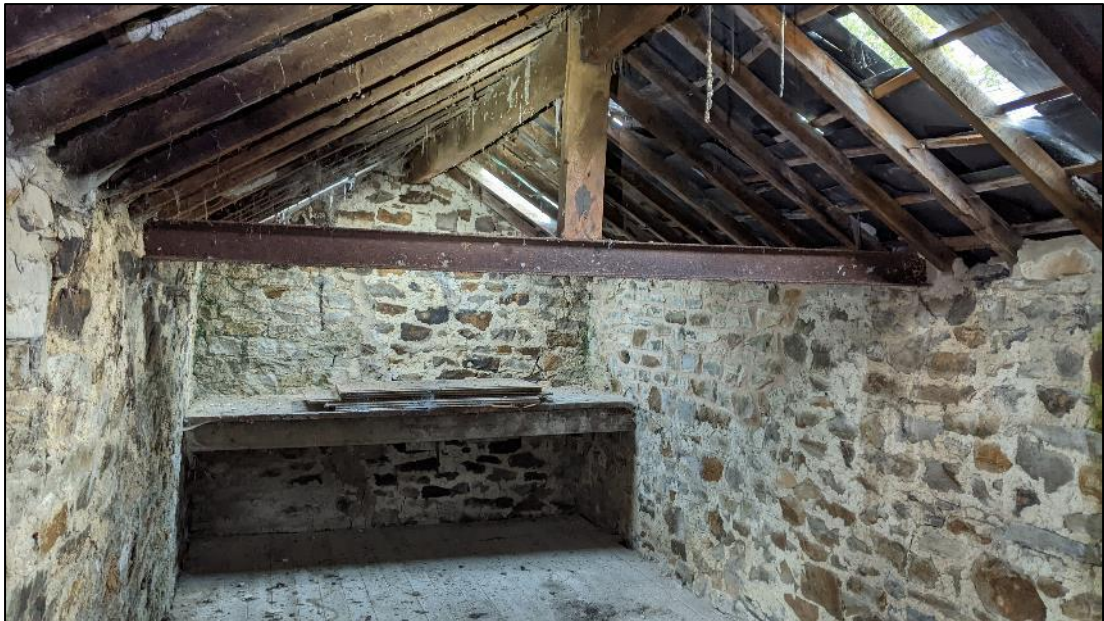
**Plate 6. Interior of first floor within stone outbuilding**

- 5.2.6 The unlined roof of the outbuilding is suspended on a ridge beam, rafters, battens and vertical wood strut suspended on a horizontal steel beam (Plate 6). Missing roof slates and windows result in a light and airy first floor, potentially accessible to bats. The first floor is not in current use, with the ground floor is used for occasional storage. No signs of bats were found (Plate 7).
- 5.2.7 The stone barn was considered to display a low level of bat roost suitability.

- 6.3.3 It is advised that use of Non-Bitumen Coated Roofing Membranes (formerly known as Breathable Roofing Membranes) be avoided during re-roofing of the outbuilding. The justification for this recommendation is that bats have been shown to regularly become entangled and die in the component filaments of modern woven roofing membranes.

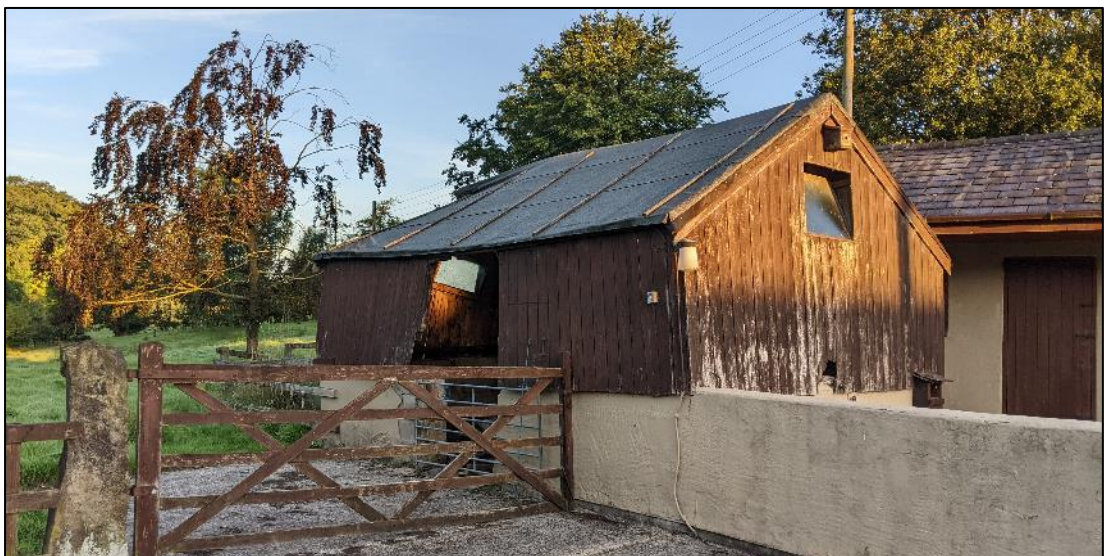
**Plate 8. Southeast corner of timber barn**

- 5.2.8 The wooden barn has brick and block walls to a height of c.1m, with timber framed wood-clad walls above that height and a pitched shed-felt covered roof (Plate 8). Open glazed windows are present in three elevations, with a door opening in the south elevation. The northwest corner of the shed is partially collapsed (Plate 9). A wooden bird box is present on the east gable.

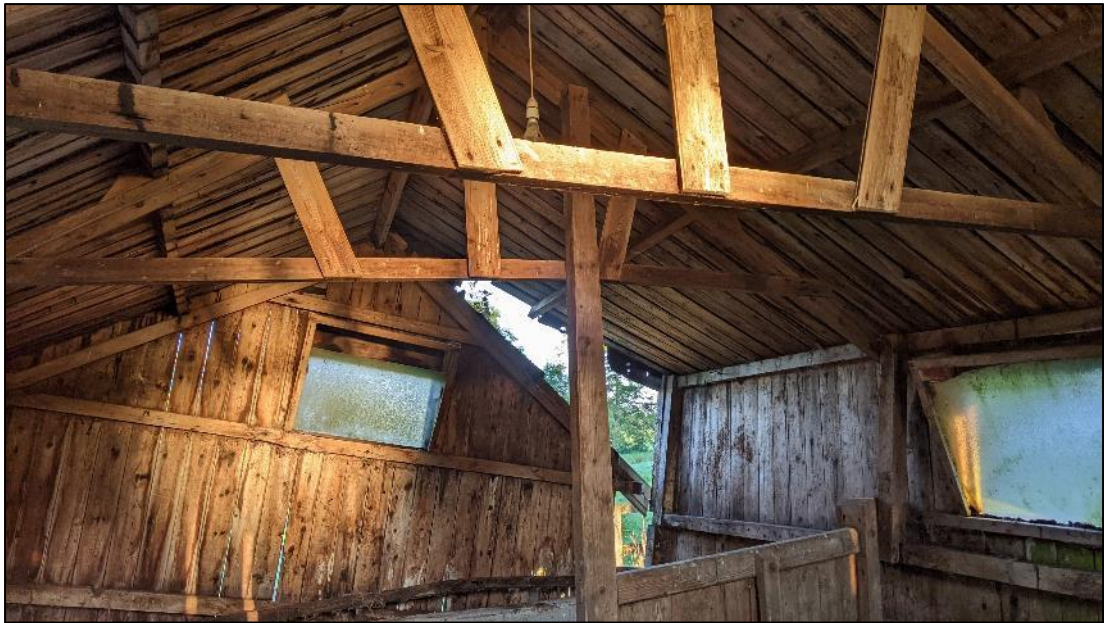
**Plate 10. Interior of timber barn**

5.2.10 Internally the roofing felt covers timber sarking with the walls unlined (Plate 10). No signs of bat presence were noted, and no potential roost features were recorded from the interior of the barn.

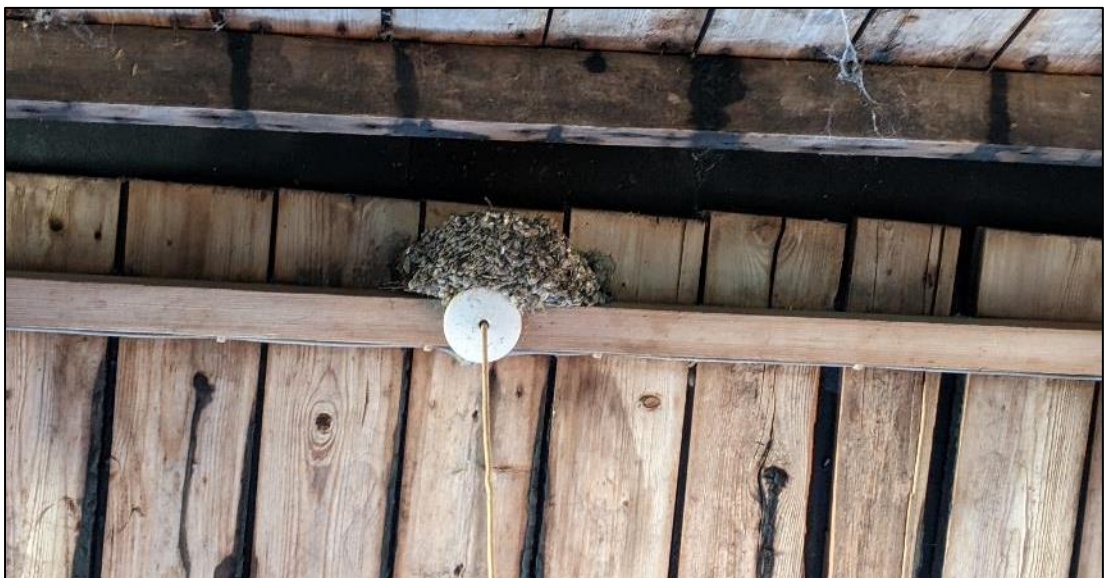
5.2.11 A disused historic swallow nest was noted from the barn interior (Plate 11).

**Plate 11. Disused swallow nest on roof timber in barn**

- 6.3.4 In order to mitigate for the loss of a historic swallow nest site during demolition of the timber barn, it is recommended that one swallow nest cup be fitted in the retained stable building (mainly used as a garage) (Plate 13). This nest cup should be fitted close to wall top height.

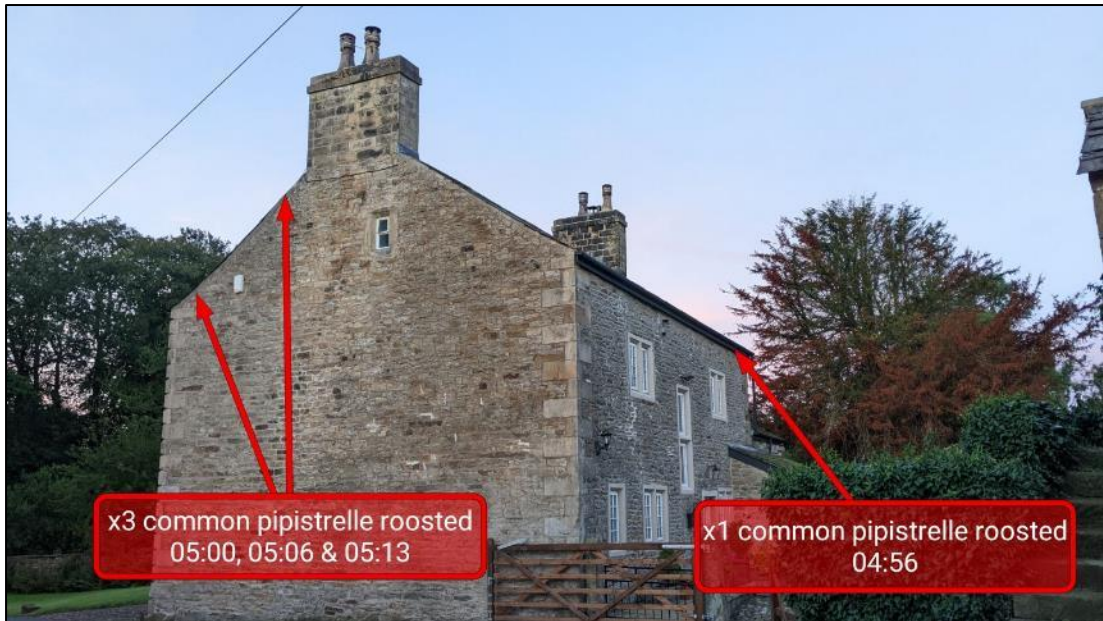
**Plate 12. Bat roost observations recorded from Higher Chipping House**

- 5.2.13 The temperature at the beginning of monitoring was 9°C, with no wind and 10% cloud cover. The temperature increased to 11°C during the survey. The weather was dry throughout. Sunrise was at 05:37.
- 5.2.14 No bat roosting activity was recorded from the stone outbuilding during the survey. Four common pipistrelle bats were however recorded occupying four day roost locations in the main house (Higher Chipping House) between 04:46 and 05:13 (Plate 12)

5.2.15 The last bat activity recorded during the survey comprised the fourth roosting common pipistrelle, recorded at 05:13 (24 minutes before sunrise). Prior to this time occasional common pipistrelle passes were noted, together with one soprano pipistrelle pass, heard at 04:37.
