# **Preliminary Bat Roost Assessment Report**

**11 Risedale Drive,  
Longridge,  
PR3 3SA**

**17.03.2022**

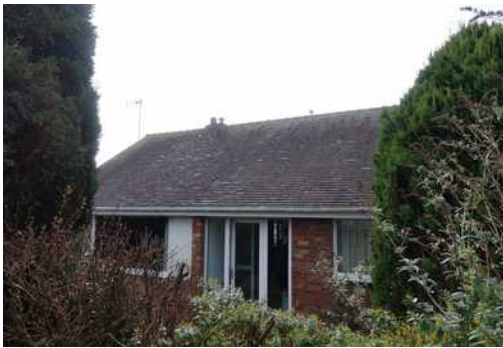
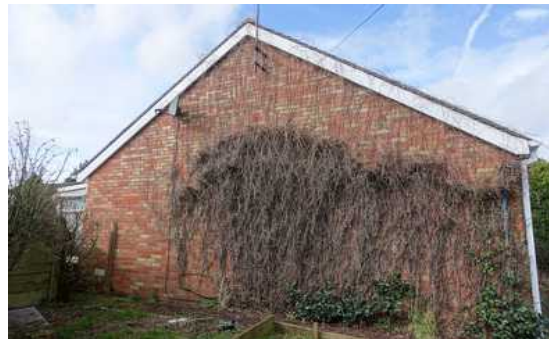
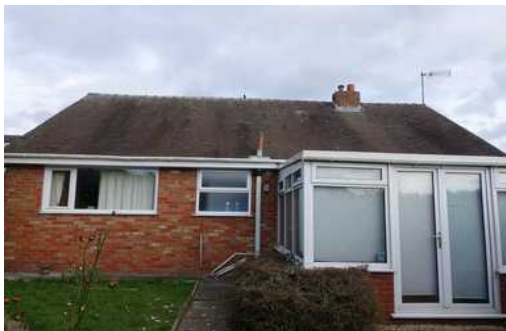
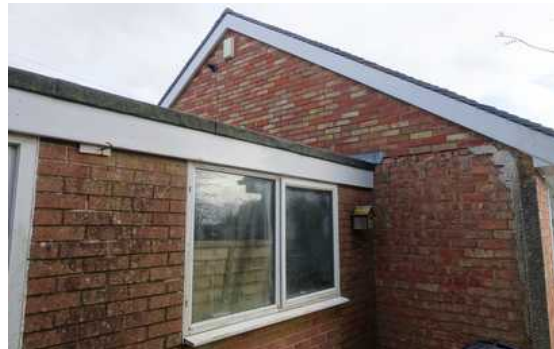
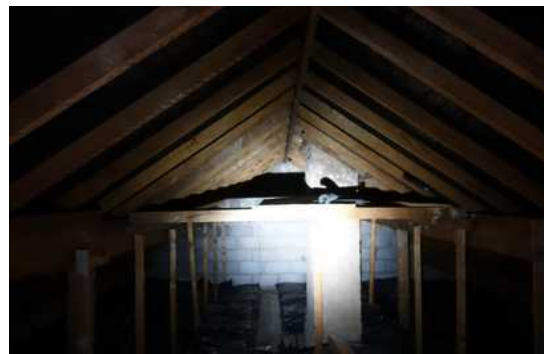
The property consists of a detached bungalow with a double pitched tile roof. A single storey flat roofed garage is present on the north gable of the building. The property has a single storey conservatory on the rear facade. External walls are well pointed, and with no cracks, crevices or cavities present. Upvc soffits and fascia boarding is close fitting and well sealed.

The roof is in good general condition with close fitting roof tiles, the ridge tiles are pointed and sealed.

The property can be considered to offer negligible bat potential.
