Preliminary Bat Roost Assessment Report

**Elliotts House Farm,
Chipping Road,
Thornley
PR3 2TS**

31.03.2022

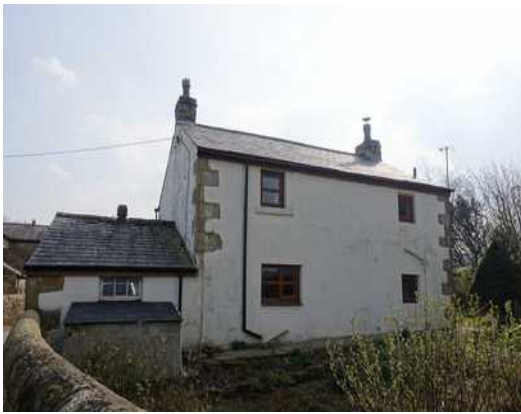
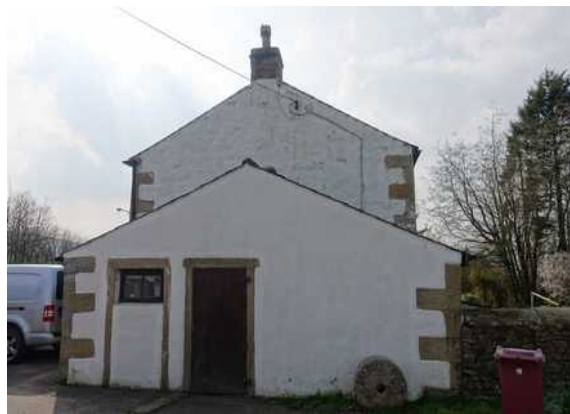
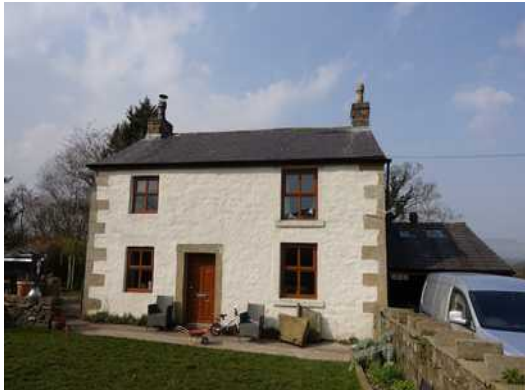
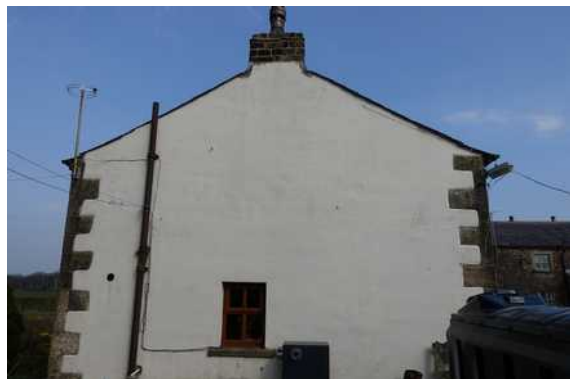
The property consists of a detached stone built two storey house with double pitched slate roof a single storey garage is present on the northeastern gable. External walls are generally rendered with no obvious cracks, gaps or crevices. Gaps were observed on the north eastern gable end on wall top/roof slate interface.

Roof slates are generally close fitting, one slipped slate and an area of lifted slates were recorded on the southern roof section. The ridge is pointed and well sealed.

Gaps were observed behind areas of fascia boarding.

The building can be considered to offer low to moderate bat potential.

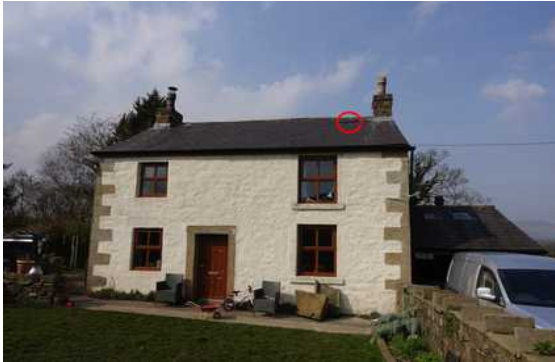
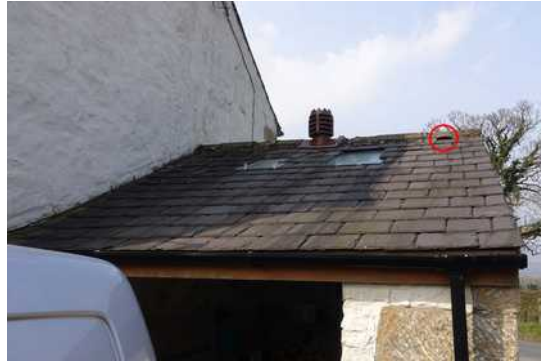
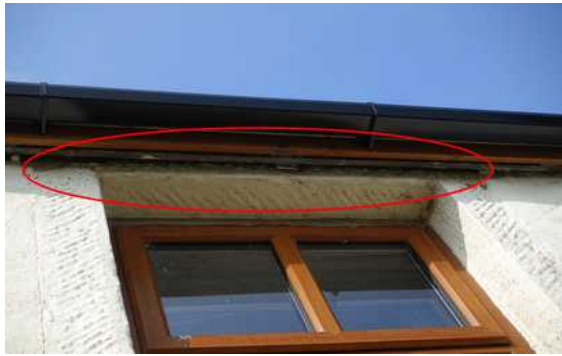
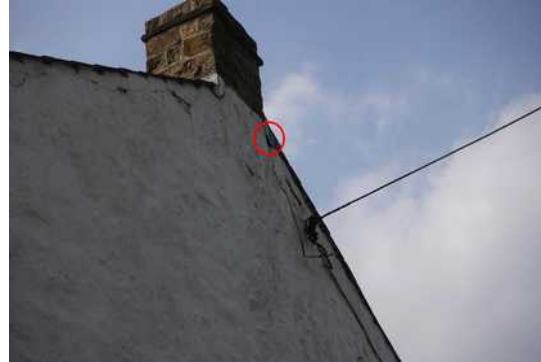
Potential roost features.

The building was assessed as offering low to moderate roosting potential with obvious gaps or crevices suitable for roosting bats on gable ends, blow lifted roof slates, within ridge tiles and behind fascia boarding.

No evidence to suggest use by bats was recorded despite suitable undisturbed horizontal surfaces being present within the garage.

Given the low to moderate bat roost potential observed up to two emergence surveys should be carried out. The surveys should take place between May and August inclusive.

Use of Infrared Video is recommended during surveys given potential for presence of brown long eared and natterer's bats.
