# **Preliminary Bat Roost Assessment Report**

**138 Ribchester Road,  
Clayton le Dale,  
BB1 9EE**

**21.04.2022**

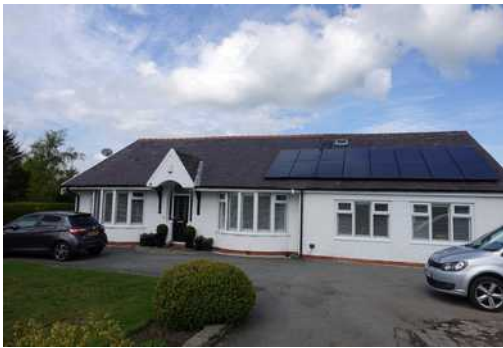
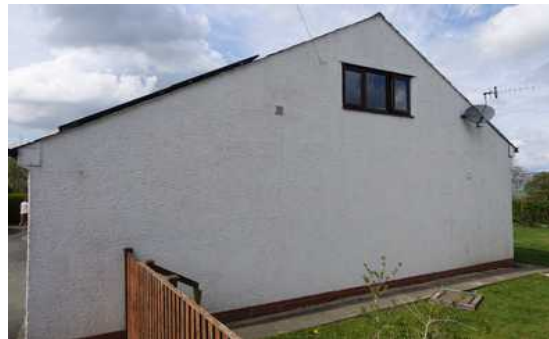
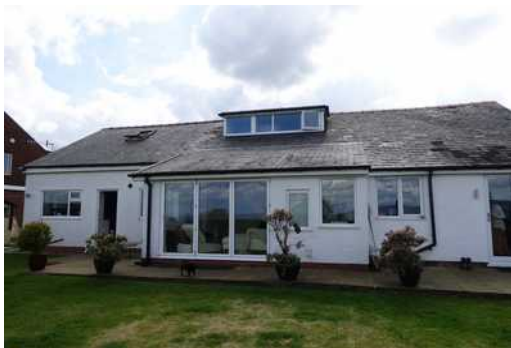
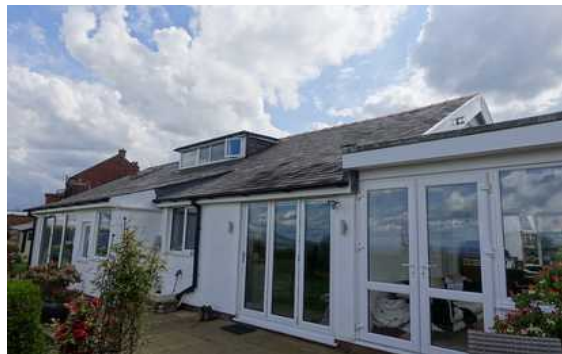
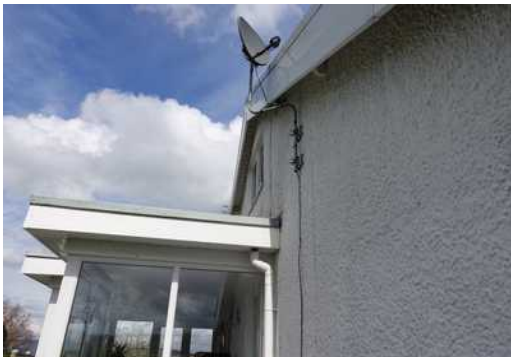
The property consists of a detached dormer bungalow with a double pitched slate roof, a single storey conservatory is present on the northern gable. External walls are rendered, painted and well pointed with no cracks, crevices or cavities present. Gable ends are pointed and well sealed. Upvc soffits and fascia boarding where present is close fitting and well sealed.

The roof is in good general condition with close fitting roof slates, the ridge tiles are pointed and sealed.

The property can be considered to offer negligible bat potential.

The property is well maintained, well sealed and was assessed as offering negligible roosting potential with no obvious gaps or crevices suitable for roosting bats.
