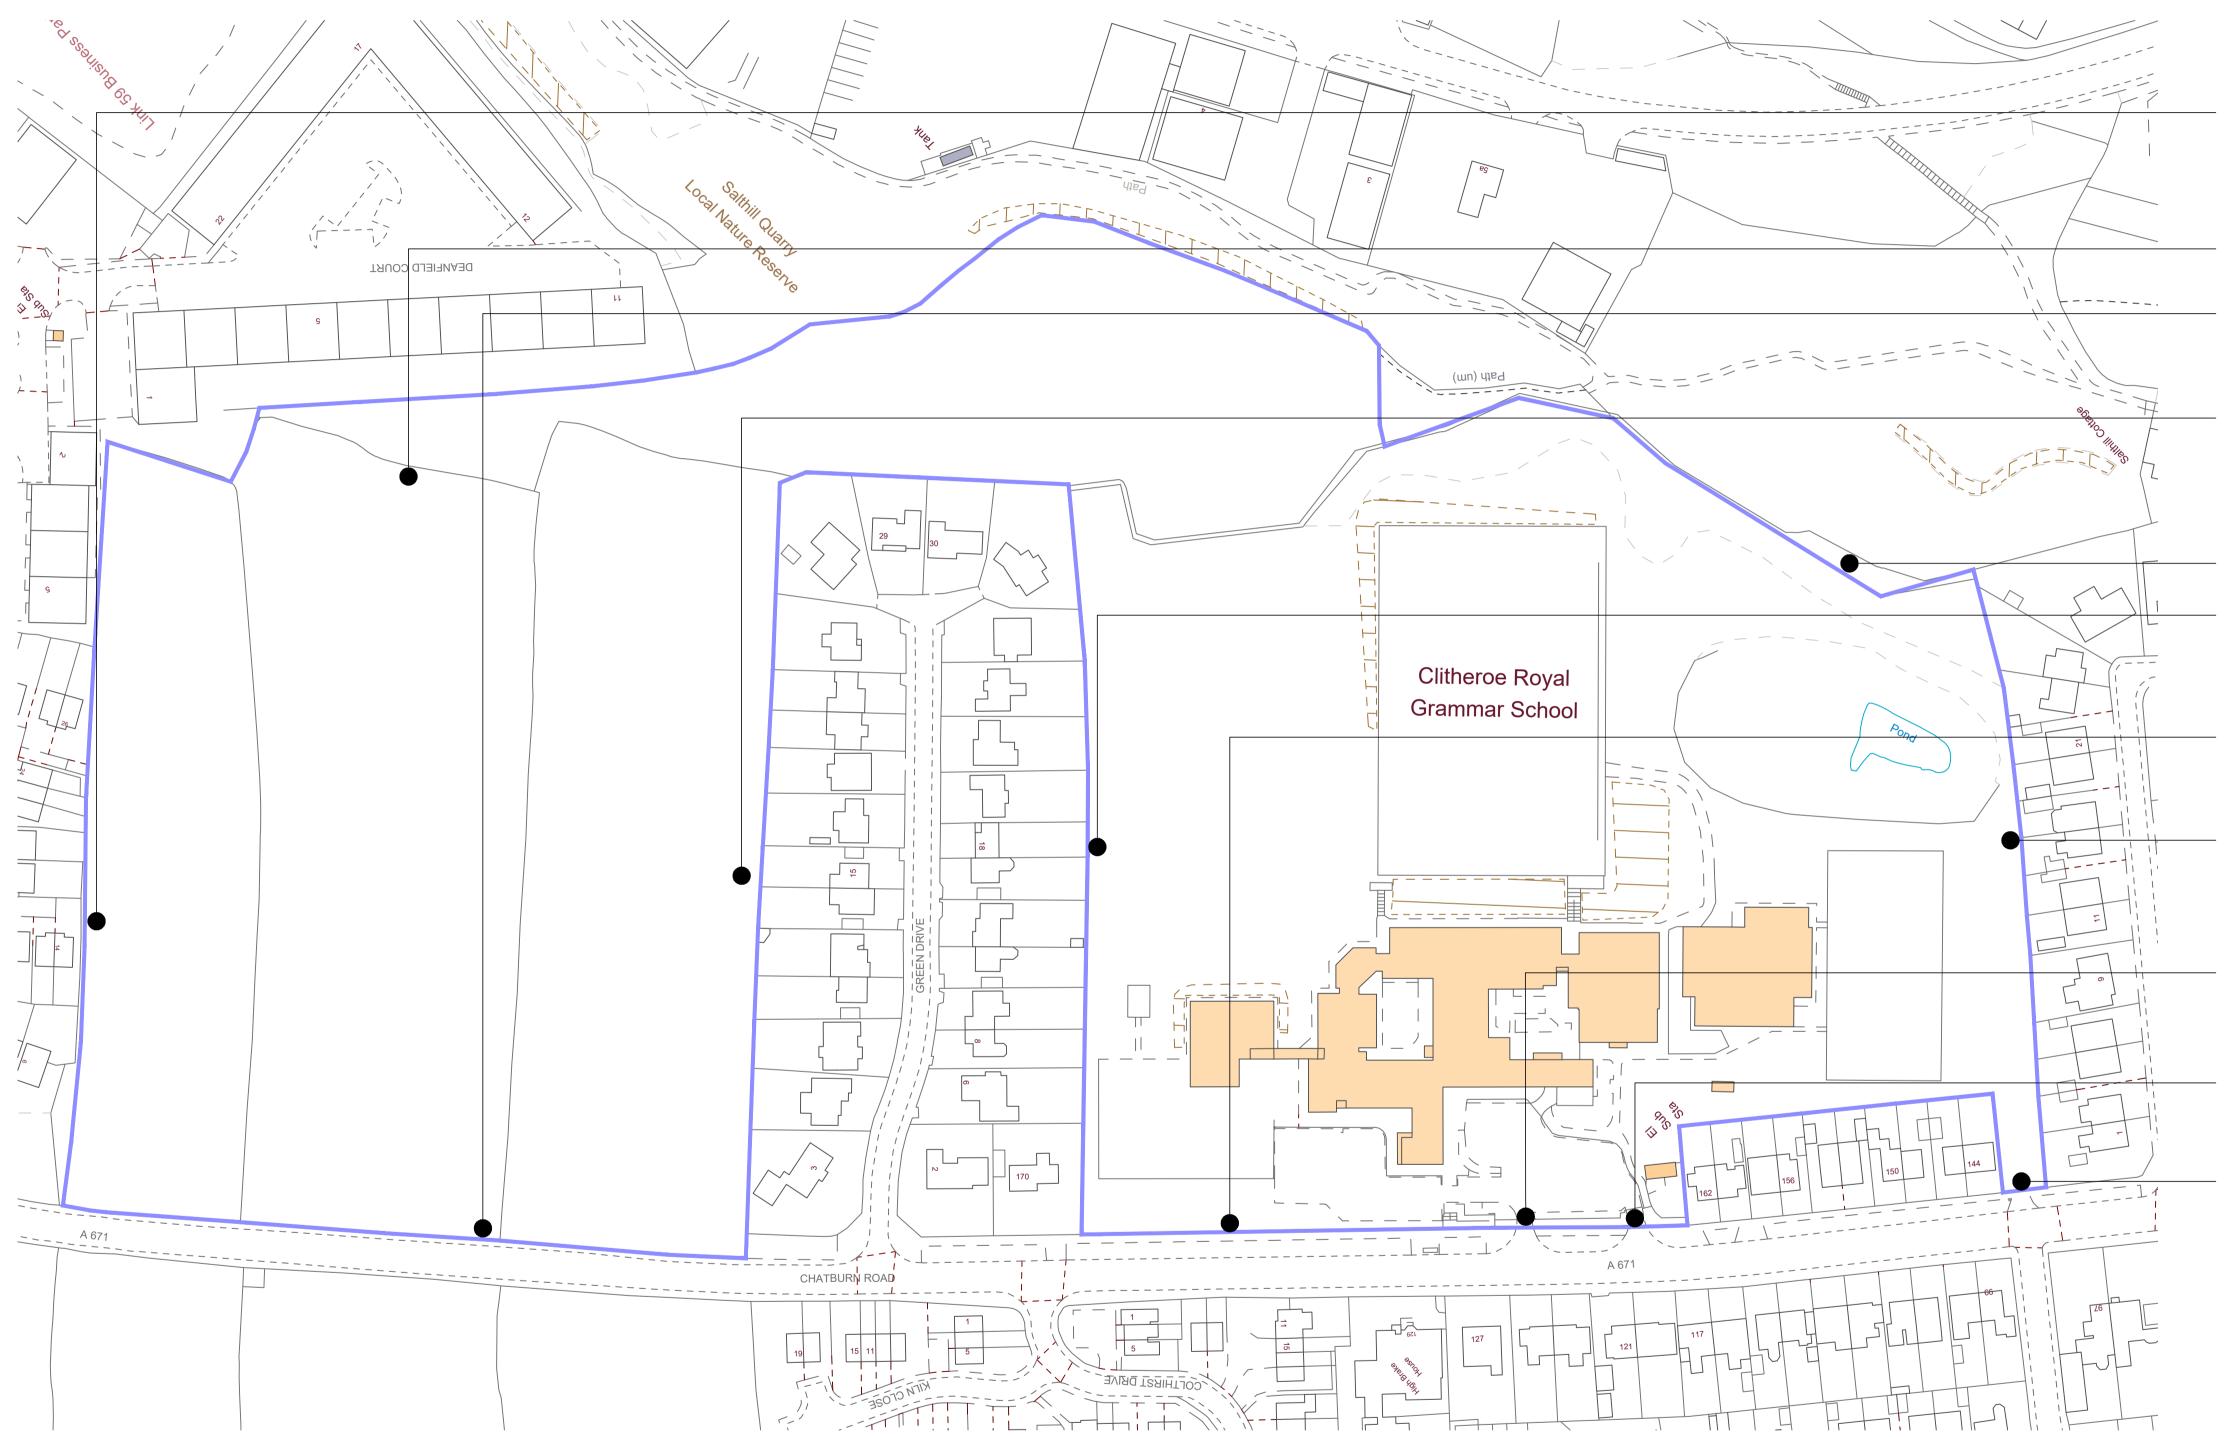
Existing low level wired fencing noted, circa 1.2m in height which straddles the boundary between the school grounds and the neighboring gardens. Noted to provide minor security measure to the side of school.

Existing shrubbery and trees noted to rear of site.

3No. Existing farm style gate and low level transparent timber picket fence offering inadequate security protection from vandals and trespassers alike.

Existing low level fencing noted, circa 1.2m in height which straddles the boundary between the school grounds and the neighboring gardens. Noted to provide adequate security measure to the side of school.

Existing low level retaining wall, circa 1m in height offers adequate security protection from vandals and trespassers alike.

Existing low level gate, circa 1.2m in height noted to vehicular entrance. Low level pedestrian access gate noted. Noted to provide minor security measure to the front of school

Series of existing low level gates, circa 1.2m in height noted to vehicular exit. Noted to provide minor security measure to the front of school

Existing farm style gate offering inadequate security protection from vandals and trespassers alike. Requires a new 2m high
