# **Preliminary Bat Roost Assessment Report**

**1 Fairfield Close,  
Clitheroe,  
BB7 2PL**

**27.04.2022**

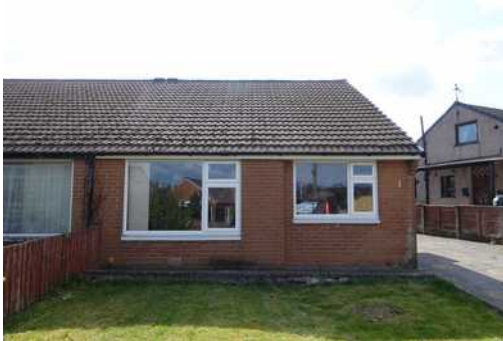
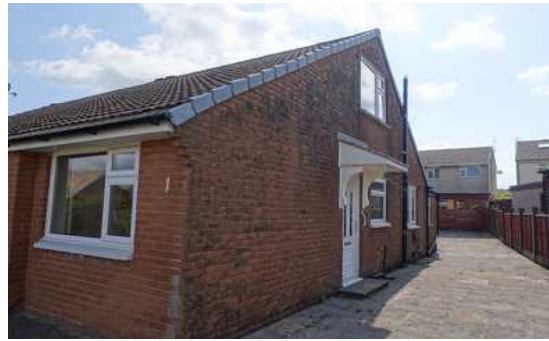
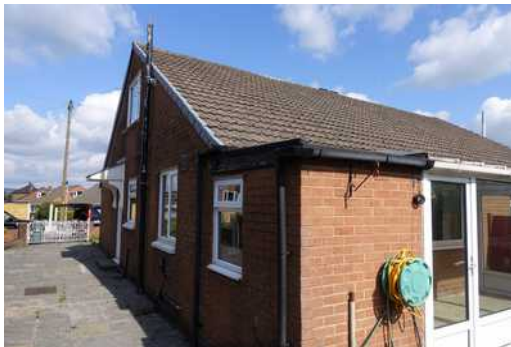
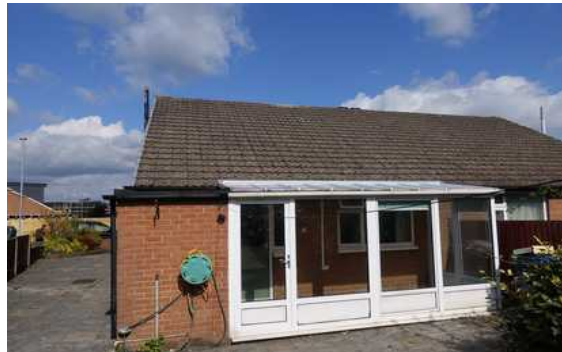
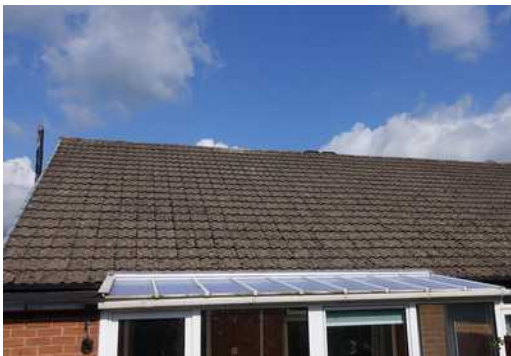
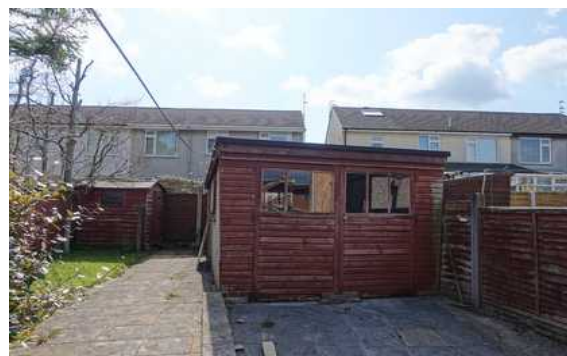
The property consists of a semi detached bungalow with a double pitched tiled roof, a single storey conservatory/extension is present to the rear. External walls are well pointed with no cracks, crevices or cavities present. The gable end is pointed and well sealed. Upvc soffits and fascia boarding where present is close fitting and well sealed.

The roof is in good general condition with close fitting roof tiles, the ridge tiles are pointed and sealed. A single storey detached garage is present.

The property can be considered to offer negligible bat potential.

The property is well maintained, well sealed and was assessed as offering negligible roosting potential with no obvious gaps or crevices suitable for roosting bats.
