**1 Parsonage Avenue,
Ribchester,
Preston
Lancashire
PR3 3ZH**

**Preliminary Survey & Assessment
in Respect of Bat Species and Nesting Birds.**

Echo Calls Bat Surveys

2nd June 2022

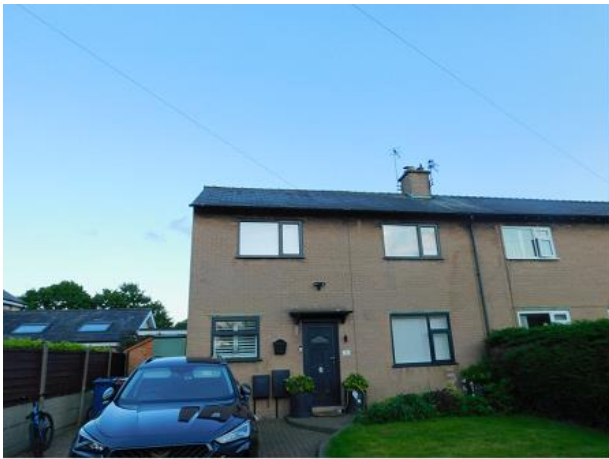
PHOTO 1
Northern Elevation of Dwelling

All parts of the dwelling, the extension and its conservatory, were all in excellent condition, being well-maintained, with well-sealed walls, windows, doors, gables, soffits and roof, and offered negligible opportunities for roosting, and therefore all were judged to be of low bat roost suitability.

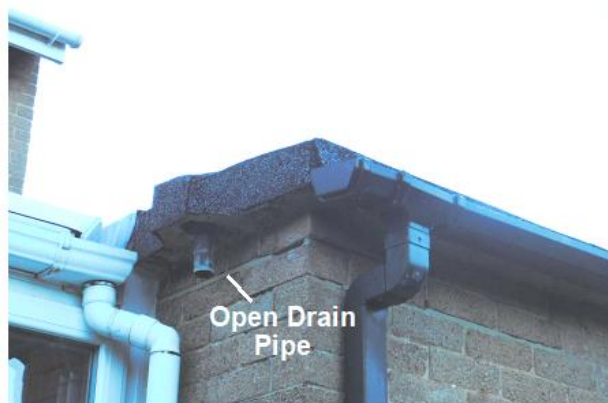
PHOTO 14
South-western Corner of Kitchen Extension

- At the south-western corner of the kitchen extension at its junction with the conservatory, there was an open vertical drain pipe, however an inspection of this found the pipe to be open both at its base and at its top, and therefore was judged to offer no bat roosting potential, (refer to **figs 3, 4 and 5**, and **photo 14**).

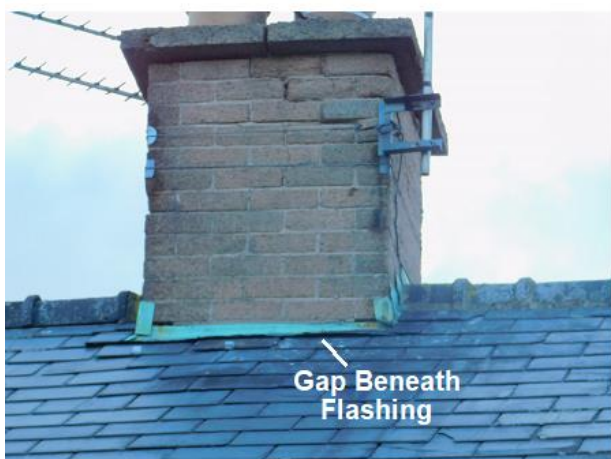
PHOTO 17
Southern View of Chimney

- An inspection of the chimney positioned centrally on the roof, found a strip of flashing at the base of the chimney stack to have lifted, resulting in a gap large enough for bats to potentially use. However, a close inspection of the gap using close-focus binoculars, and also a visible search of the roof beneath the gap, found neither bat droppings, invertebrate prey remains, urine staining, nor any fur staining from continual passage between the sides of the gap, nor were any bats themselves found, and therefore the gap was deemed to offer low bat suitability, (refer to **figs 3, 4 and 5**, and **photo 17**).

5.3 However, as is likely that the building will be worked on at other times, it will be very unlikely that roosting bats will be disturbed, but it is recommended that work starts as soon as possible after this survey, and that any ridge tiles, slates or sheeting over walls and gables, be carefully removed by hand, (the ridge and edge tiles, and copingstones, are the features most likely to harbour potential for the support of roosting bats).
