# **Preliminary Bat Roost Assessment Report**

**2 Bramley View,  
Barrow,  
BB7 9AL**

**11.05.2022**

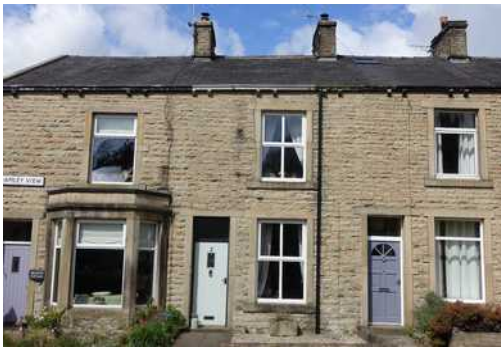
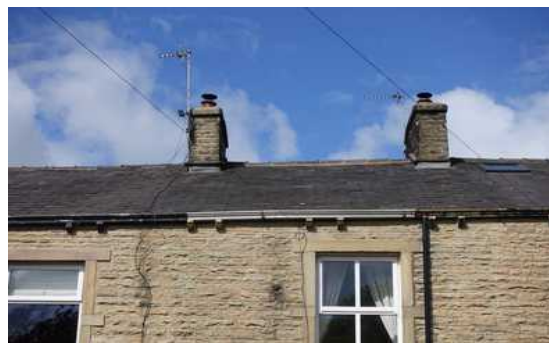
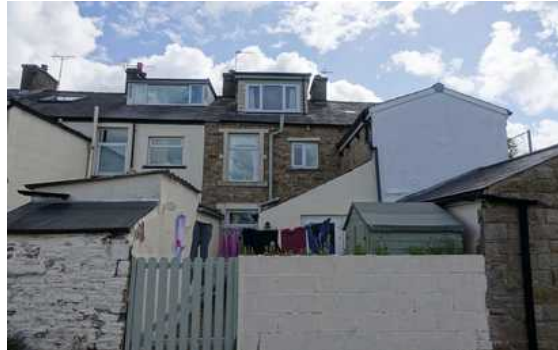
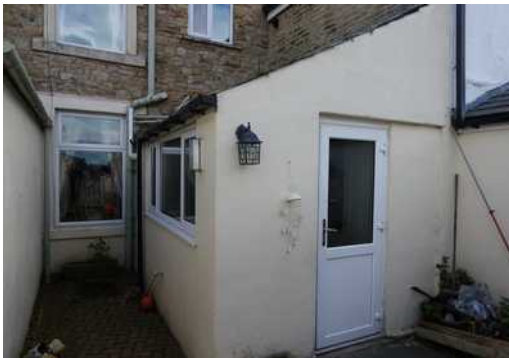
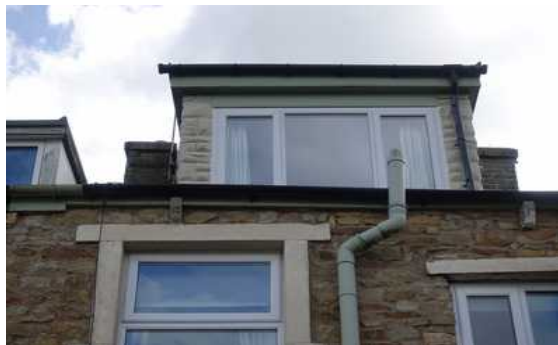
The property consists of a stone built mid-terraced two storey house with a double pitched slate roof, the property has a single storey extension to the rear. External walls are well pointed with no cracks, crevices or cavities present. Fascia boarding where present is close fitting and well sealed.

The roof is in good general condition with close fitting roof slates, no evidence of slipped, lifted, or missing slates was observed. The ridge tiles are pointed and sealed. Lead flashing where present is tight and close fitting. A dormer is present on the rear roof face.

The property can be considered to offer negligible bat potential.

The property is well maintained, well sealed and was assessed as offering negligible roosting potential with no obvious gaps or crevices suitable for roosting bats.

No evidence to suggest use by bats was recorded.
