**BAT SURVEY AT -  
ABBAY HOUSE  
WORSTON**

REFERENCE NO. 6198

## **PROPOSED DEVELOPMENT**

Demolition of garage prior to constructing new single storey extension

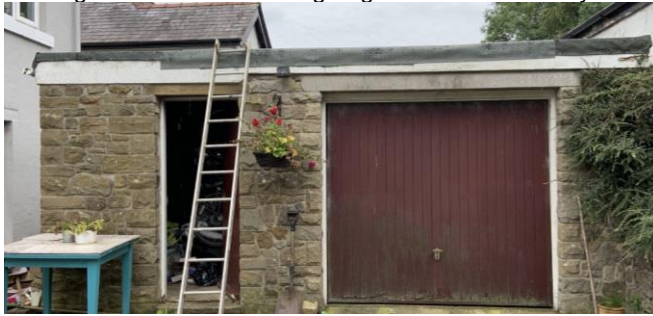
The building is a detached garage adjacent to a detached property. It comprises of a garage section with an adjacent store area, accessed via a personnel door. At the rear corner of the building an open sided wood store is formed by infilling the corner with a timber wall and with roof over. There are no window openings in the building. The rear wall of the garage is on the boundary of the property.

Front elevation

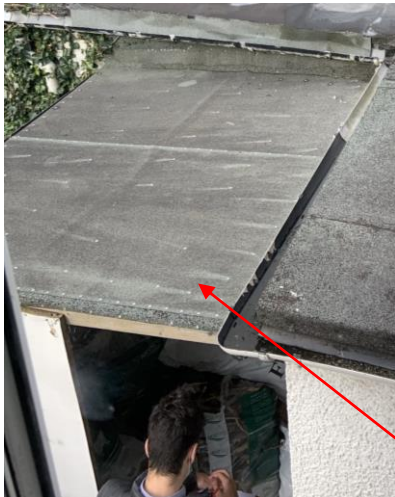
Infill timber roof over open store

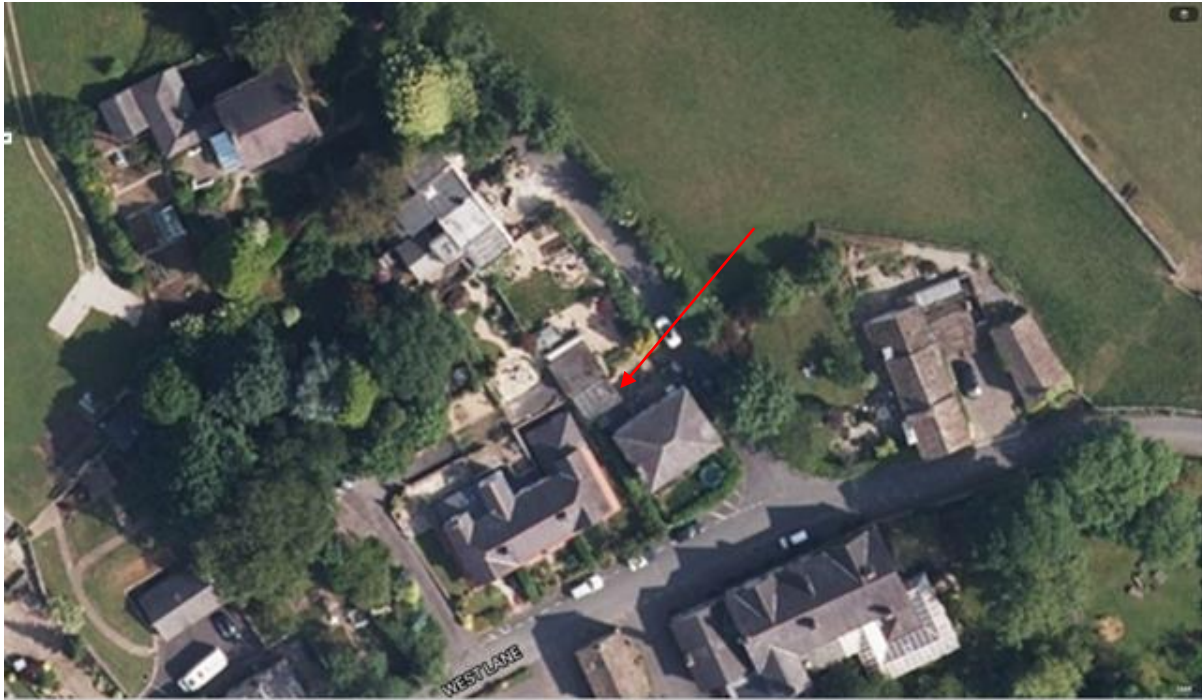
The garage is a relatively new structure in relation to the adjoining house. the walls are block work with a stone cladding to the front north east elevation. the north west side elevation has a smooth unpainted render finish. the south west and rear elevation has a rough cast painted render finish.

All the walls are in reasonable condition and do not have any cracks, crevices with the potential to provide any roost habitat, nor access points into the interior.

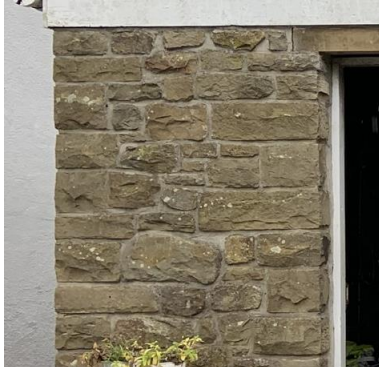
Front elevation

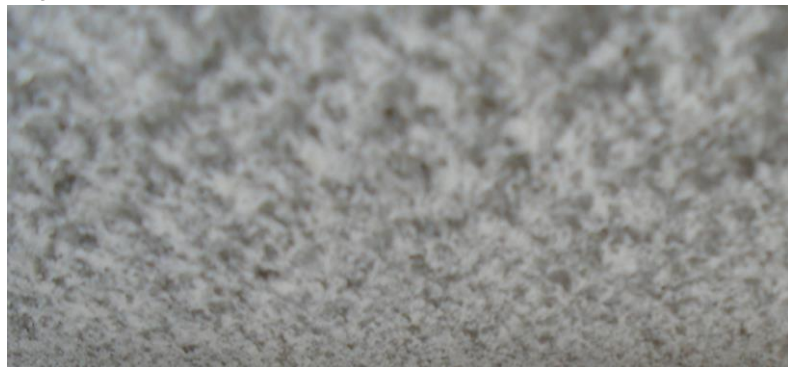
South west elevation

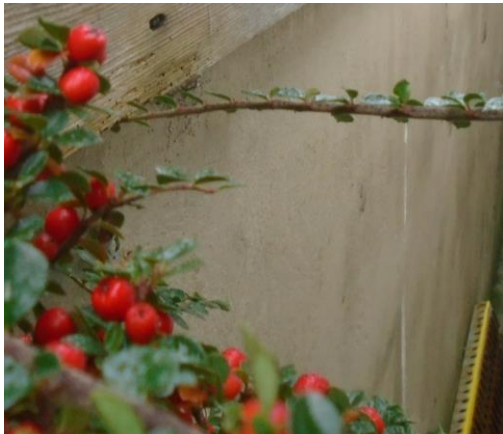
North west elevation

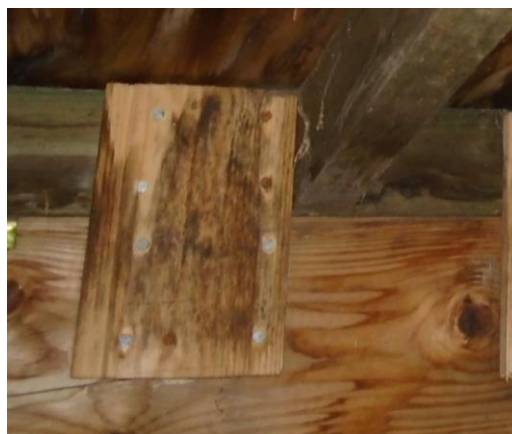
Interior of single skin timber wall to open store

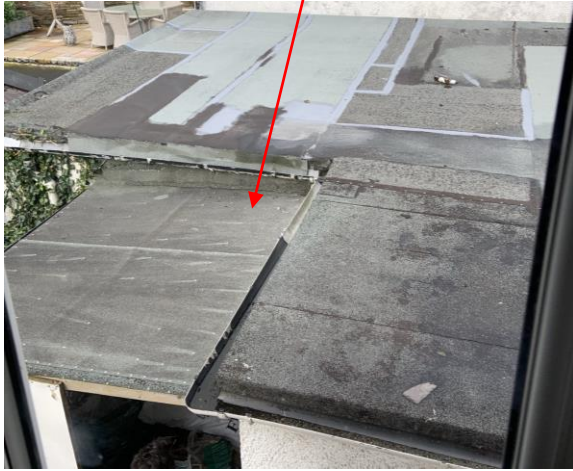
The roof is flat with a patchwork of bitumus felt covering. The open shed roof is set below the main roof felt fixed over timber deck as before.

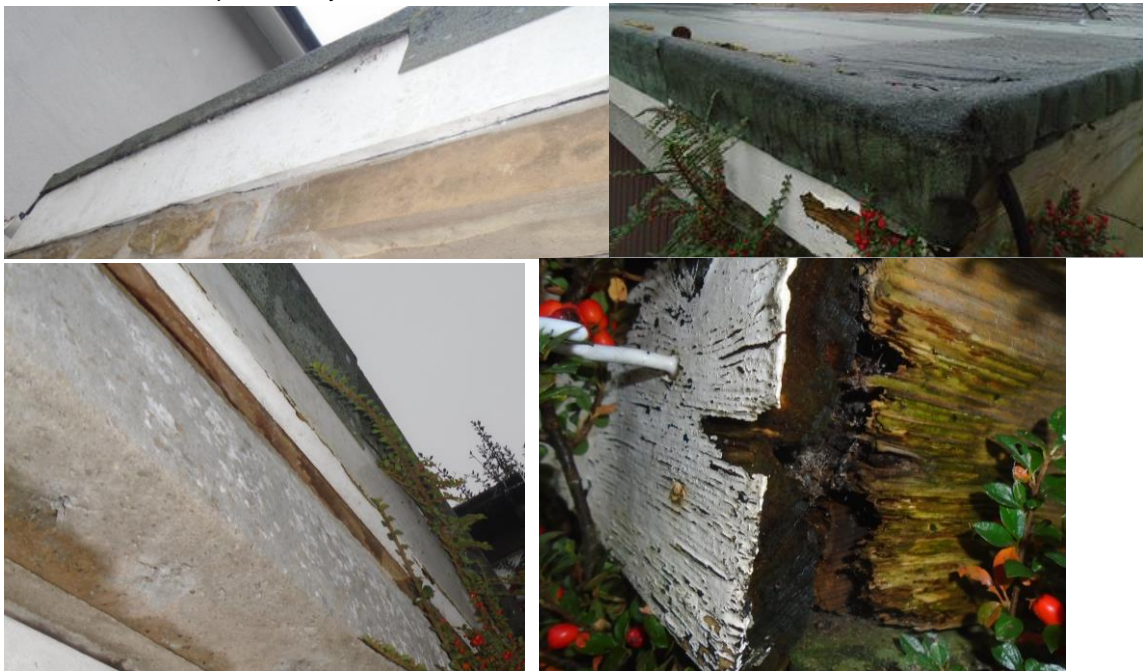
Although the roof appears to be in a poor condition, close inspection did not reveal any ingress points, tears or lifted sections at the verges with the potential to provide any roost opportunities for bats. The front, north west side and rear fascia's are flush to the walls and in reasonable condition and do not provide any crevices behind. However the north corner is rotten and does provide a gap which was possible to examine closely, the gap was shallow and did not provide any roost habitat.

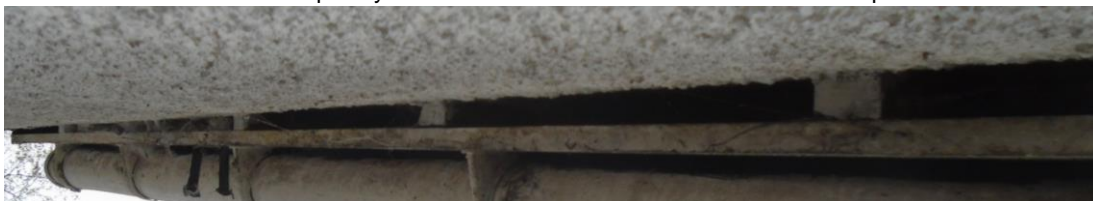
The south east elevation fascia has a small void behind but was easily examined, there was no access to the interior and the void was completely visible. No current or historic evidence of bat presence was found.

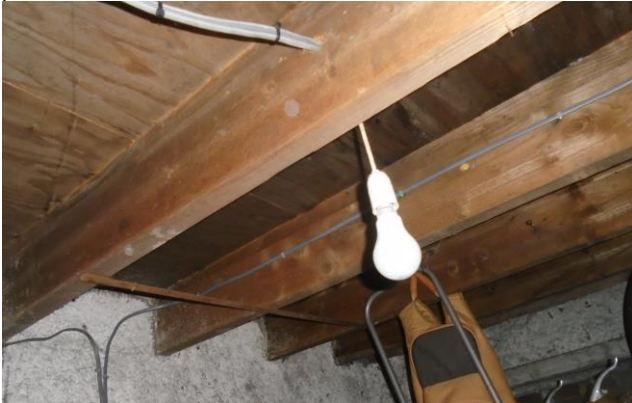
There was not an enclosed roof space in the garage the ply deck and joists were fully visible and closely inspected. The timbers were in good condition with no cracks or crevices the structure did not provide any roost potential for bats.

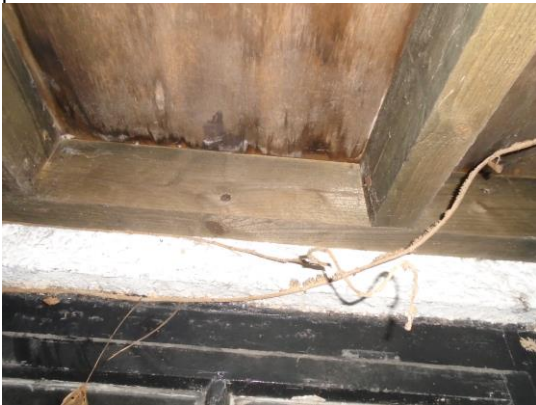
The Open store roof is timber rafters with ply fixed over, as before the structure did not provide any roost potential for bats.
