**BAT SURVEY AT -
HIGHER COLLEGE FARM
And ADJACENT LAND
LOWER ROAD
LONGRIDGE
PR3 2YY**

DATE AND TIME OF VISIT
9th Sept 2021 7.45 pm

REFERENCE NO. 6478

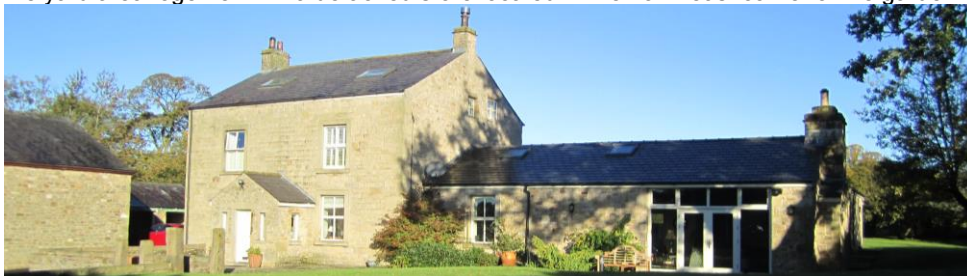
South elevation Farmhouse.

The building is a currently occupied dwelling which consists of an original two storey farmhouse which has been extended into the converted attached single storey outbuildings. There is a detached double garage located in the yard area together with a detached store located in the north east corner of the garden.

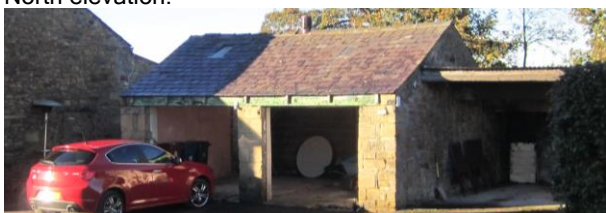
Garage outbuilding

The garage roof slates were in reasonable condition and were generally tight fitting and did not provide any crevices suitable for bat entry. The car port sheet was also in reasonable condition with no holes or gaps. However the interior of the buildings are freely accessible via the door openings.

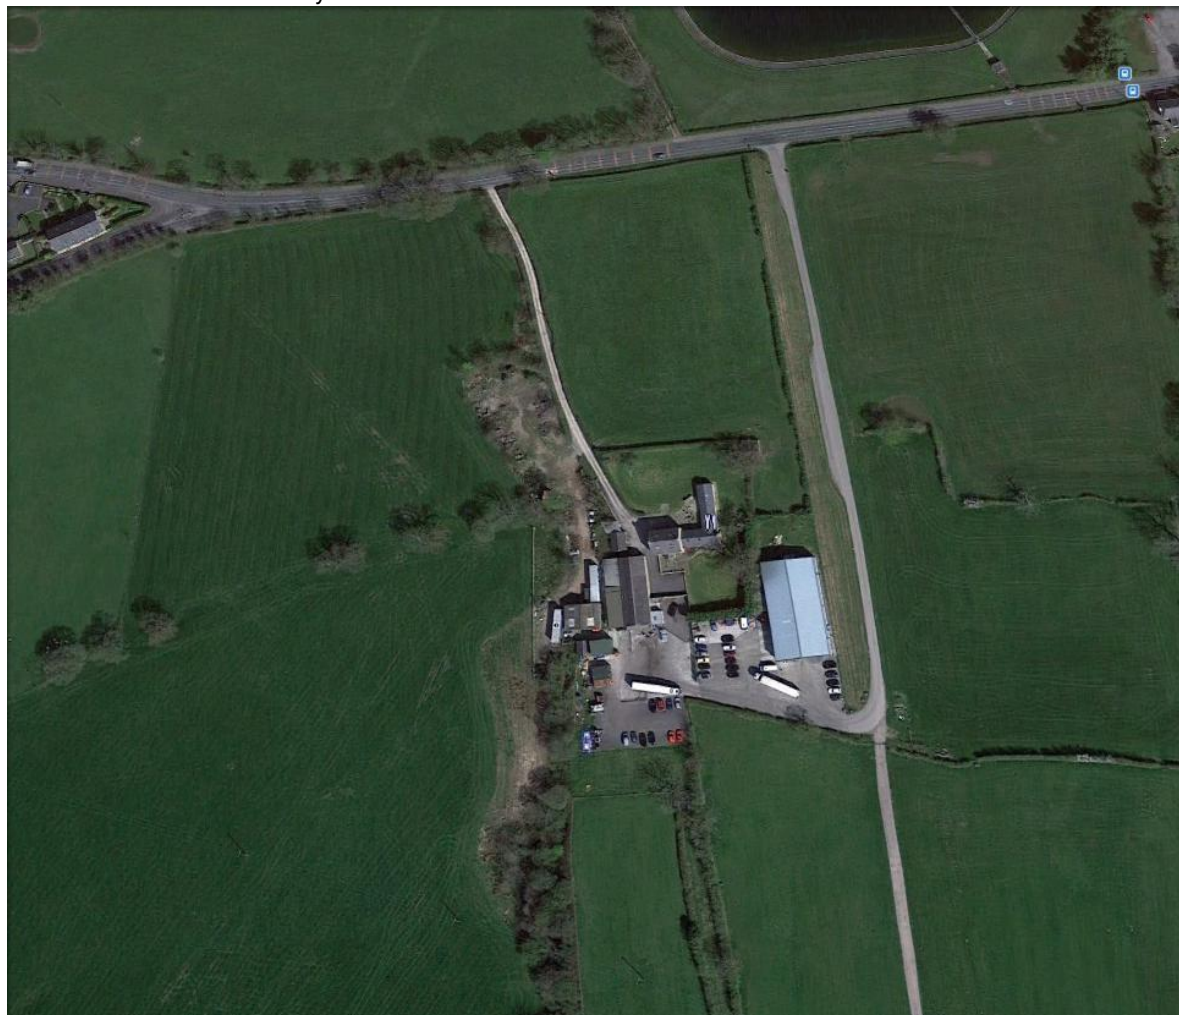
The house is located in a garden which extends to the north and south of the buildings, it is mainly laid to lawn with trees and hedgerow forming the boundary. The rear (south) boundary is adjacent to a functioning commercial depot. The north boundary also forms the south boundary of the field (proposed development site). 200m to the north of the site are two reservoirs a further reservoir is 770m to the south west. A tree lined brook flowing in a southerly direction passes within 50m of the house, the trees lining it increase to form a more extensive but still linear wooded area further to the south.

The access roads both to the farm and the commercial site form the west and east boundaries of the proposed development field, all the boundaries are hedgerow. The farm access road also has some broad leaf trees lining the west side. The site is between commute/ forage avenues which are linear and run in a north /south direction to the west and east boundary of the site.

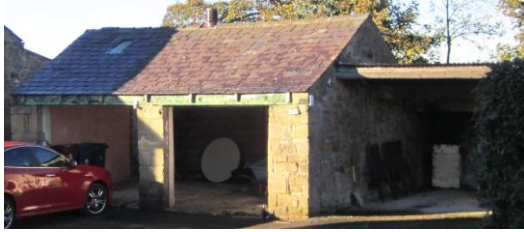
The garage roof is a pitched natural slate construction with a couple of glazed lights. There is a car port to the north elevation which has a mono pitch corrugated fibre cement sheet covering.

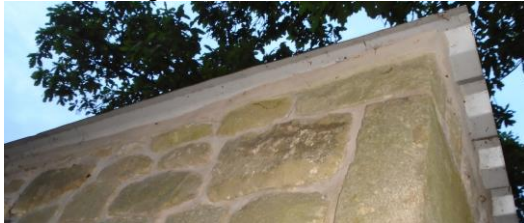
The store has a mono pitch roof with a corrugated steel sheet roof, the abutments with the wall are pointed.

The store steel sheet covering and pointing appeared to be relatively new both were in perfect condition with no possible access points.

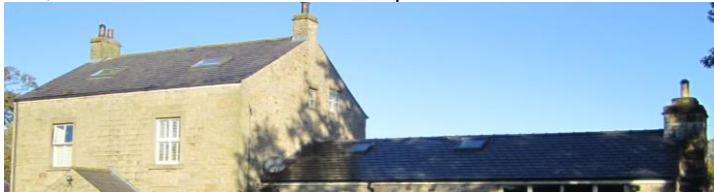
House roof south elevation

The house roof is pitched over the main two storey section and the single storey wing. All the roof coverings are natural blue slate, with roof windows in the southern facing pitches. The gutters are fixed to a timber fascia flush to the wall.

The house slates, ridge slates and flashings are in perfect condition with no gaps however an emergence survey carried out 01/06/17 recorded bat roosts present in the South west and north west corners of the two storey section of the farmhouse,

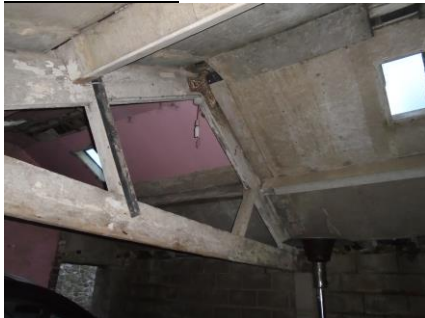
Garage roof : There is no enclosed roof space, timber trusses, purlins and rafters, rafters boarded out to the underside. Timber structure was easily examined but not possible to fully inspect behind the boarding. Gaps in the boarding were checked for any signs of grease marks, droppings or staining. The result was negative.

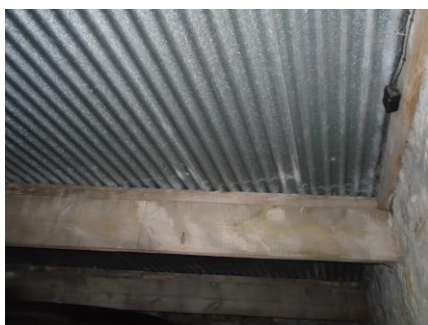
Car port roof : There was no enclosed roof space, the sheet was fixed directly to timber purlins. All the structure was easily examined. The space did not provide any potential habitat for bats.

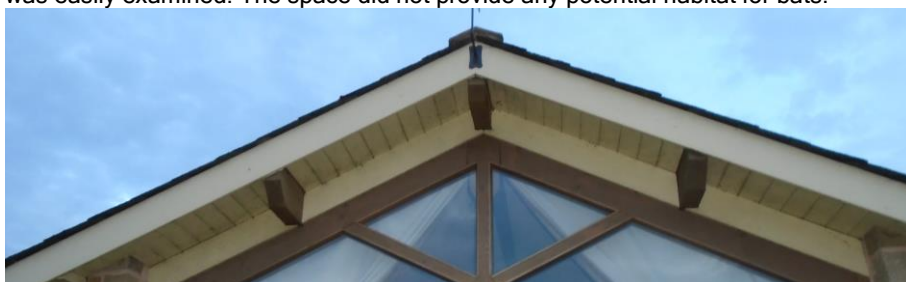
The roof void in the main house is lined out with plaster board to the underside of the rafters to form bedroom accommodation with roof windows. There is no enclosed roof space in the single storey wing the rafters also being lined out with plaster board.

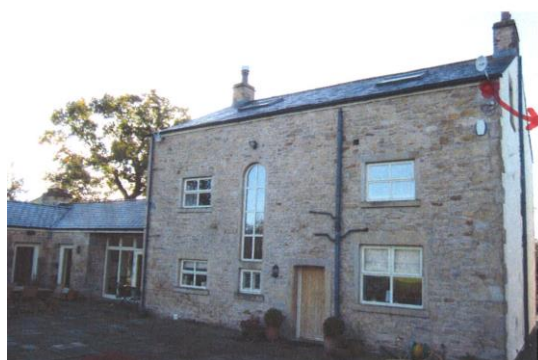
North elevation

←Historic Emergence point and direction of flight. As of 01/06/17

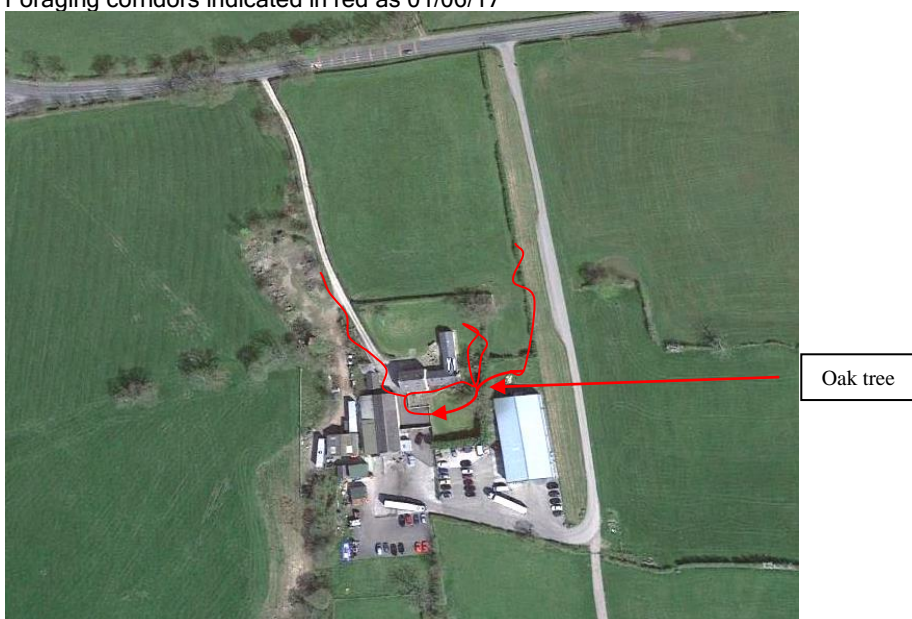
At 8.05pm bat activity was detected before any sighting from the trees to the east side of the garden particularly the Oak tree on the boundary. The first sighting was 8.15 pm appearing from the direction of the Oak tree and proceeded to forage in the garden to the east of the house and around the rear yard area adjacent to the neighbouring barn. This activity continued for approx. ½ hour, approx 3no bats carried out this foraging activity, the actual emergence location could not be determined as it was not on the site. No bats emerged from any of the buildings on site.

Some minor activity was detected (although not seen) in the trees lining the west side of the west access track. The current Pipistrelle bat foraging activity is indicated on the aerial photo below together with the results from the 2017 survey.

Bats do not generally fly over open land preferring to follow tree or hedge lines, this pattern of activity was confirmed during this survey. All activity was confined to the corridors indicated on the aerial photograph. The survey continued until it was too dark to see.

Foraging routes recorded 09/09/21
