**BAT SURVEY AT -  
29 LANGSHAW DRIVE  
CLITHEROE**

**DATE AND TIME OF VISIT  
23<sup>rd</sup> June 2022 5.30 pm**

**REFERENCE. Mr & Mrs Harrison**

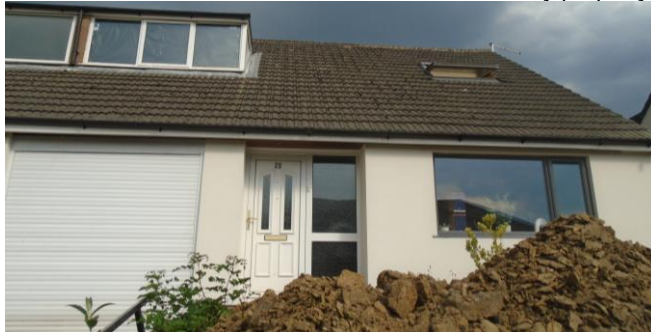
Front Elevation

The house is an inhabited semi detached 1½ storey property, probably dating from the 1960's /70's

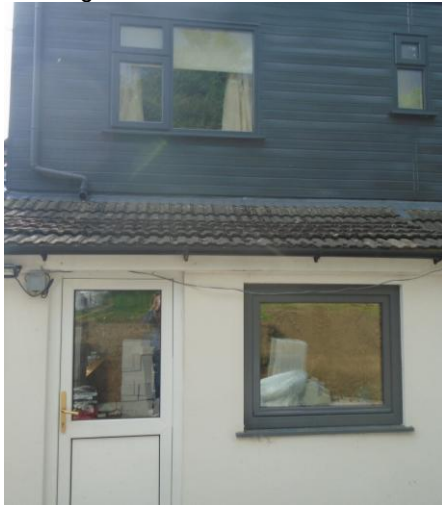
The walls are cavity construction with smooth white render finish. The rear dormer walls have a upvc sheet cladding finish. The front dormer has white upvc cladding walls.

The wall render is in perfect condition with no cracks or crevices. The upvc cladding appears to be relatively new and is in excellent condition and tight fitting. Access points, cracks or crevices are not present.

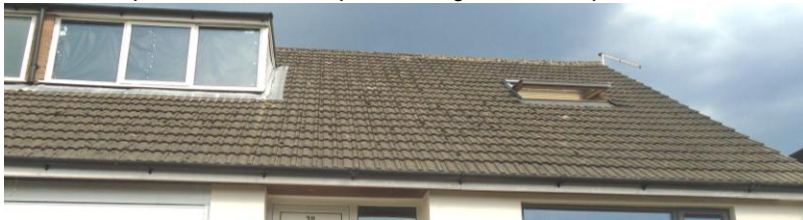
Front roof pitch

The main roof is pitched with upvc fascias and soffits. The finish is profile tile with ridge tiles. There is a roof light and dormer present in the front pitch. A large dormer is present to the rear elevation.

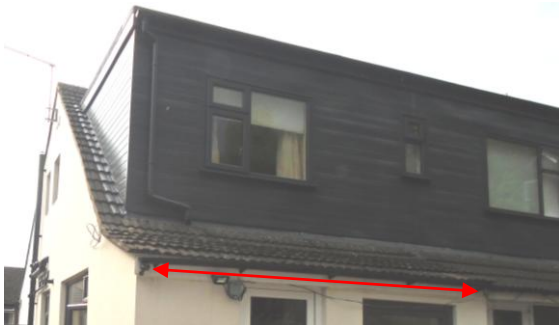
Rear roof pitch section of eaves being affected by the extension.

The roof is in reasonable condition with no slipped or missing tiles and all are tight fitting. The ridge tiles are well pointed. The upvc soffits and fascias are in excellent condition with tight abutments to the walls. The flashings to the rooflight and dormers are tight fitting. The verge is well pointed. The roof does not provide any access points for bats.

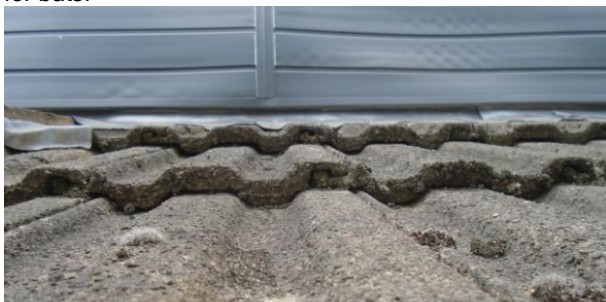
Section of roof being disturbed by the extension

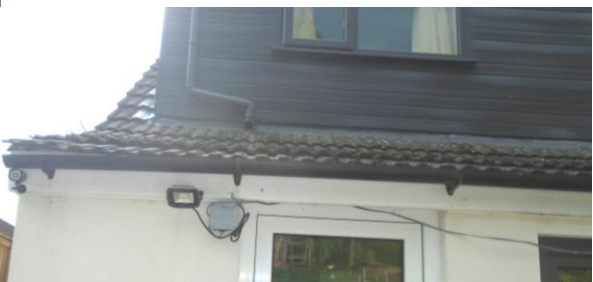
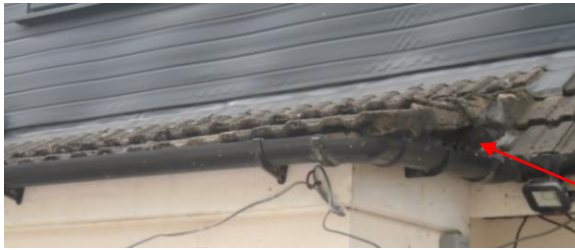
A single crevice was noted to the side of the affected roof section however it was possible to closely examine, there was no sign of current or historic access to the crevice.

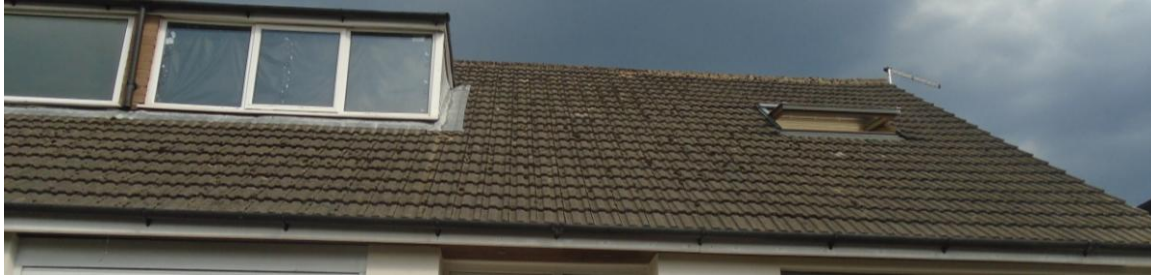
Front roof pitch did not have any access points

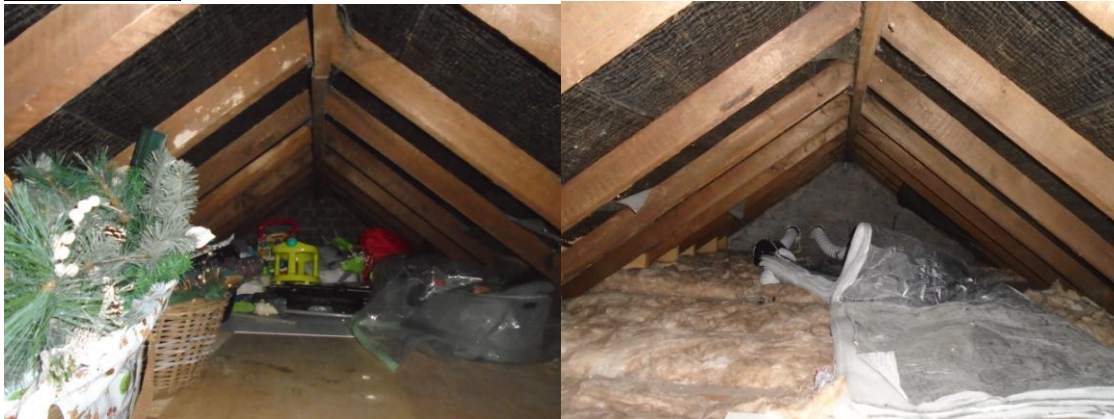
### **ROOF SPACE**

As the roof void is mainly bedroom accommodation there was only a small void under the ridge which was accessible via a ceiling hatch. The timber rafters, purlins and underlay are in good condition and do not provide any cracks or crevices suitable for roost habitat. The insulation quilt present to the floor was clean with no evidence of droppings or insect feeding remains. The space did not provide any high value roost potential for bats, and no signs of current or historic use was evident.
