**BAT SURVEY AT -
3 HAREWOOD AVENUE
SIMONSTONE**

**DATE AND TIME OF VISIT
12TH April 2022 9.30 am**

REFERENCE NO. 6646

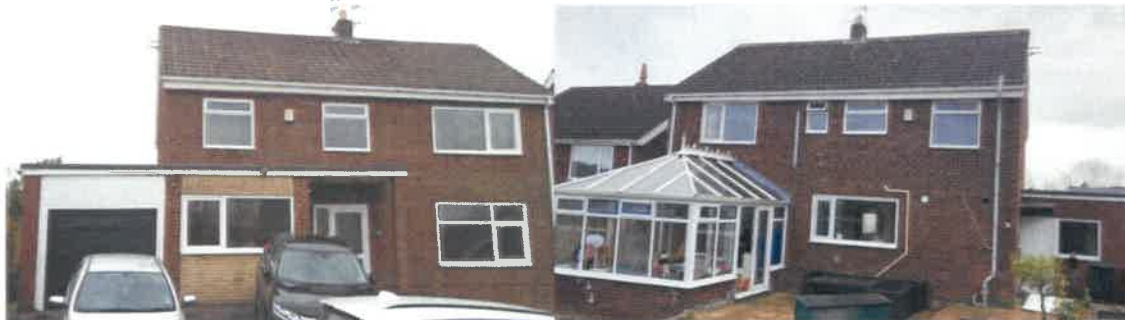
The property is a detached house with an attached garage conservatory probably built during the 1960's /70 's

Front elevation

Rear elevation

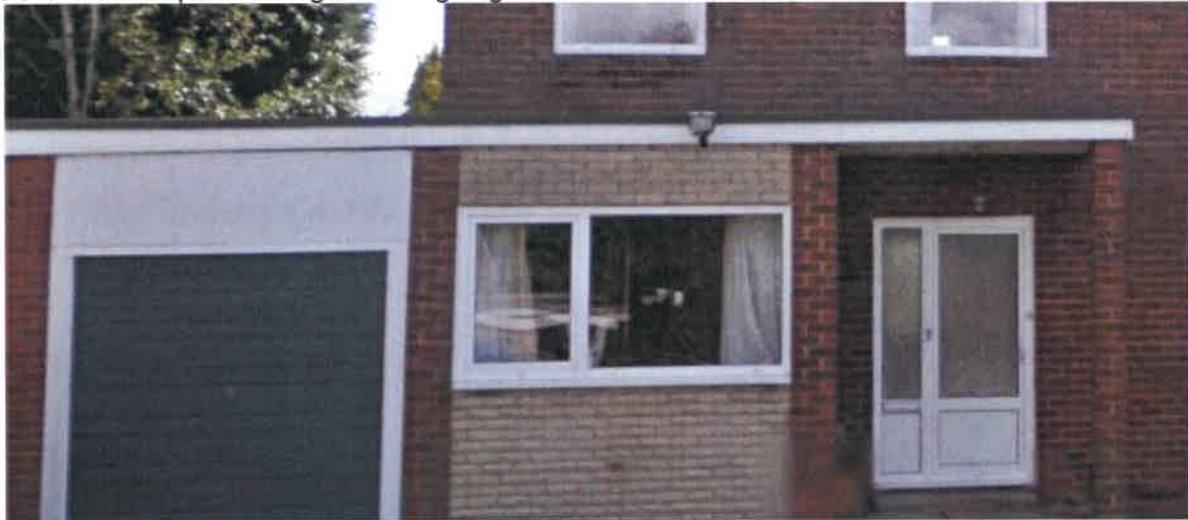
The walls are mainly brick (likely cavity construction) with a small section of artificial stone to the front elevation and upvc cladding over the garage door.

The walls are in good condition with no cracks or crevices suitable for bat ingress. Access behind the upvc boarding was not possible.

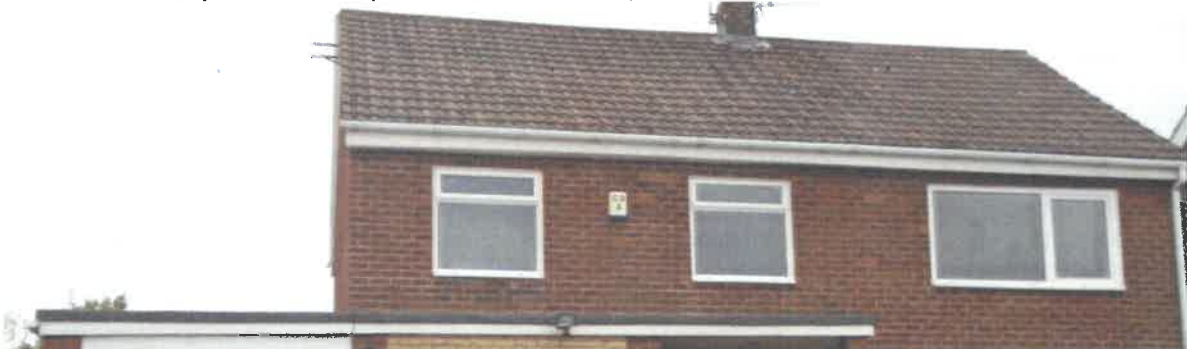
The main roof is pitched with a profile tile finish and upvc fascia and soffit.

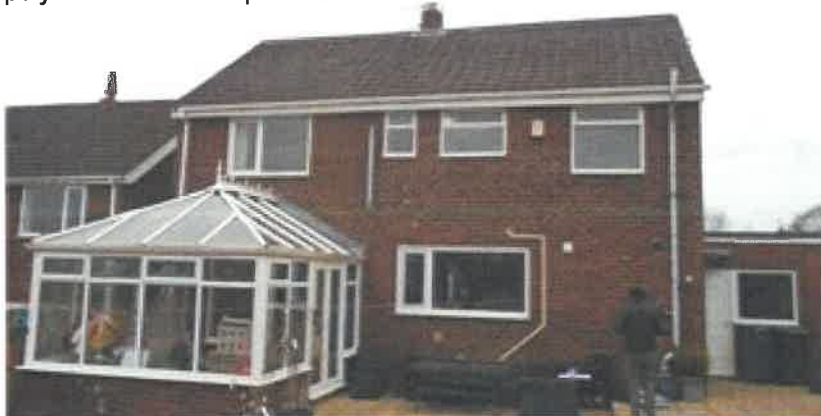
The garage and front porch roof is a felt flat with upvc fascias. The conservatory is clear polycarbonate in a upvc frame.

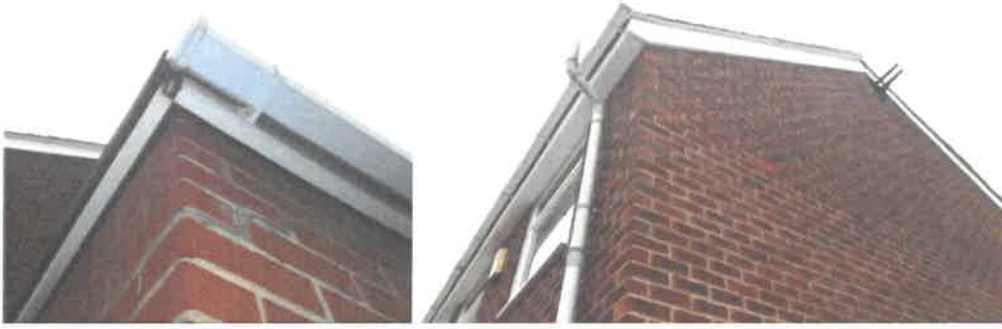
The roof tiles are tight fitting with no gaps or slipped tiles. The flashings to the chimney, conservatory and flat roof are all tight fitting as are the upvc soffits and fascias. The conservatory roof has no access points. The flat roof is in good condition with no rips in the felt. The roof structures do not provide any potential bat roost habitat.

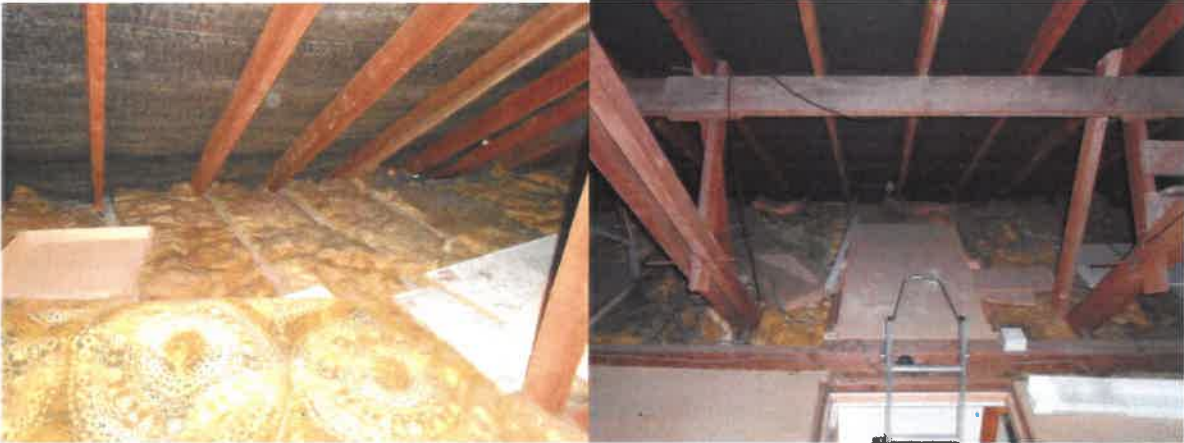
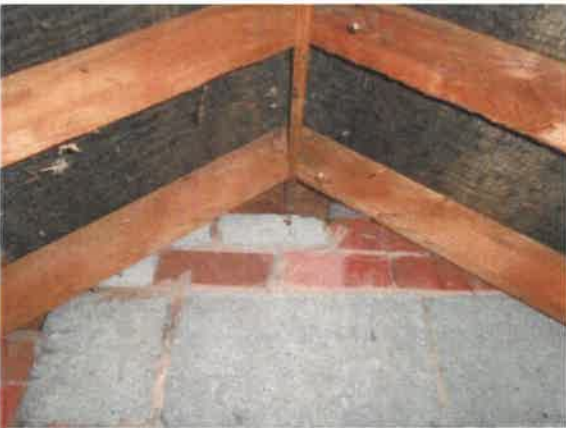
House roof space was accessed via a hatch and used for storage. All the timber trusses are in good condition as is the felt, the space is very clean with no evidence of any dropping or insect remains. Evidence of current or historic bat presence was not found

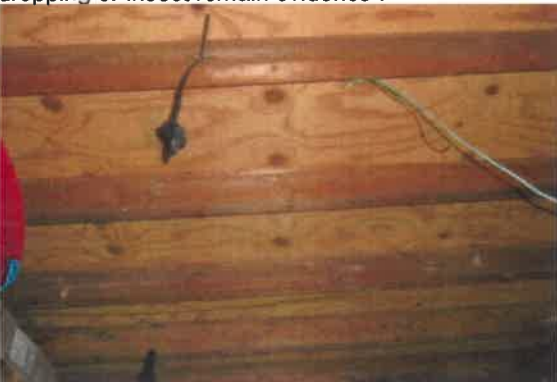
The garage roof structure was not enclosed the joists with boarding over the was easily examined from floor level. All the structure was in good condition and all surfaces within the garage were clean and free from any dropping or insect remain evidence .
