**HERITAGE STATEMENT  
RENDER REMOVAL AND REPAIRS  
COACH & HORSES  
BOLTON BY BOWLAND.  
MAIN STREET  
BB7 4NW.**

**AUGUST 2022  
JOB NO. 6705  
VERSION HS-1.0**

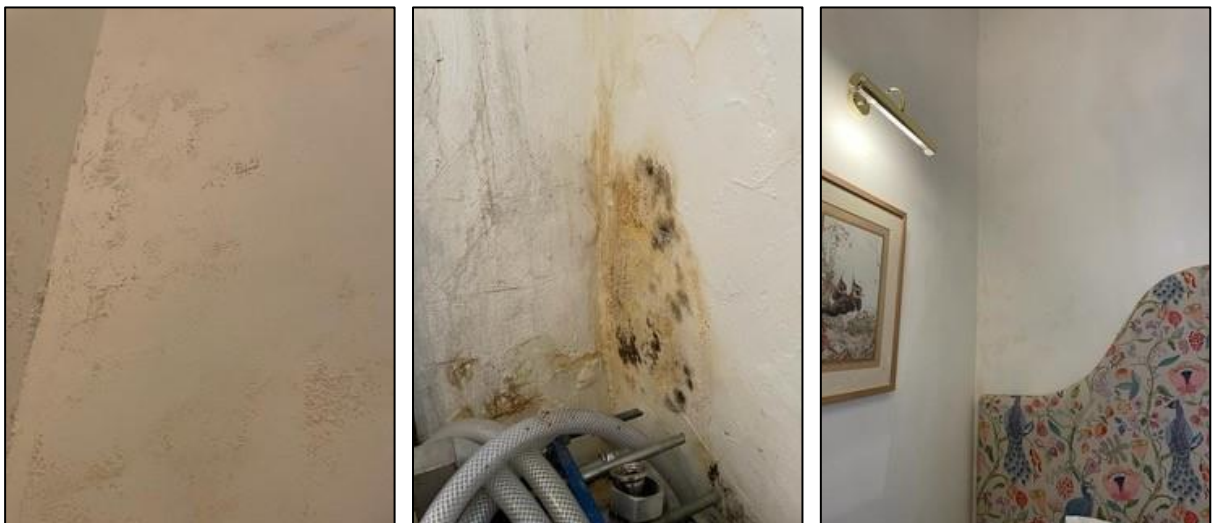
Fig. 1 illustrating internal damp issues.

- 4.2 It is clear that the render has not allowed the building fabric to breathe and had created internal damp issues as well as detachment from the external elevation causing potential risk of falling. Refer to Fig. 1 which illustrate the internal damp issues.

- 4.1 Following extensive internal damp issues which have directly affected the business due to being unable to rent bedrooms, the former cement render has been removed to reveal coursed limestone which is reflective of the front elevation. The work carried out are high quality and with re-pointing carried out in lime as required for the breathability of the building fabric. Refer to Fig.2 for the completed photographs subject to signage completion.

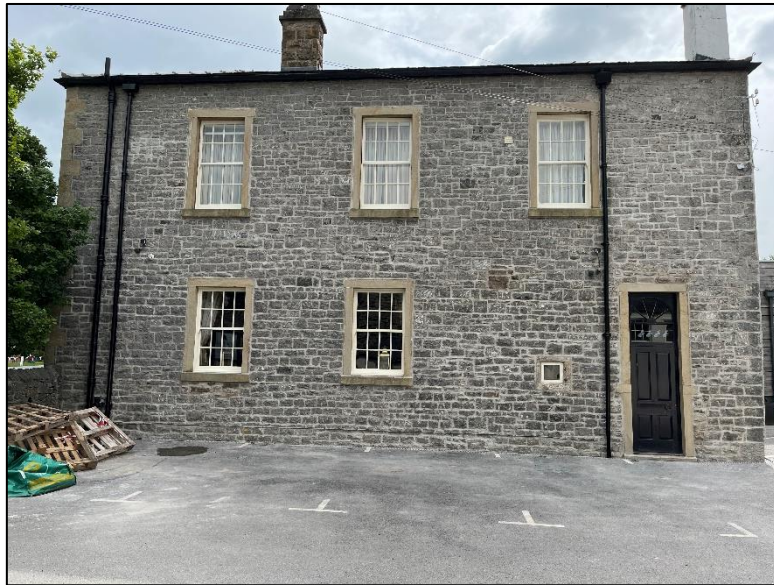
*Fig. 2 west elevation following render removal and re-pointing which is now reflective of the North (front) elevation with exposed quoins and window surrounds.*

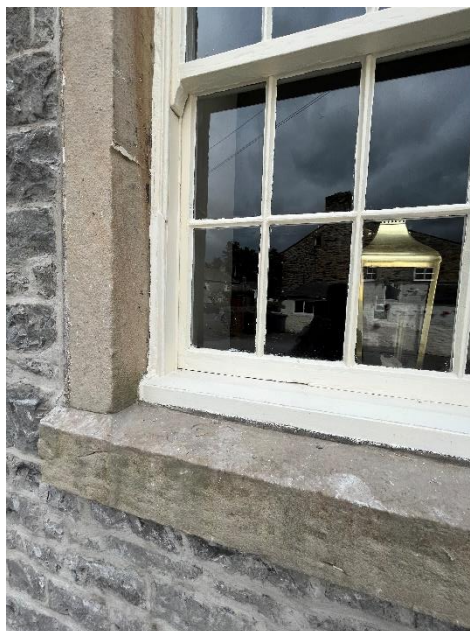
*Fig 3 illustrating the seamless repair and repainting of existing window.*

- 4.3 There have been minor repairs to the existing window frame, refer to Fig 3, and repainted along with repairs to the gutter line which has been fixed and replaced to match existing. These works are considered to have been carried out under lawful repair and not requiring approval.

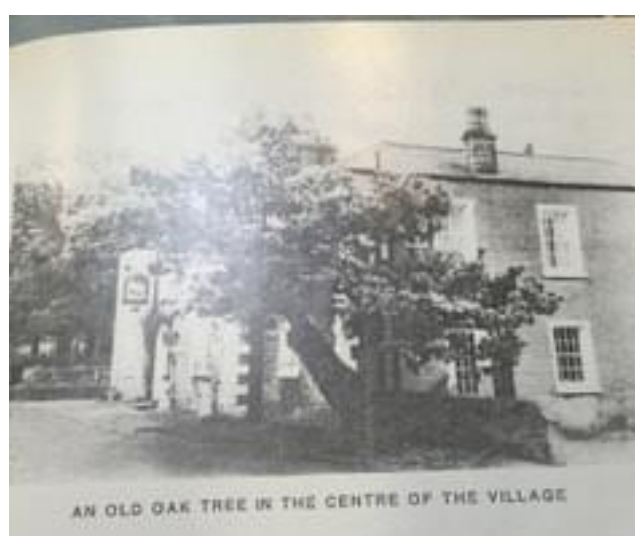
- 5.1 The proposals will result in 'less than substantial harm' to the building as the removal of the render has revealed a matching coursed limestone which will continue the material aesthetic to the west elevation. Fig 4 illustrates a historical image of the wall as former stonework. The removal of the cement render which was previously caused damp issues will be resolved and provide a direct positive impact on the fabric of the building through improved breathability and to the business as the affected rooms can now continue to be used as tourist / visitor accommodation. The window and gutter repairs will also provide a positive enhancement to the appearance o the listed building and conservation area.

*Fig 4 illustrating a historical image of the wall as former stonework.*
