## PHASE II GEO-ENVIRONMENTAL SITE ASSESSMENT

Land North of Church Raikie  
Chipping  
Preston  
PR3 2QL

Report Ref: 12-424-R1-2  
Date Issued: July 2022

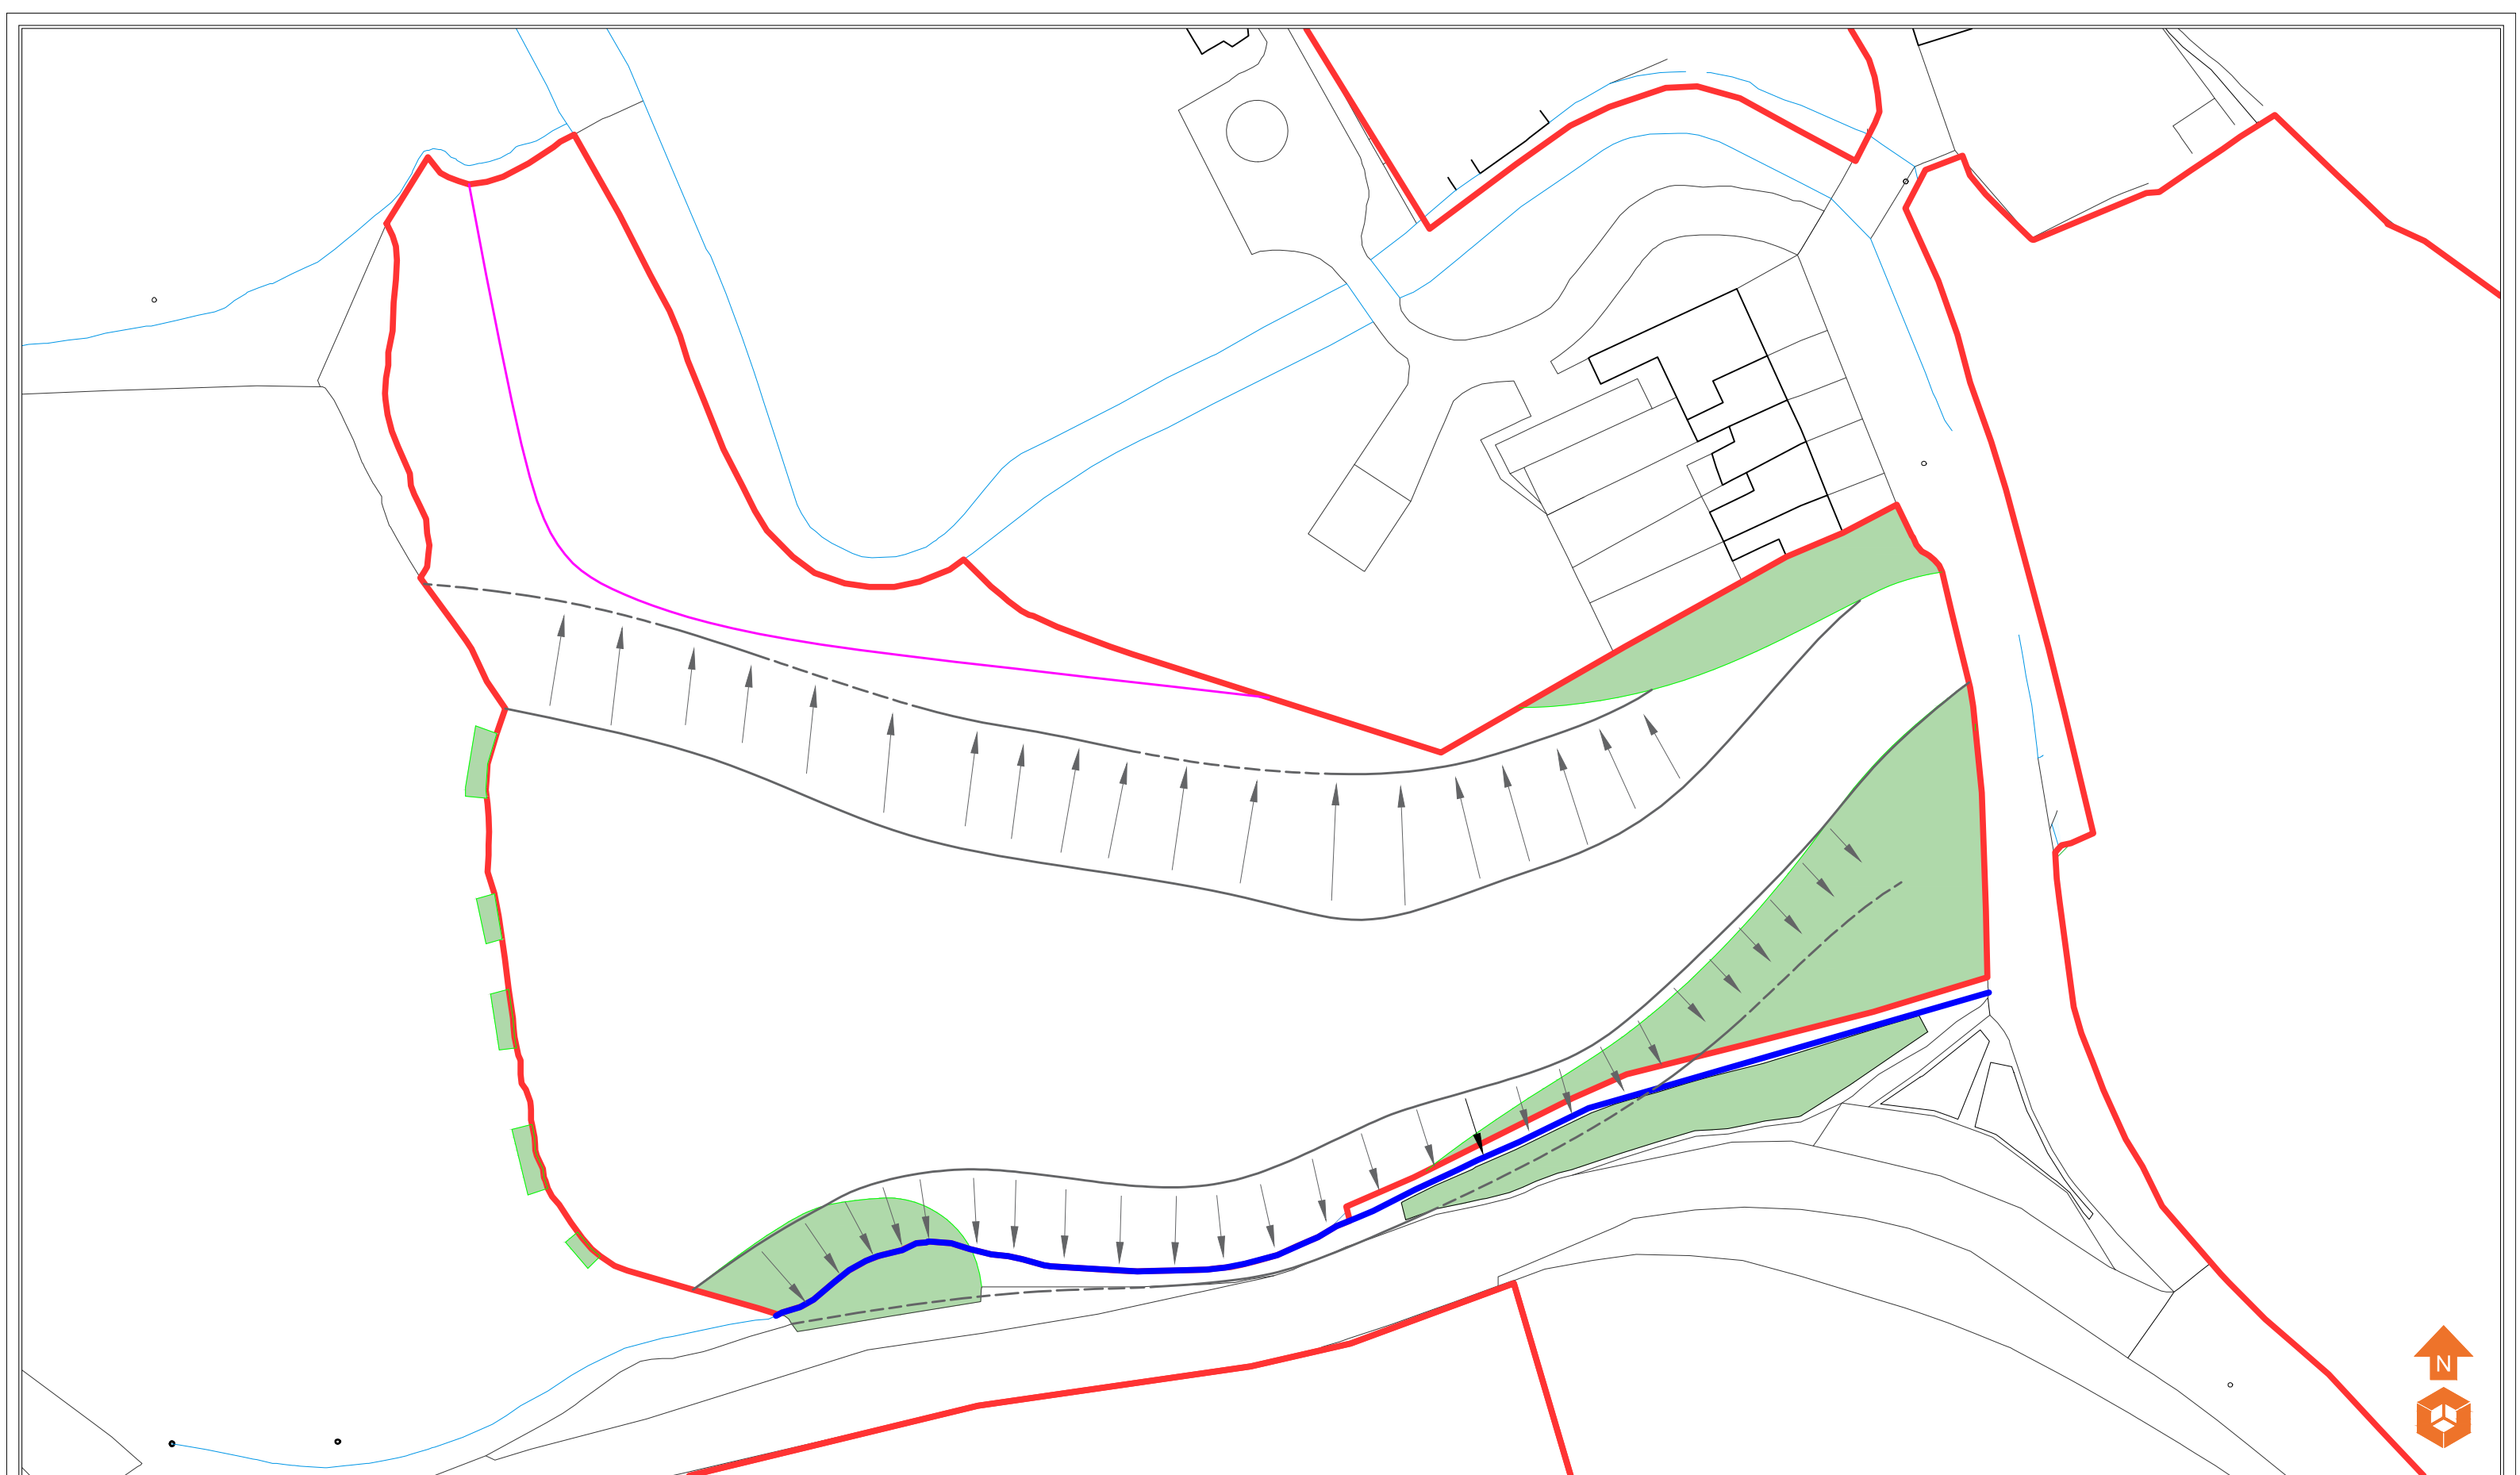
**Drawing Title:**  
Site Features Plan

- Woodland Areas
- Stream
- Footpath
- Top of Slope
- Base of Slope
- Dip Direction Down the Slope

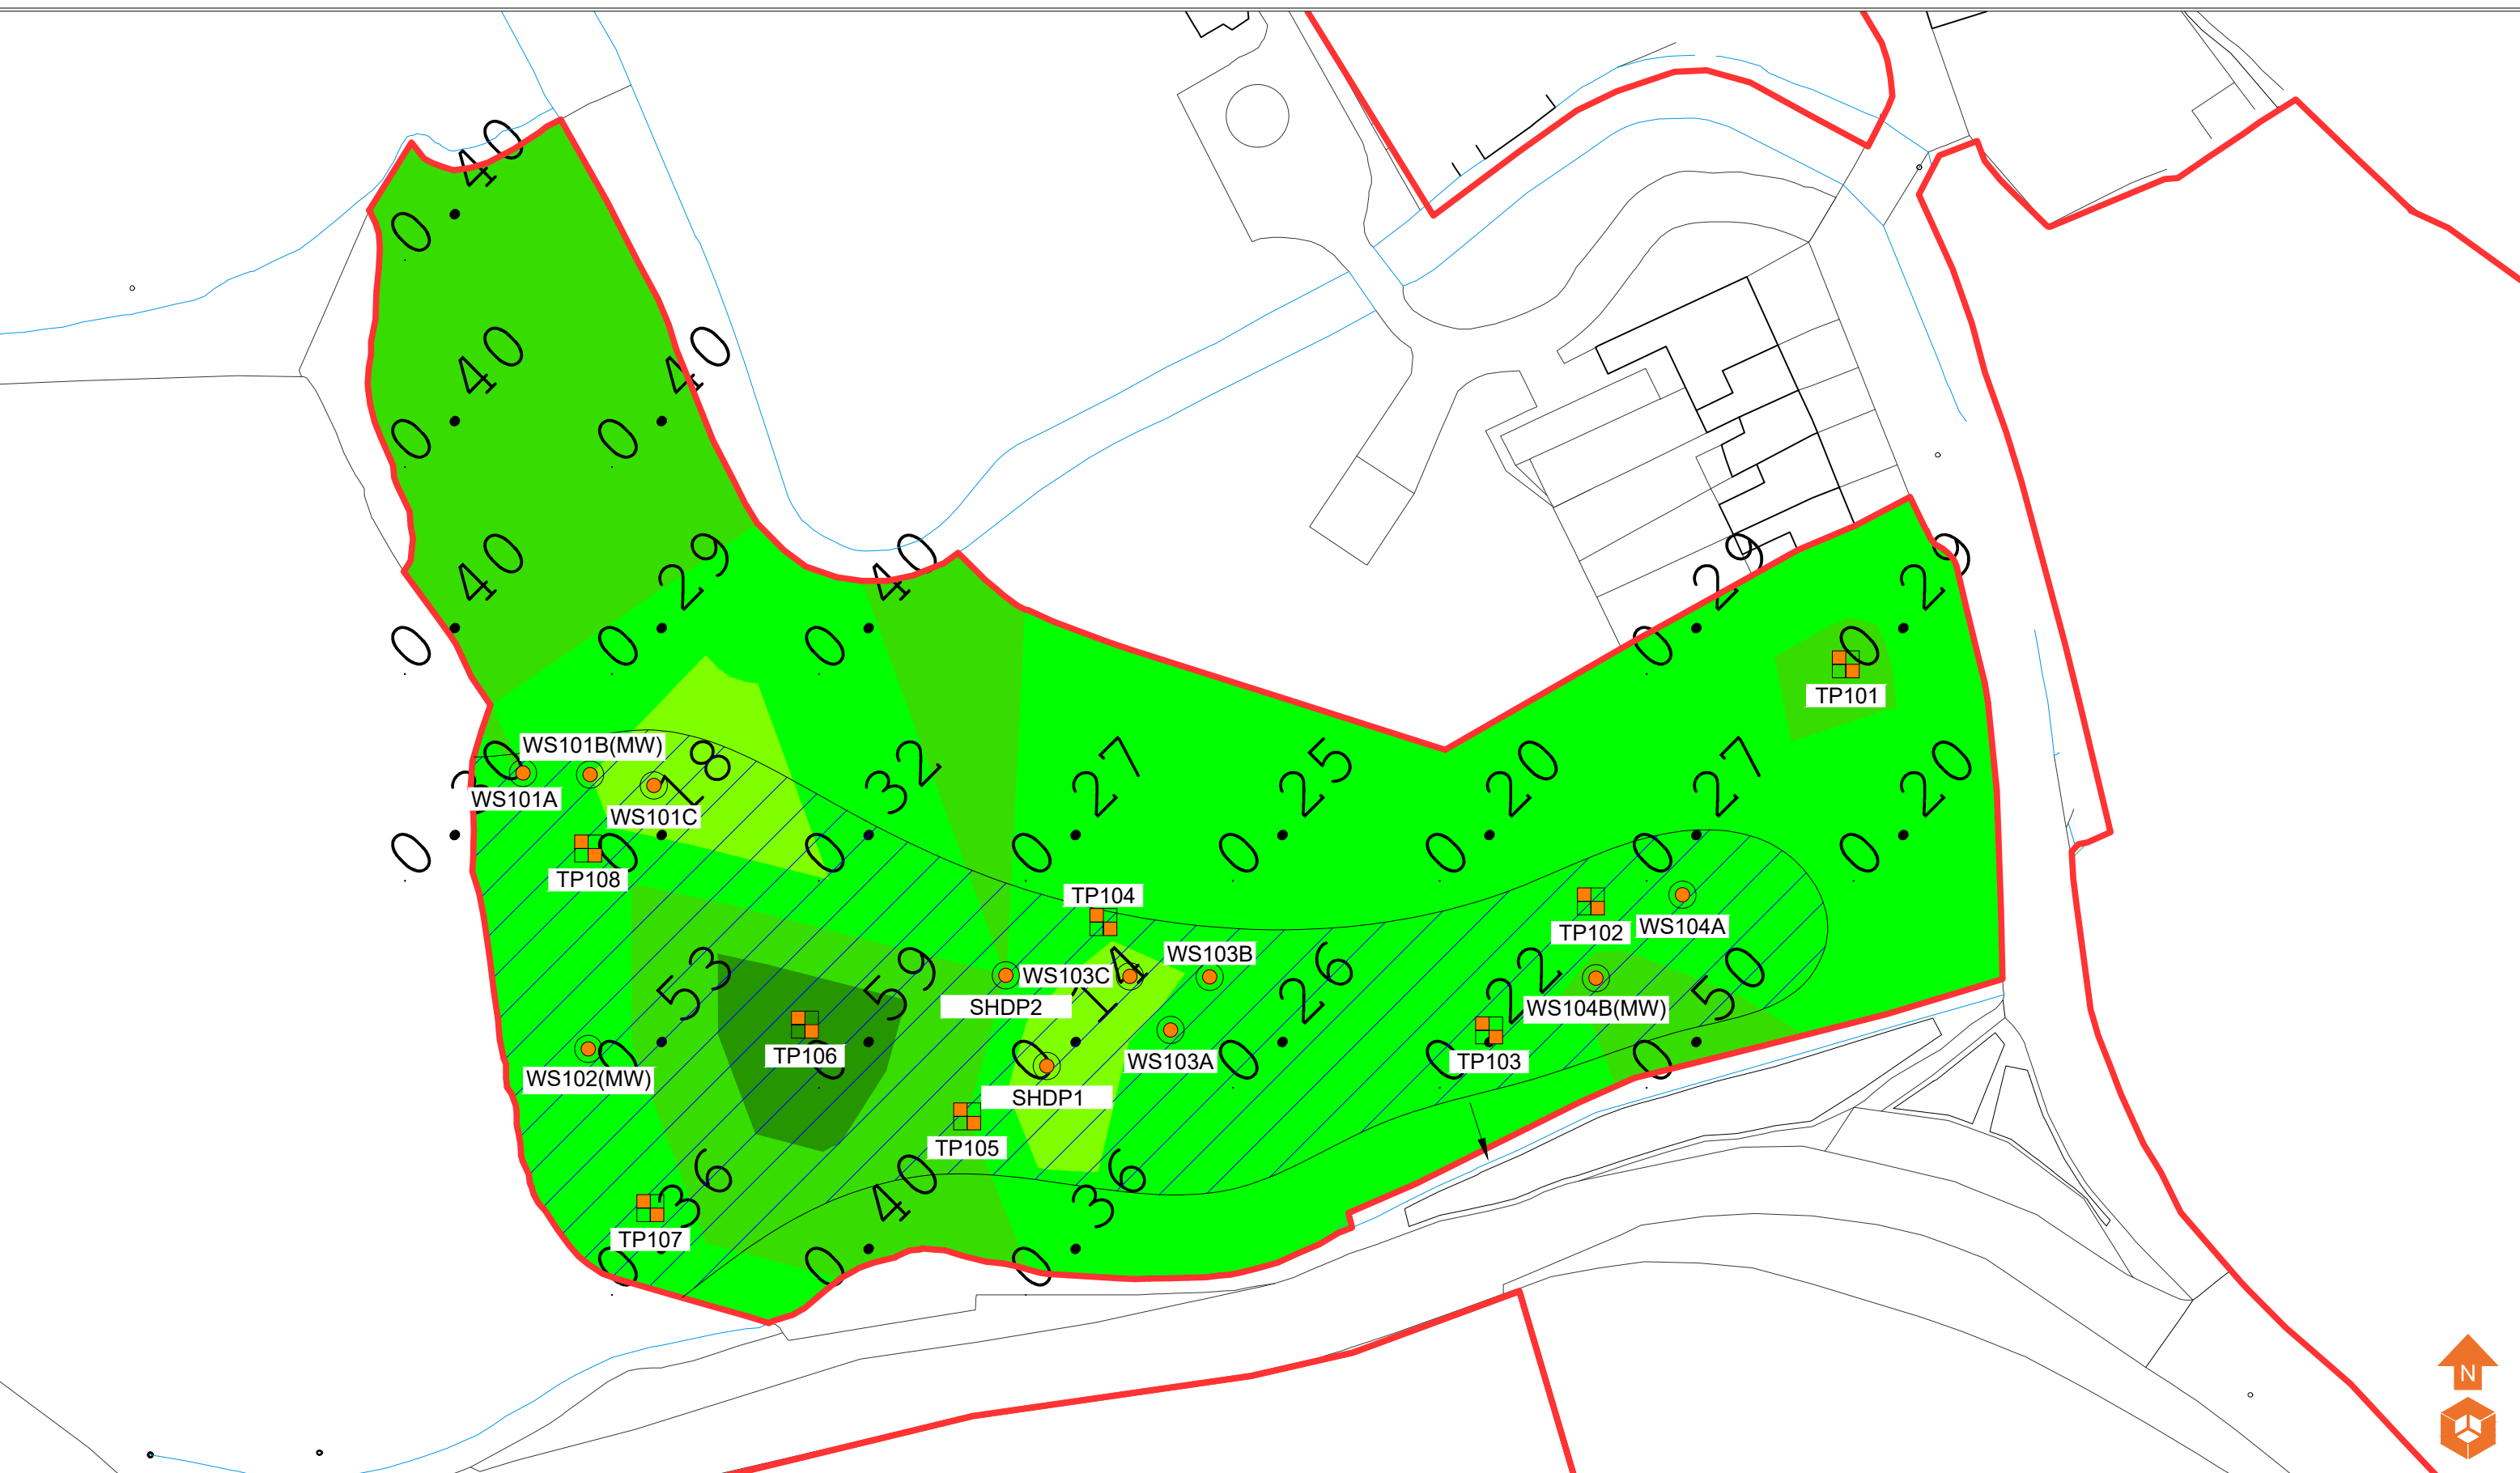
Depth of Topsoil Plan

Location Symbols		Topsoil Depth (m)	
	Approximate Window Sample Probehole Location		Depth of Topsoil 0.00 - 0.19m
	Approximate Window Sample Probehole Location with Install		Depth of Topsoil 0.20 - 0.39m
	Approximate Trial Pit Location		Depth of Topsoil 0.40 - 0.59m
	Approximate Rotary Borehole Location		Depth of Topsoil 0.60 - 0.79m
	Approximate Super Heavy Dynamic Probing Location		Depth of Topsoil 0.80 - 0.99m
	Development Area
