**Ground and Project**  
CONSULTANTS LTD

**Chipping**

**Slope Stability Report**

**Report No. 80783**

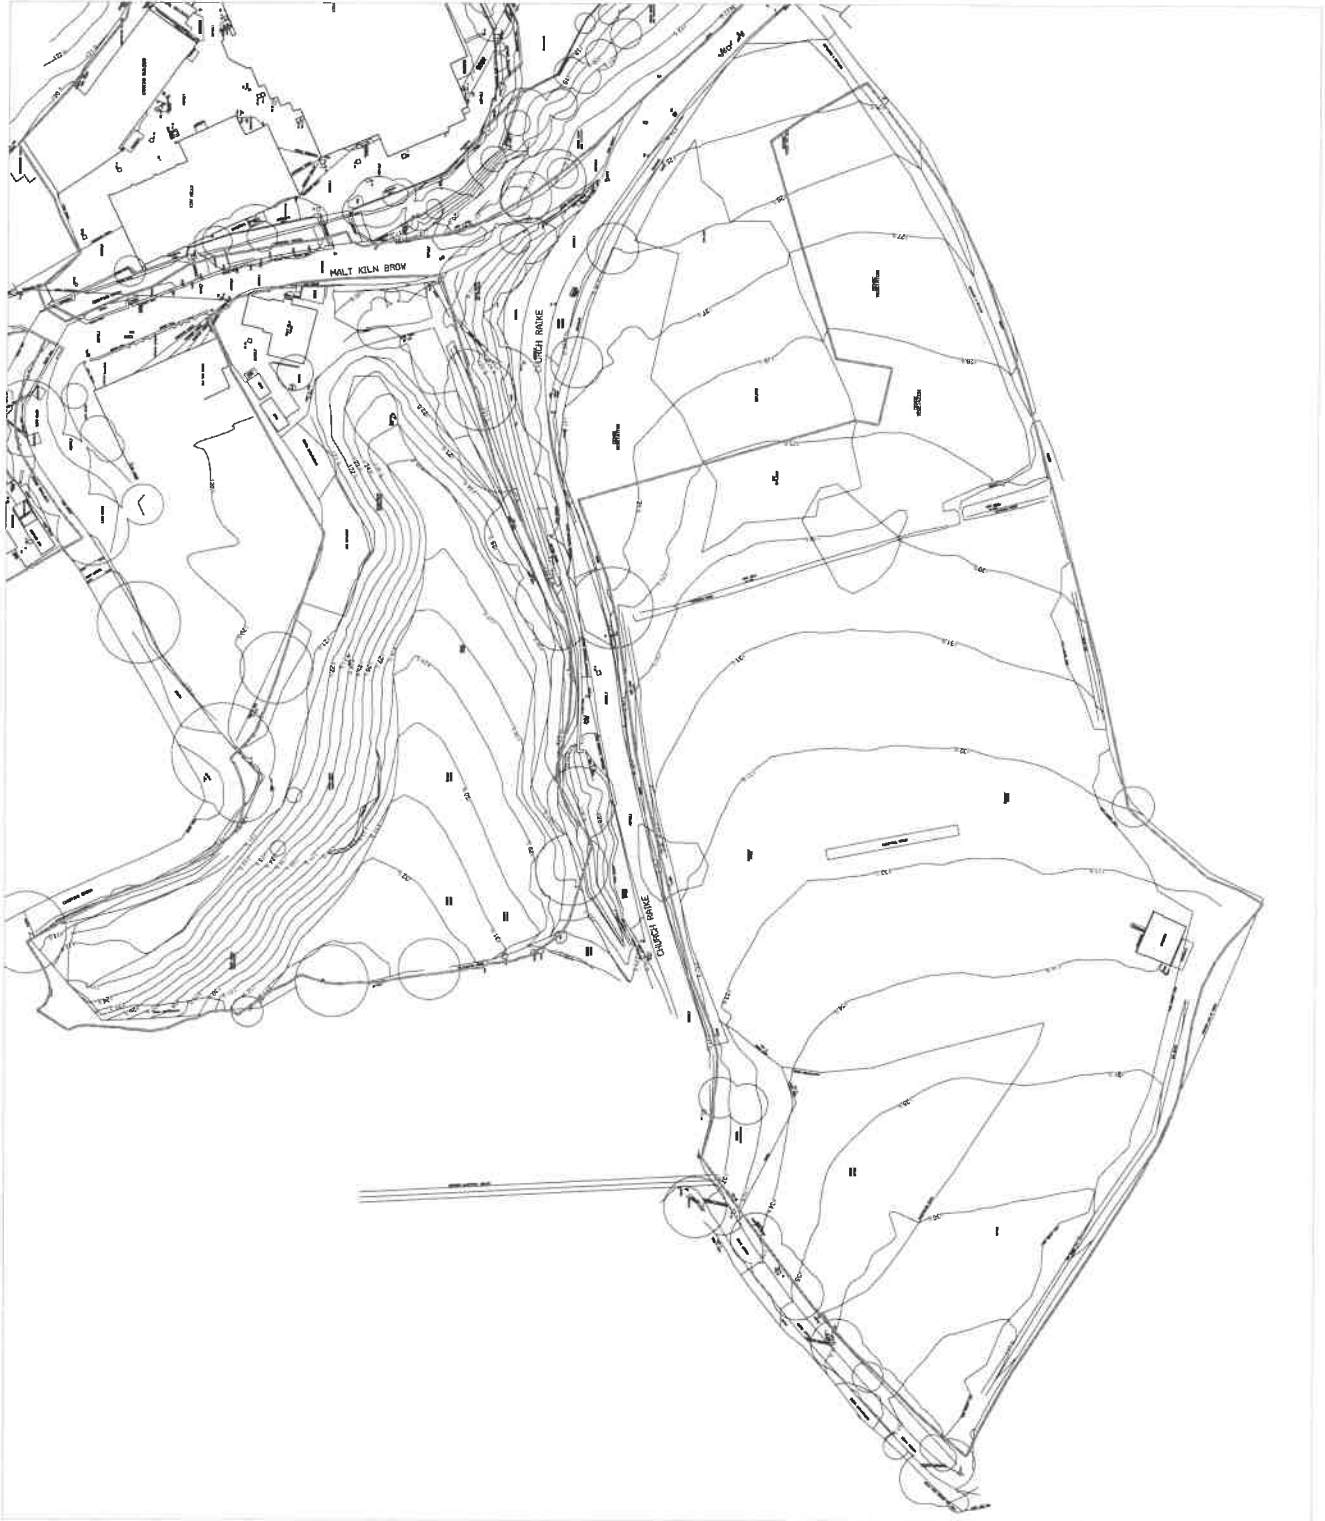
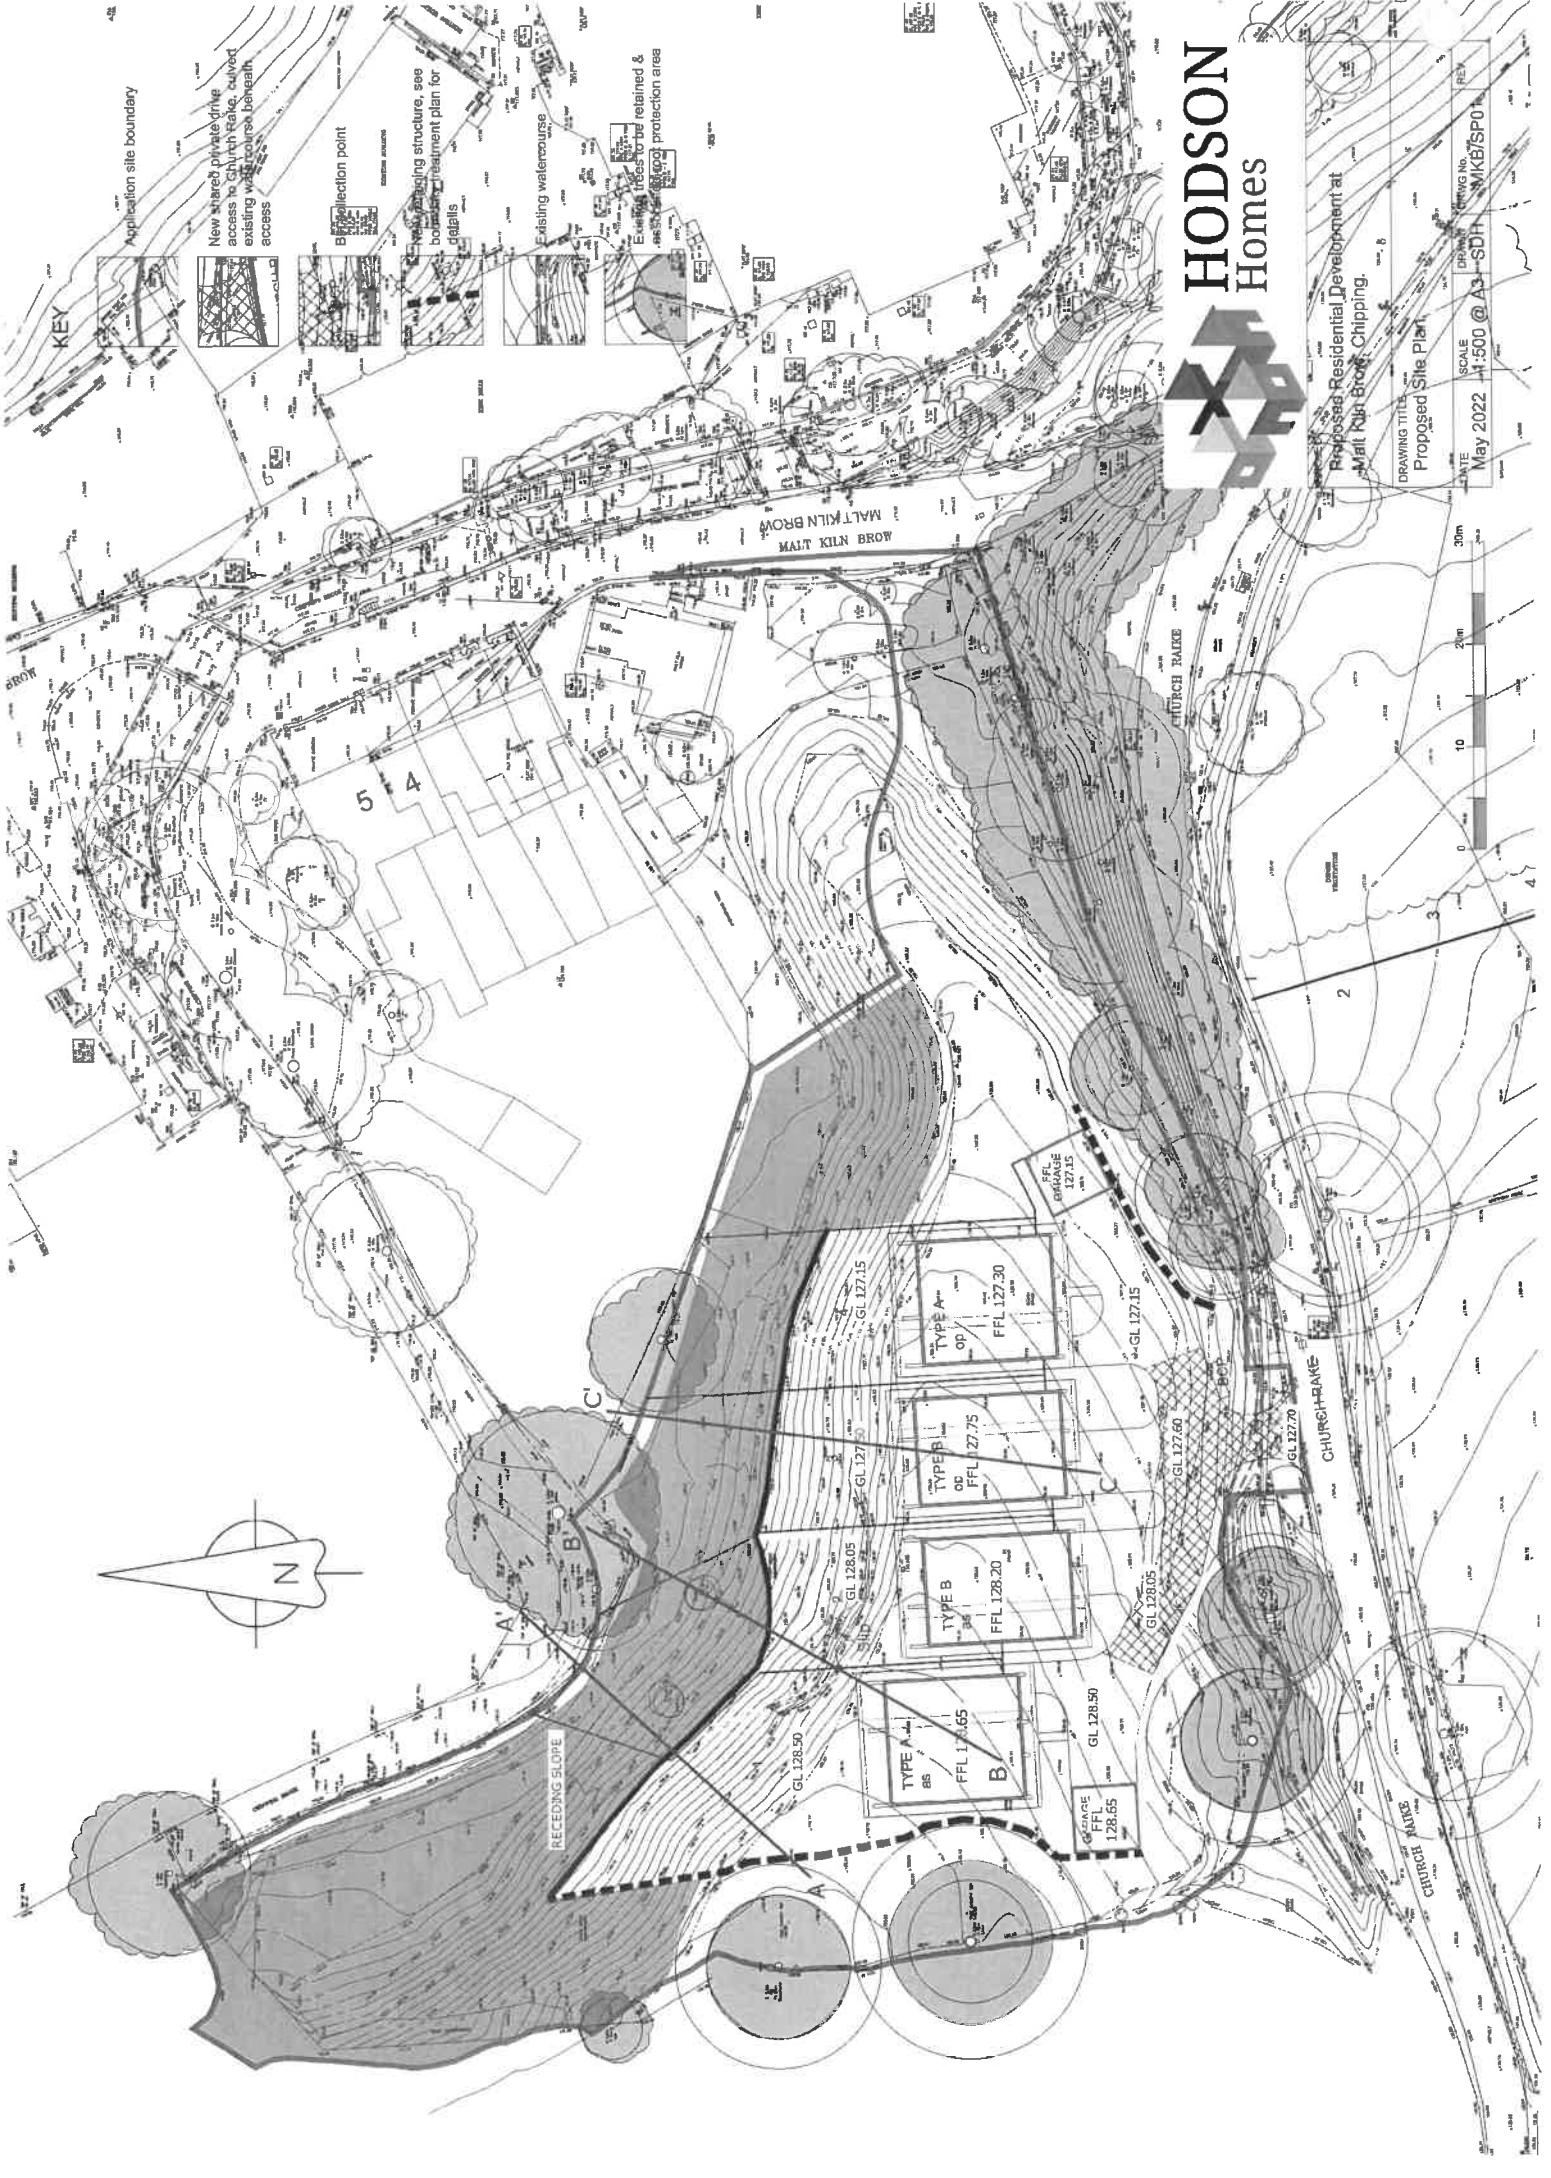
DRAWING TITLE  
Proposed Site Plan

Proposed Residential Development at  
Malt Kiln Brow, Chipping.

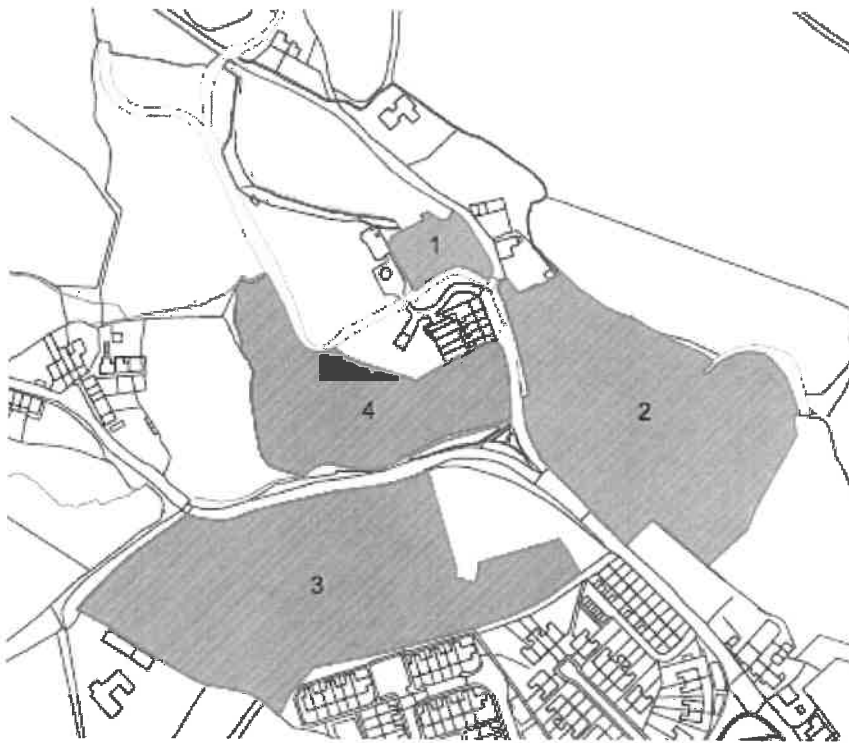
**Figure 1.1 Snapshot of Proposed Development**

A snapshot of the wider chipping development area is indicated in Figure 1.1 overleaf:

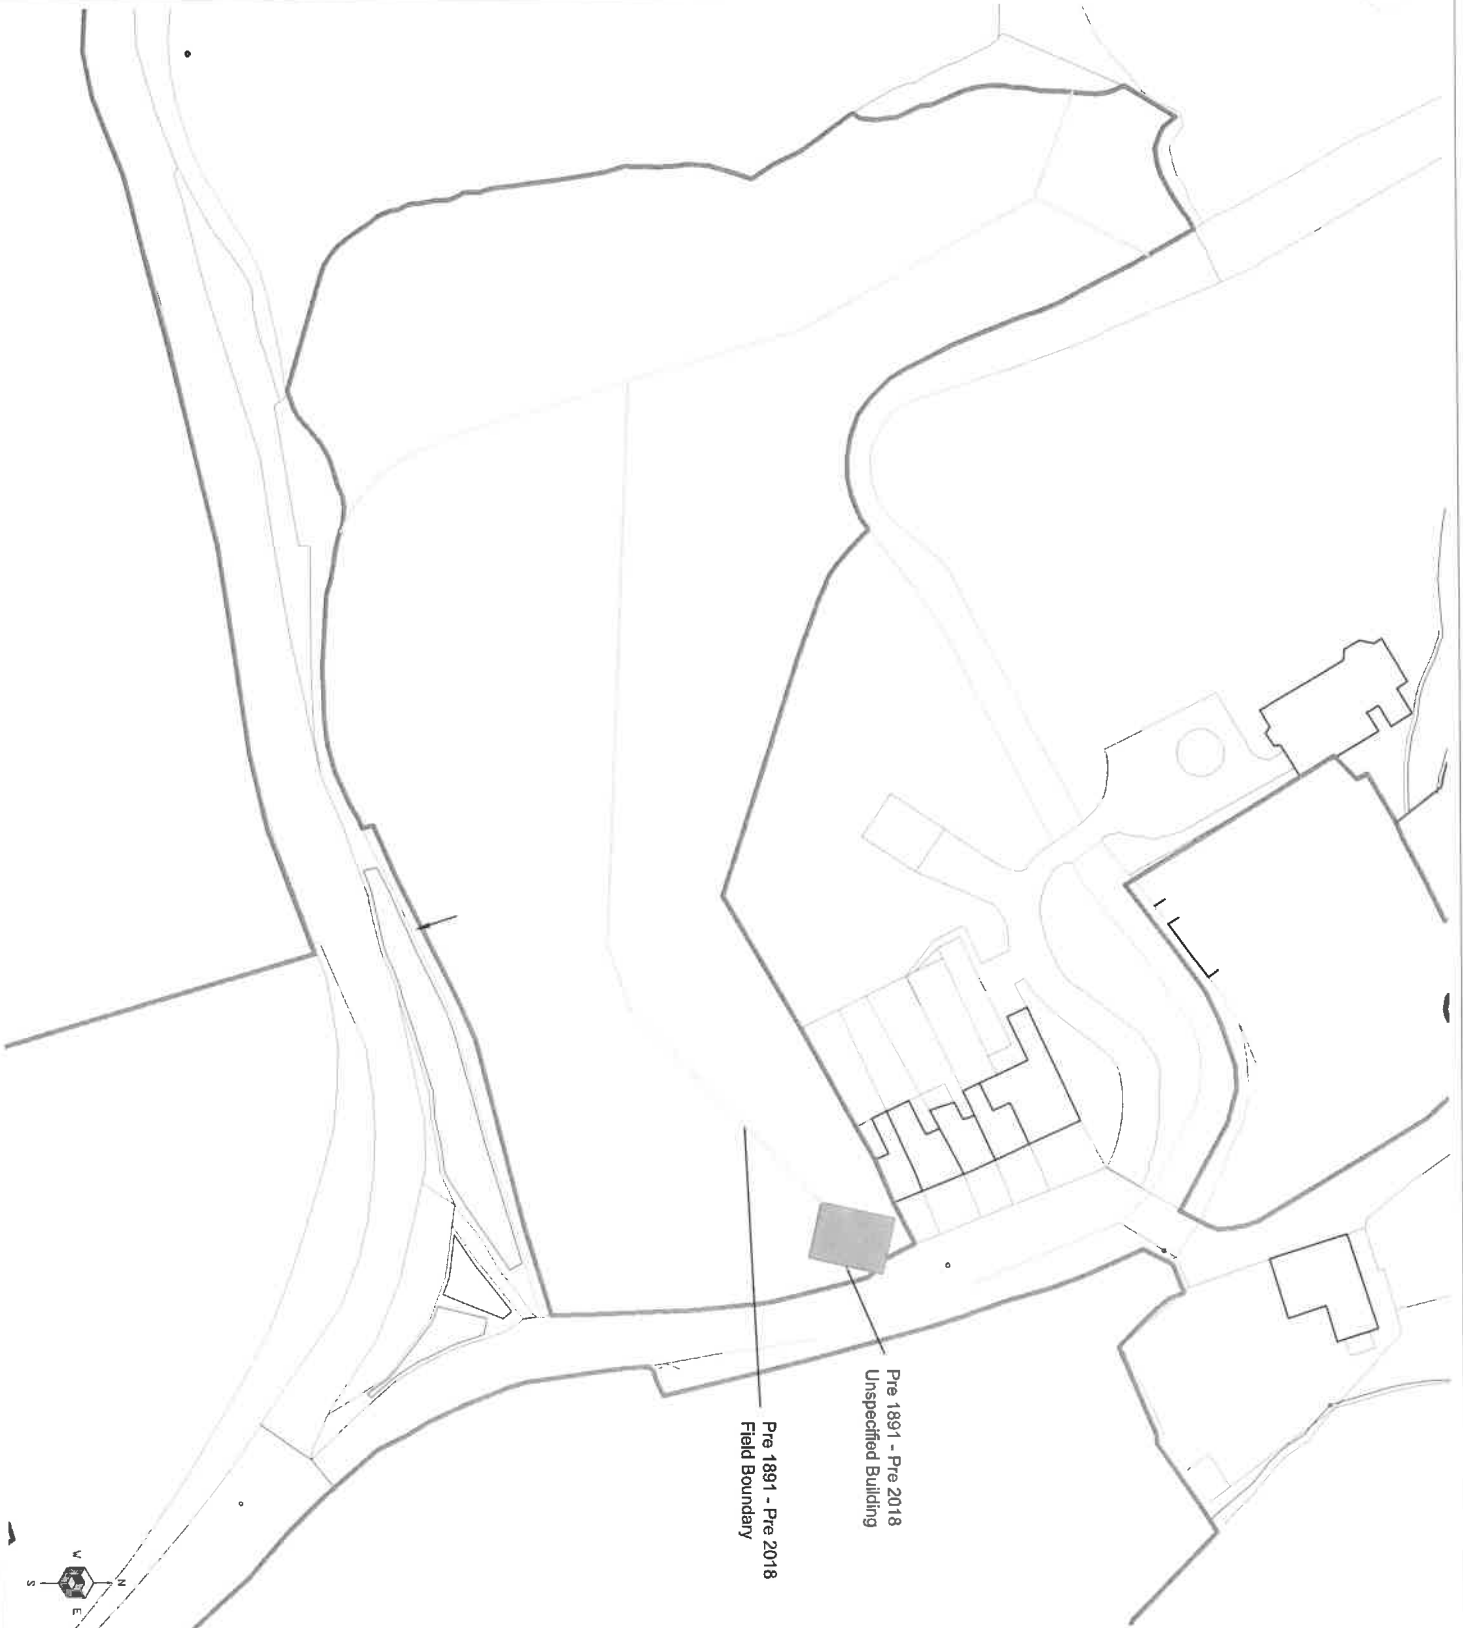
P1		25-05-2018		DRAFT		CB		MD	
Phase	Revision	Date	Issue	Drawn	Authorised				
Chipping Homes Ltd		12-424		003		NTS			
Client		Drawing No.		Scale					
Chipping Parrel 4		Historical Features Plan

- Historical Features**
- Unspecified Building (Pre 1891 - Pre 2018)
  - Field Boundary (Pre 1891 - Pre 2018)

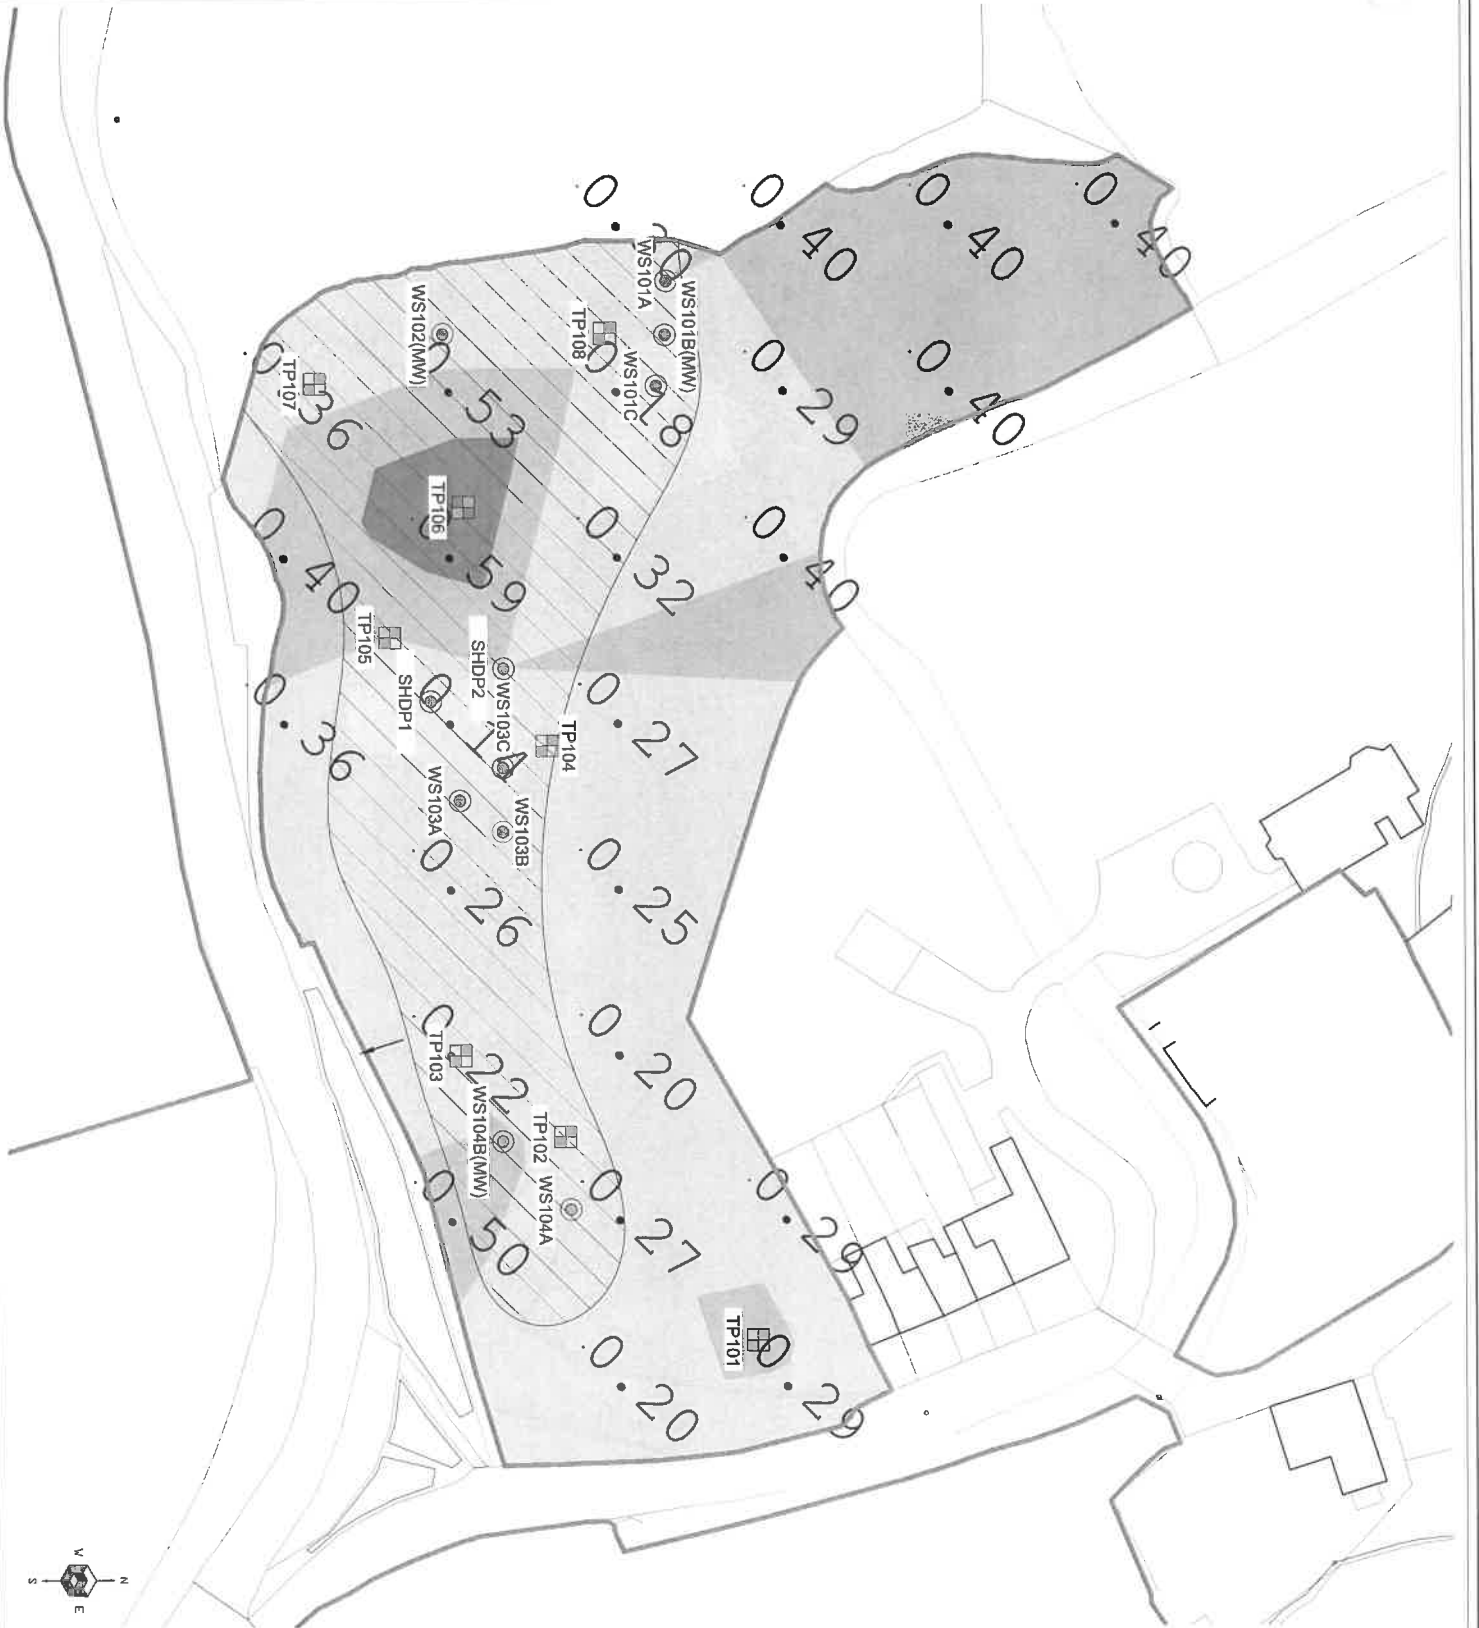
**Location Symbols**

- Approximate Window Sample Pictorial Location
- Approximate Trial Pit Location
- Approximate Hand Dig Pit Location
- Approximate Cable Percussive Borehole Location
- Approximate Rotary Borehole Location
- Approximate California Bearing Ratio Test Location
- Approximate Dynamic Cone Penetrometer Test Location

The sampling locations are illustrated in Drawing 10-470-005 (Appendix III). The ground conditions encountered are indicated on the logs which are provided in Appendix VI.
