Preliminary Bat Roost Assessment Report

Former Water Tower,
Dewhurst Farm,
Longsight Road,
Langho, BB6 8AD

31.05.2022

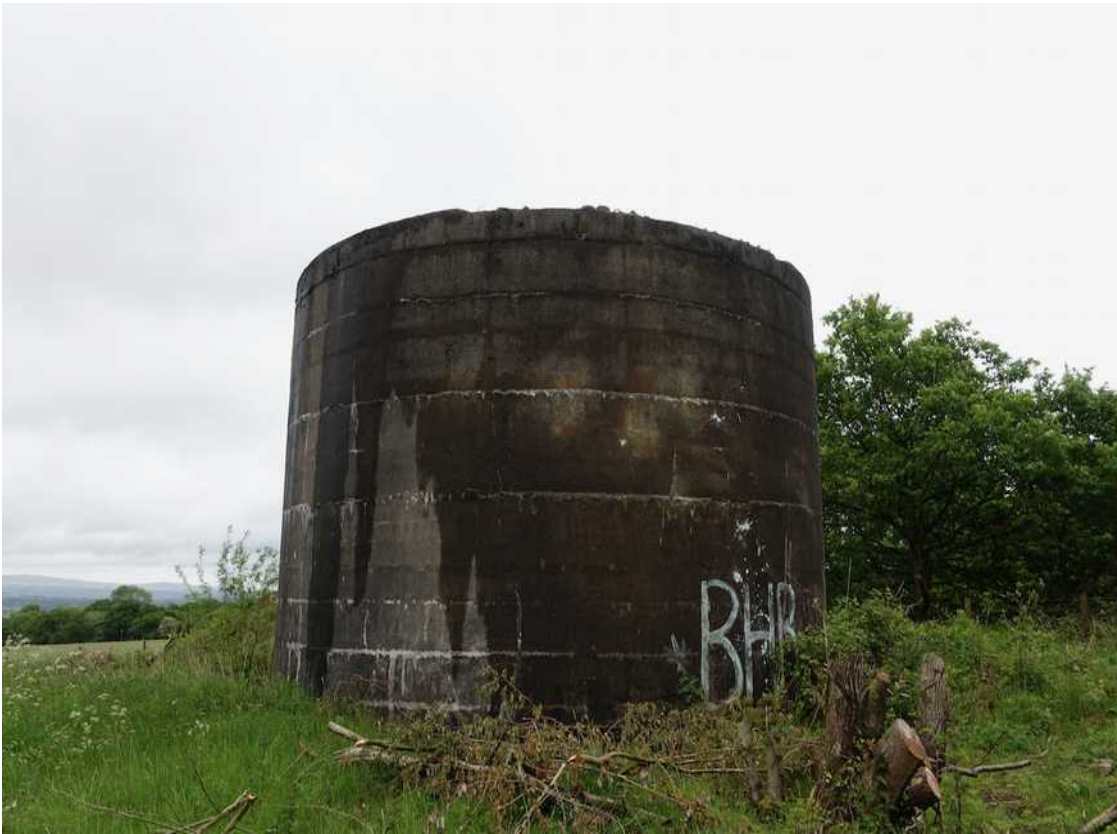
The property consists of a former concrete block water tower and associated brick built single storey building. External walls single skin and are well pointed with no cracks, crevices or cavities present.

The roofs of both buildings are missing with considerable light and weather penetration to the interiors.

The property can be considered to offer negligible bat potential.

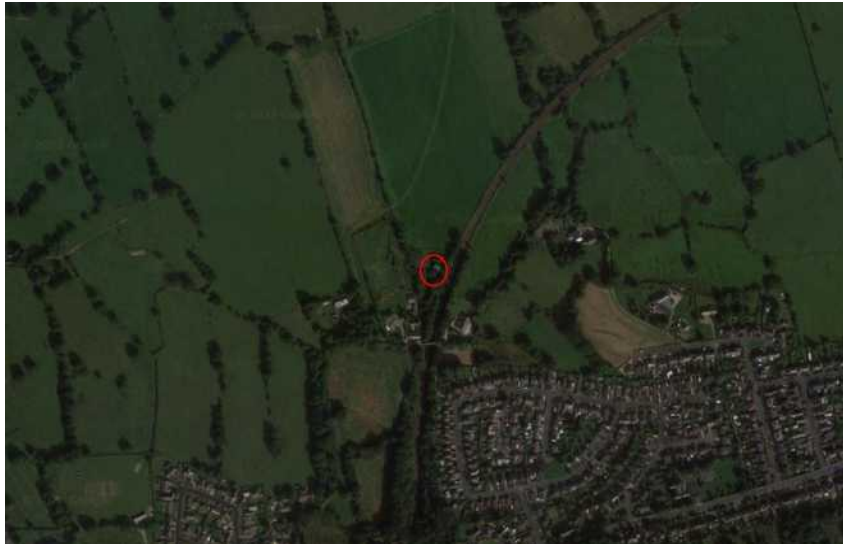
Habitat

The property is located in a rural setting in an area dominated by improved and semi improved grassland with hedgerow present on field boundaries. The buildings are adjacent to a semi natural deciduous tree line associated with the nearby railway line which provides connectivity to semi natural deciduous woodland in the wider landscape.

Connectivity to the wider landscape is good. Bat foraging potential is moderate.
