RE: Preliminary Bat Roost Assessment: 15 Hacking Drive, Longridge, Preston, PR3 3EP

Date: 28th July 2022

Site Photographs: July 27th 2022

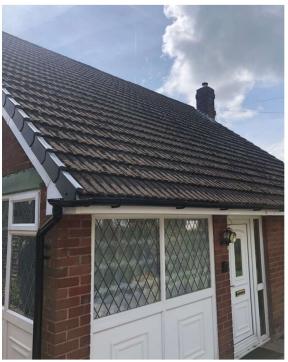
Photograph 1: View of the front (west) elevation of the property. Brick wall and concrete tile roof.

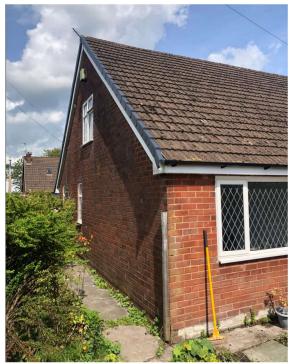
The building is in good structural condition and there are no suitable gaps which could be used by bats to roost.

Photograph 3:View of the side (south) elevation which shows the plastic soffits and concrete roof in good condition and no gaps present.

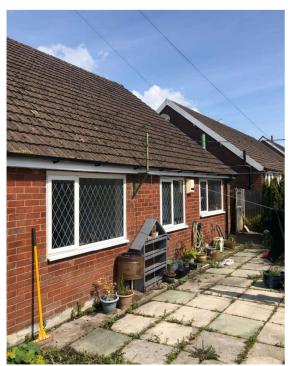
Photograph 2: View of the rear (east) elevation where the extension to the property is proposed. Roof and soffits tightly sealed.

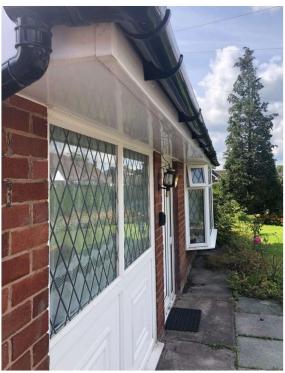
The owner informed the surveyor that the roof and soffits were worked on approximately two years ago. No evidence of bats (e.g. droppings) were identified within the building. The loft space was very warm at the time of survey (approximately 11:00) and the roof space is anticipated to fluctuate in temperature significantly due to the lack of insulation within the loft space (this was confirmed by the property owner). Fluctuating temperatures within potential roost spaces are unsuitable for bats.

Photograph 4: Close up of the plastic soffits which were all installed approximately two years ago.

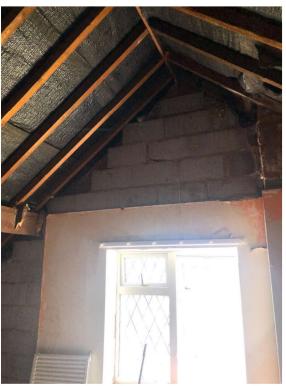
Photograph 5: Internal roof space used as bedroom. Internal walls knocked down and exposed roof. Concrete tiles underlay with geotextile material.

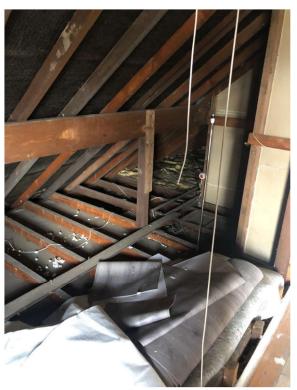
There is an absence of Potential Roost Feature's (PRFs) within the building and therefore the bat roost potential is considered to be **Negligible**.

Photograph 7: Internal roof space. No bat droppings or other evidence of bats recorded.

There are no requirements for further surveys. The client is reminded that in the highly unlikely event that bats are encountered during the work, then all work must stop immediately, and the bat consultant must be contacted for further advice.

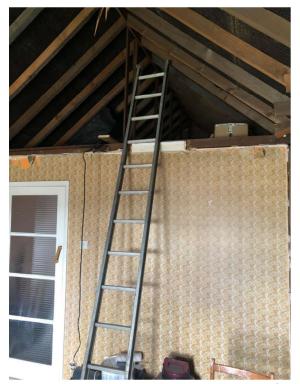
Photograph 6: View internally and some of the internal walls removed.
