## Bat Survey Report

Keepers Cottage,  
Northcote Road,  
Langho,  
BB6 8BD

30.06.2022

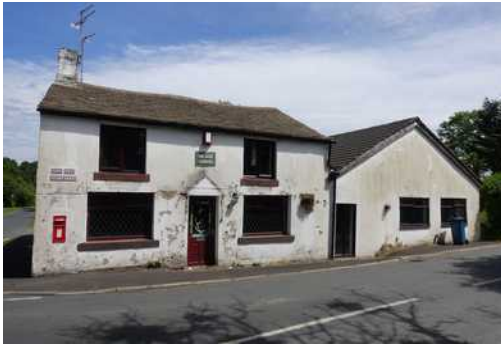
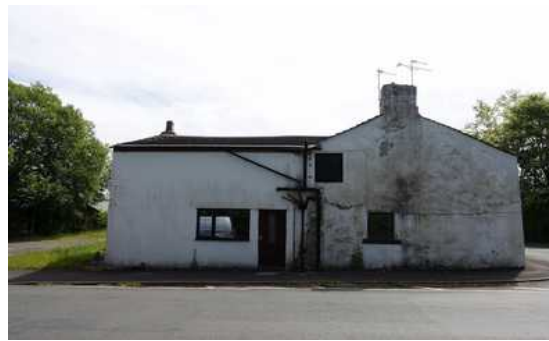
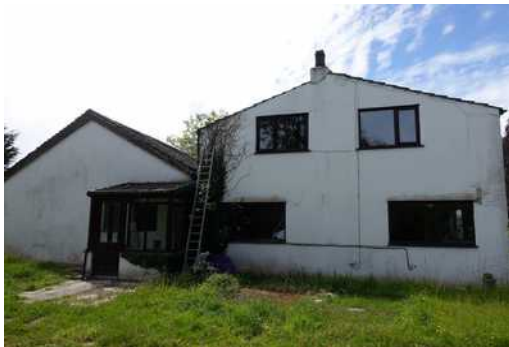
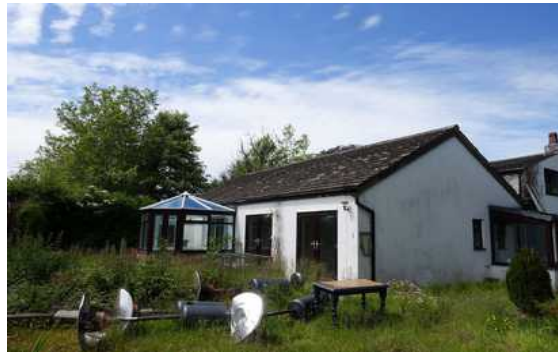
The property consists of a stone built two storey house with double pitched slate roof, a two storey extension is present to the rear and an adjoining single storey tiled roof extension is present on the northern gable. External walls are generally well pointed and rendered, however gaps are present at wall top level on gable ends.

Roof slates and tiles are generally close fitting, with no obvious lifted, slipped or missing slates. and the ridge is well sealed.

The property can be considered to offer low bat potential.
