**Bat Survey Report (preliminary day-time survey):
Mill House Farm,
Chipping Lane,
Chaigley,
BB7 3LS**

OS grid reference:
SD 6911 4152

Survey Date: 25/8/22

Report Date: 1/9/22

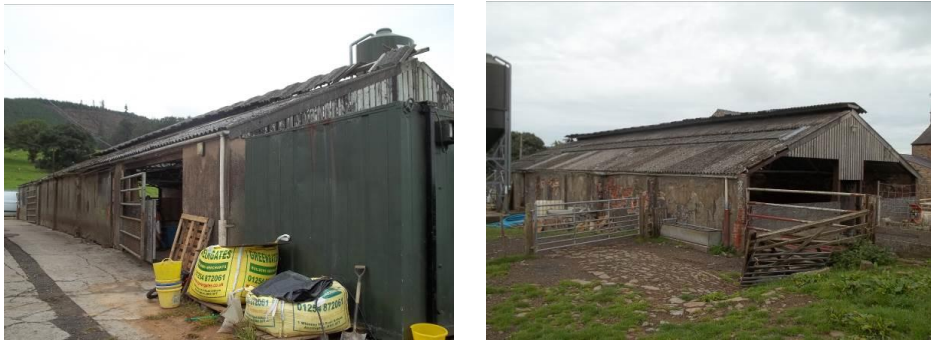
This is a brick-built, largely open-ended barn with an unlined, asbestos roof:

Front (east)/north and rear/south elevations

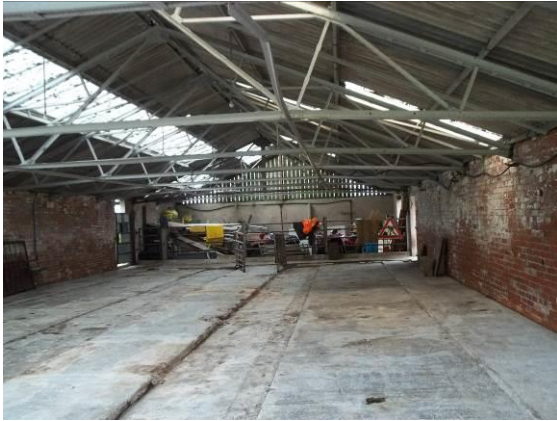
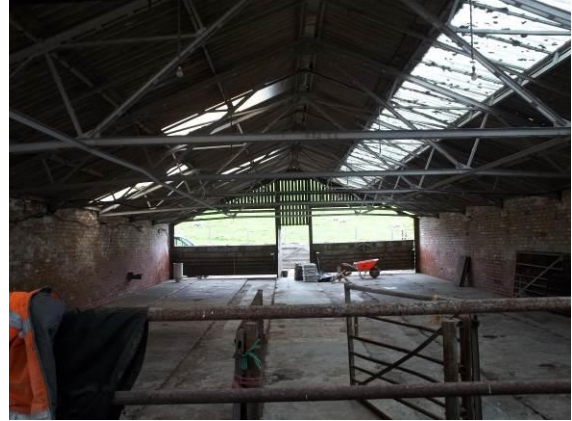
The building consists of a single, open void:

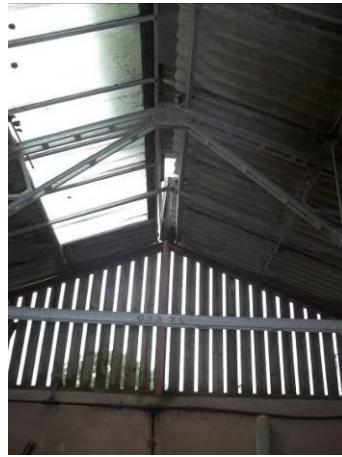
The roof is unlined and has no ridge beam:

Bat access is easily possible at both gable ends and in places at the ridge.

The roof must be removed with appropriate care first.

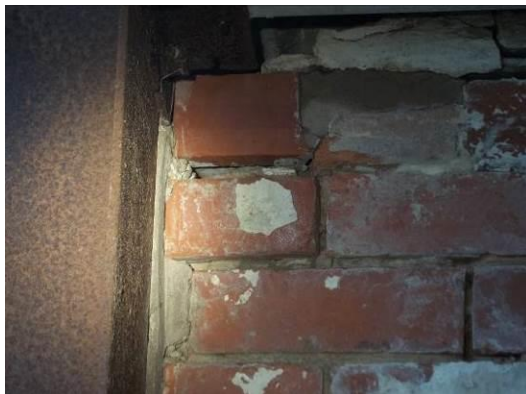
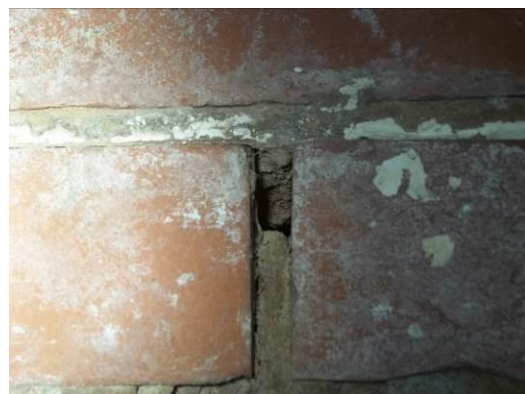
There are a few gaps into the internal brickwork, where there is clearly a cavity within the wall where bats could roost:

The walls have a cavity with some bat access available - at internal wall-heads in particular. While pipistrelle bats are the smallest and most common so most likely to make use of some of the opportunities available, a variety of species can be found within wall-cavities, including in winter when hibernating.

Do not demolish the walls of the building between the months of November and March inclusive unless the temperature the night before has remained above 8°C.

Demolition should be by operatives who are familiar-with and sympathetic-to the law relating to bats. They must understand that if at any time a bat or droppings that may have come from a bat are found work **must stop immediately**. They have a legal obligation to do this. As far as practicable the feature that was sheltering the bat/s should be replaced. Further advice **must** then be sought from the bat consultant before work continues, even if the bat has flown off or droppings appear old.

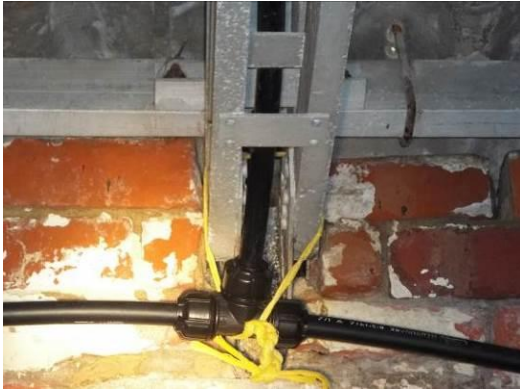
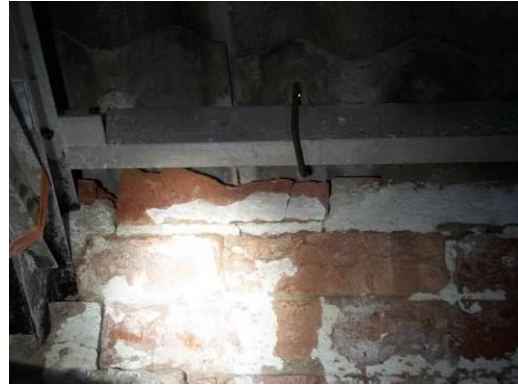
There are a few gaps at beam-insertion-points too, and access to wall-heads:

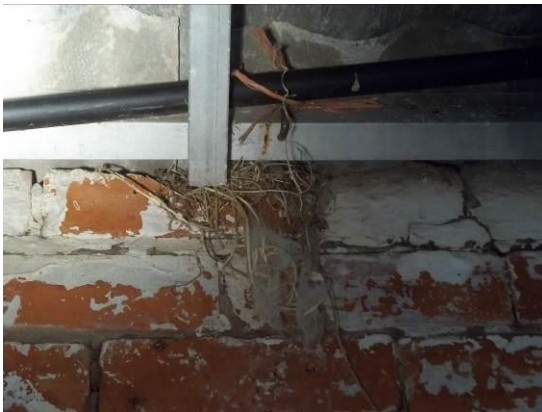
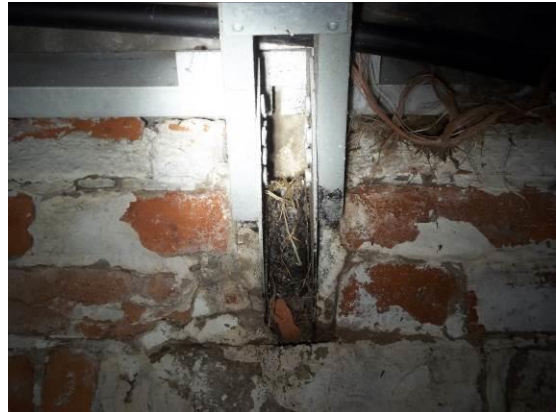
There was evidence of nesting by birds:

House sparrows use a nearby hedge so it is likely the nests are of house sparrows.

Demolition must not take place while birds are actively nesting.

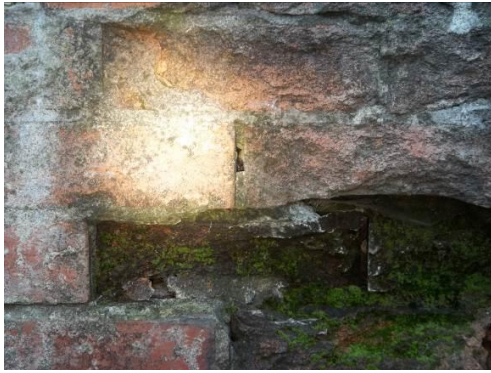
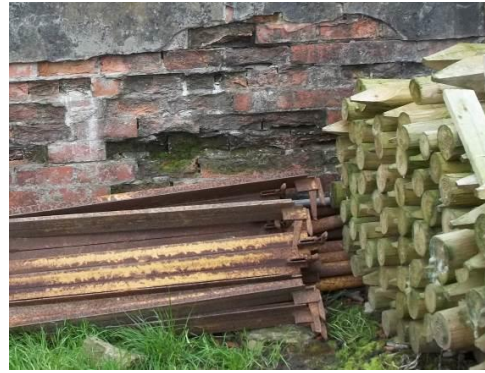
External fascias along the sides of the building are close-fitting and the walls are generally intact, with an occasional minor exception at low level in the west-facing elevation:

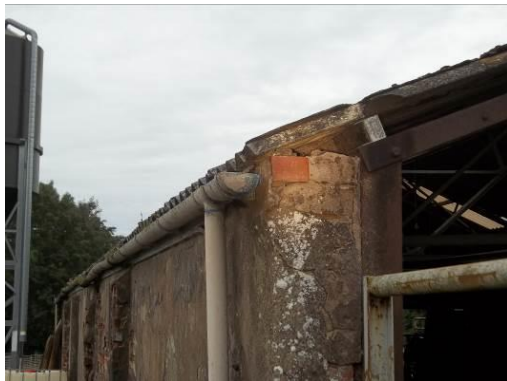
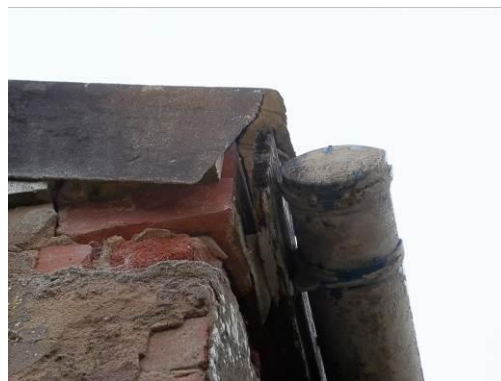
There is access to wall-heads at the gable ends:

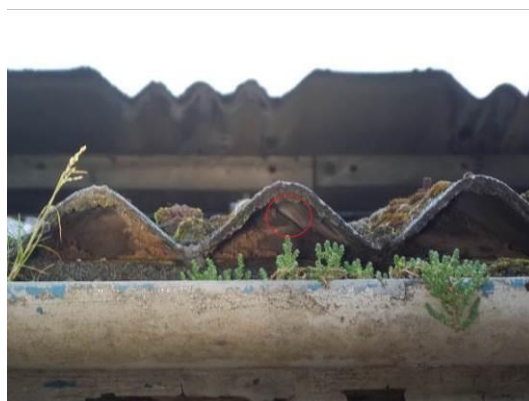
There is some apparent roosting potential available under the asbestos roof where mortar-work is no-longer intact. This was hard to photograph effectively but is illustrated below:

Gap circled in red

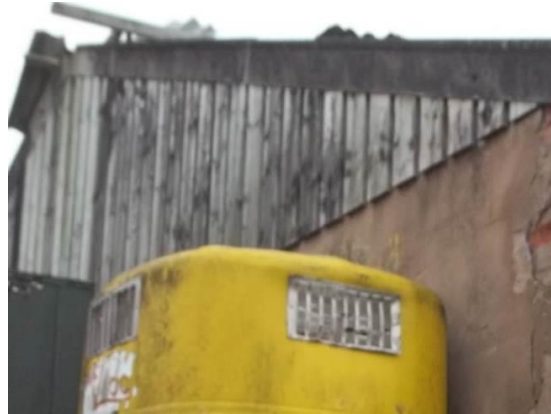
There did not appear to be any roosting potential at the northern gable end between vertical planking and the wall or fascia:

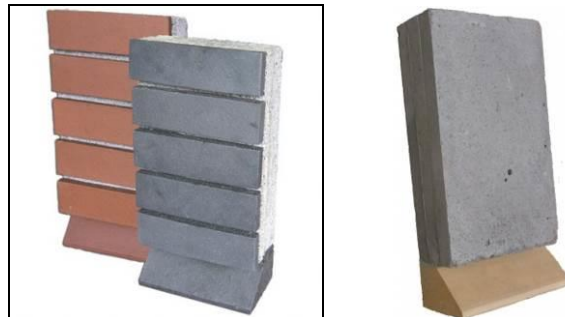
“Designed to be built into an exterior wall and is available in a variety of faces to match the building. Standard facings of red or blue brick - ideal for new builds - are normally available from stock, or boxes can be made to your specific requirements with a face of brick, stone, timber, or plain (for rendering). Supplied un-pointed.”

Example of Habibat boxes Can also be faced with stone.

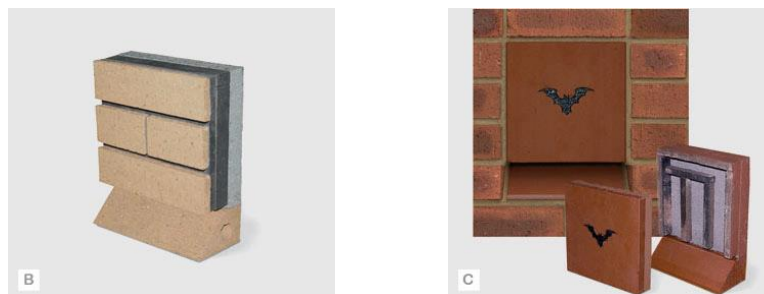
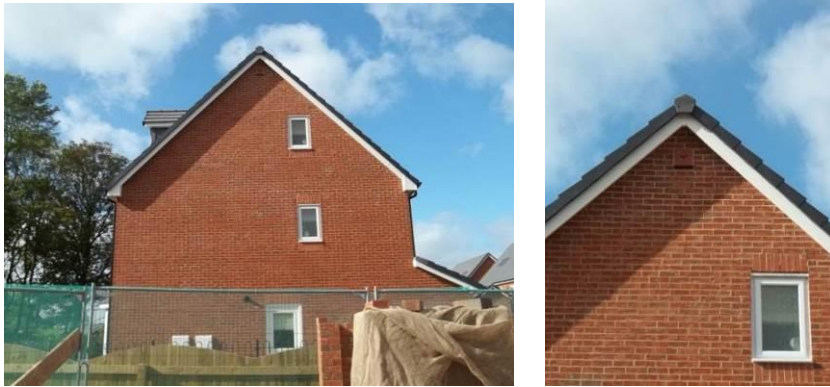
Ibstock Ecozone

Above: typical unit in situ. Photo © Angela Graham

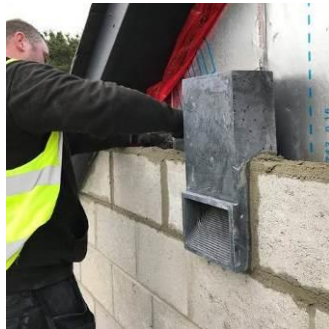
Green and Blue Bat Block/Brick in situ

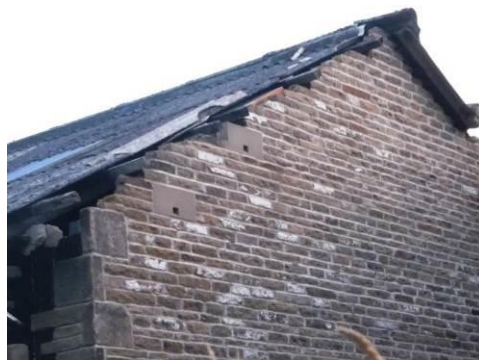
Example of Forticrete boxes in situ

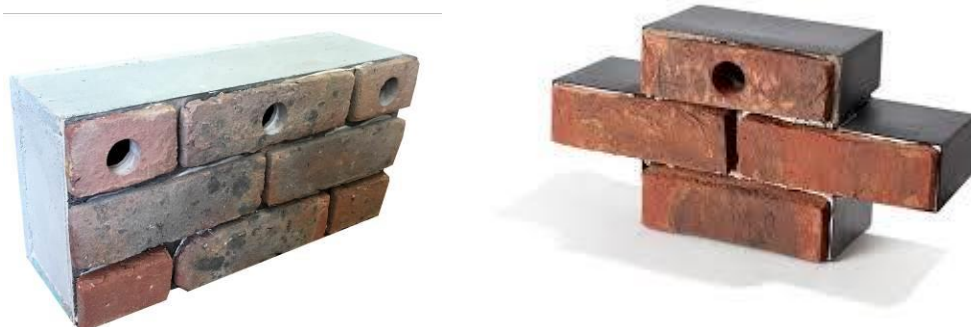
Habibat sparrow bricks
EcoSurv Habibat: <http://www.ecosurv.co.uk>

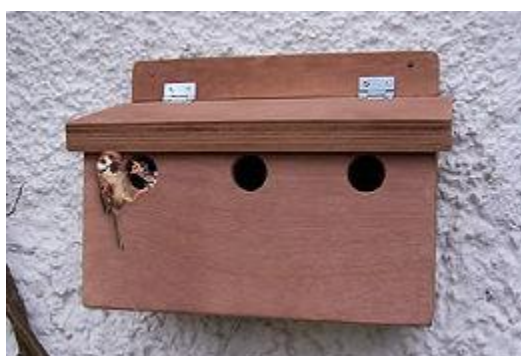
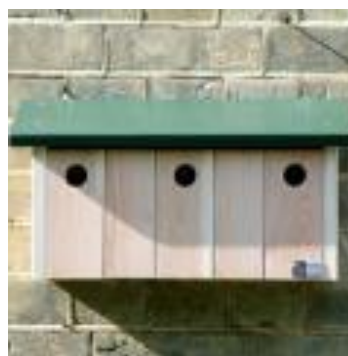
examples of wooden sparrow terracing above and below. An internet search for sparrow terracing or sparrow bricks will provide additional suppliers

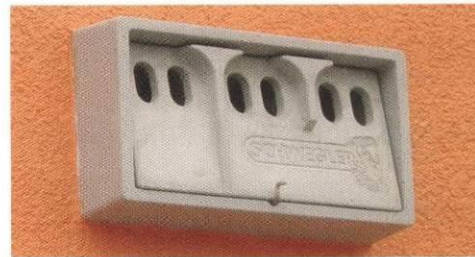
Installation Method 1

Simple surface installation using the plugs and screws supplied

▲ Built into insulation of walls

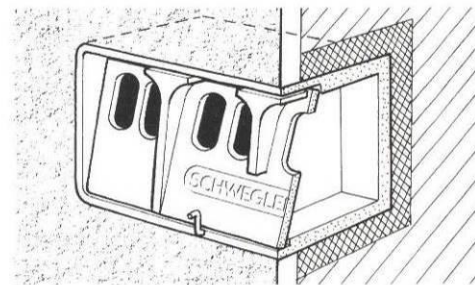
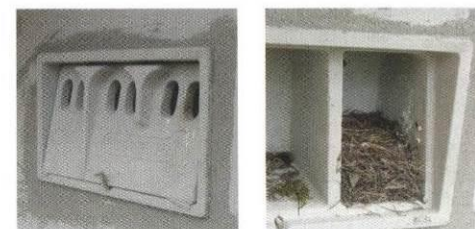
Installation Method 2

Complete installation as a nesting block within brick or concrete walls

To avoid heat-conduction please also use wall insulation, or install at a suitable depth in the wall
