SHIPPON AT MILL HOUSE FARM, CHIPPING ROAD, CHAIGLEY

LICENSED BAT AND BARN OWL SURVEY AND ASSESSMENT

July 2014

[ERAP Ltd ref: 2014_204]

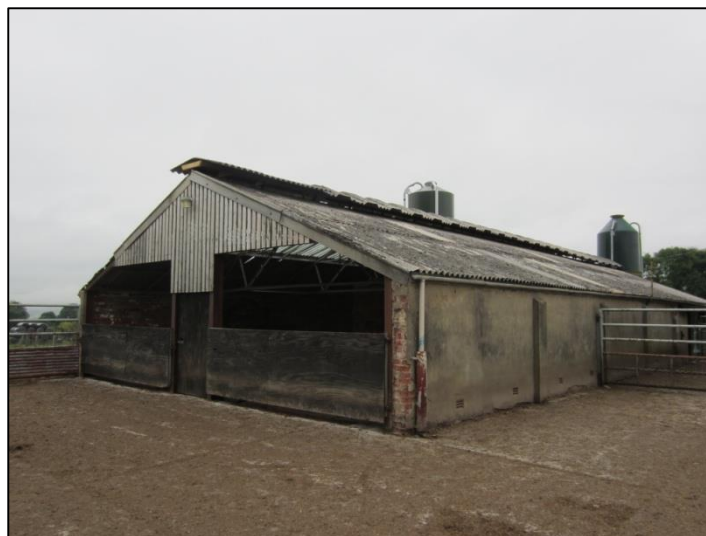
Photo 2: East gable and south elevation of the shippon

- 1.9 The shippon is a single storey steel framed building with rendered brick elevation walls and a pitched corrugated sheeting covered roof, refer to **Photo 2**. No livestock was present at the time of the survey but the building is used to shelter and sort sheep.

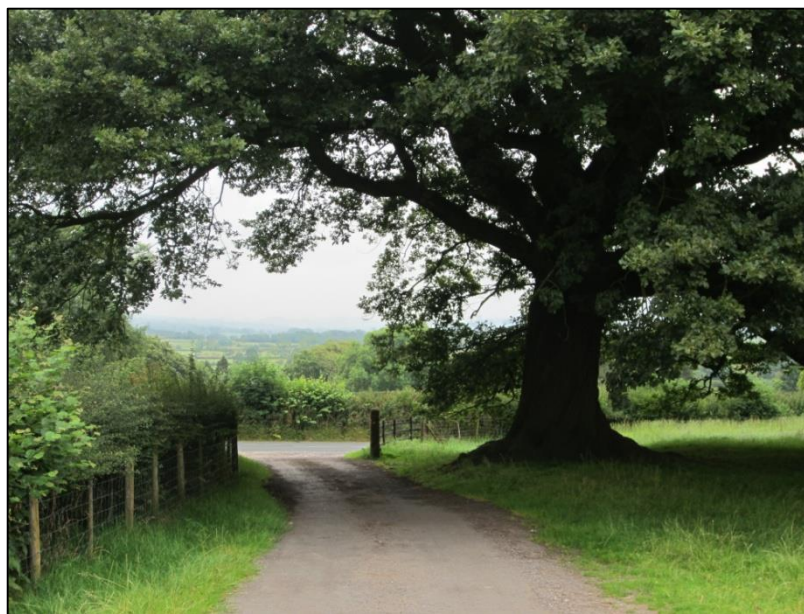
Photo 3: Veteran Oak tree to the south of the Mill House Farm access track and hedgerow to the north.

- 3.2.1 The Mill House Farm complex is accessed off Chipping Road via an existing farm track. At the site entrance is a veteran Pedunculate Oak tree, refer to **Photo 3** below. Farm machinery currently passes beneath the branches of the Oak tree and sufficient clearance height is present. However, as detailed in **Section 4.4**, care must be taken during the construction phase to ensure construction machinery does not damage the tree.
- 3.2.2 Along the north side of the access track is a Hawthorn, Elder and Hazel hedgerow. Again, care must be taken during construction to protect the hedgerow, refer to **Section 4.4**.

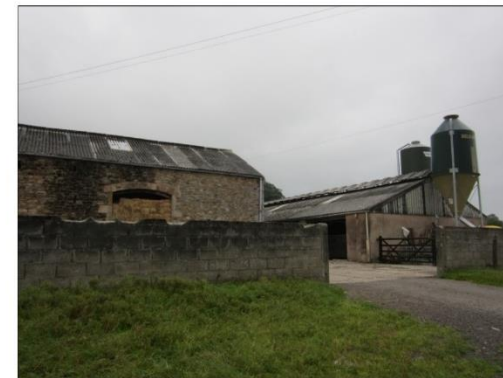
Photo 1: Shippon (right) and adjacent stone barn (left)

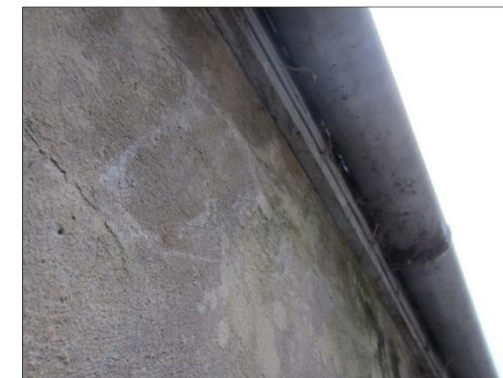
Photo 2: Tightly sealed timber fascia at shippon; no opportunities for roosting bats

- 3.3.1 The shippon comprises a single storey steel framed building with brick, rendered elevation walls and a pitched corrugated sheeting covered roof.
- 3.3.2 The external walls are covered with concrete render; no gaps or opportunities for bats are present.
- 3.3.3 A timber fascia board at eaves height on the south elevation is tightly sealed against the rendered wall; no gaps or opportunities for bat access are present, refer to **Photo 2** on **Figure 1**. The north elevation supports the same timber fascia but owing to crumbling render local gaps are present. However all gaps are densely covered with cobwebs and no opportunities for bat access are present.

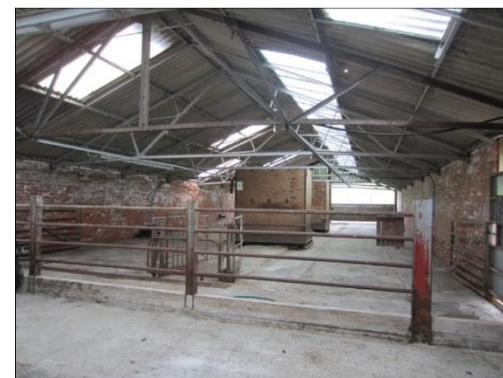
Photo 3: Interior of the shippon (facing west). Mortared internal brick walls; no gaps for bat access.

- 3.3.7 The internal sides of the brick elevation walls are well-pointed (the eastern wall is entirely covered with concrete); no gaps or opportunities for bat access are present. The wall tops are sealed with concrete plaster. No crevices or gaps suitable for bat access are present, refer to **Photos 3, 4 and 5 on Figure 1**.

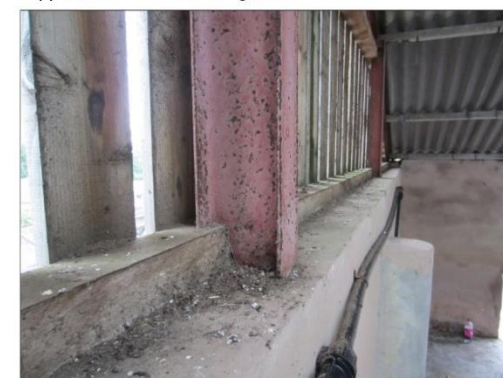
Photo 4: No gaps at the wall tops inside the shippon.

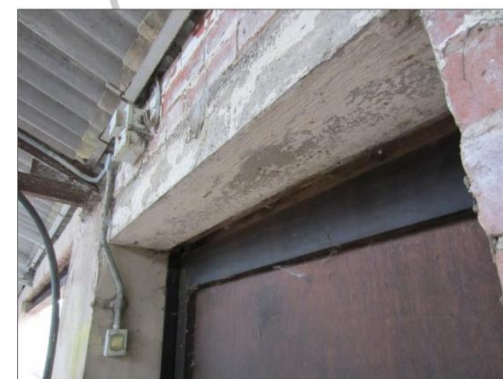
Photo 5: No gaps for bat access beneath the door lintels at shippon

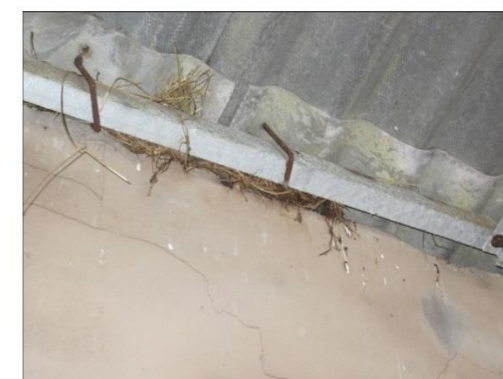
Photo 6: House Sparrow nests at wall top inside shippon.

- 3.4.6 Nesting House Sparrow, a UK Biodiversity Action Plan (BAP) Priority Species nest at the shippon. As annotated on **Figure 1**, six old and active nests were detected. A flock of up to six House Sparrow regularly entered the shippon during the survey.
- 3.4.7 No other active or old bird's nests were found.

4.3.4 To ensure there is no net loss of opportunities for use by nesting House Sparrow at the site it is recommended that two House Sparrow terrace boxes are installed at the converted building. All recommendations are annotated on **Figure 2**.

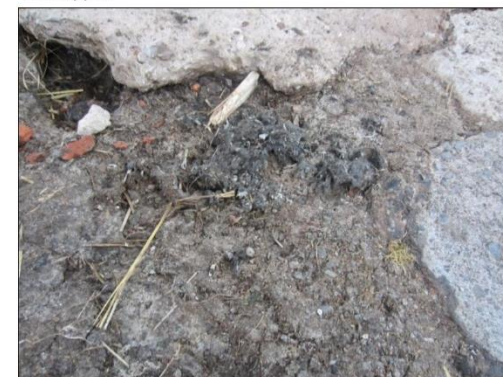
- 3.4.1 As annotated on **Figure 1**, evidence of occasional use of the shippon by roosting Barn Owl was detected. Evidence comprised three areas of faecal splashes, two old (>12 months*) trampled pellets and a single feather, refer to **Photo 8 on Figure 1**.

Photo 8: Old (>12 months), trampled Barn Owl pellets inside the shippon

- 4.2.1 Evidence of use of the shippon by roosting Barn Owl was detected. Use of the shippon by nesting Barn Owl is reasonably discounted owing to the conditions present.
- 4.2.2 In accordance with the guidelines in Ramsden 2009 and Barn Owl Trust 2012 the following guidance is applicable in relation to the shippon application: -

- a. There is no requirement to carry out a pre-construction survey at the shippon for nesting Barn Owl owing to the building's structure and conditions present at the building; and,
- b. In consideration of the provision of alternative opportunities for nesting/roosting Barn Owl it is concluded that the specifications for two Barn Owl boxes to be installed in connection with the approved conversion of the adjacent stone barn are appropriate (Condition 10 of planning reference 3/2013/0840). No further actions in relation to the shippon conversion are warranted. The boxes should be installed as soon as possible regardless of the proposed start of works date at either the barn or the shippon. The boxes could be installed on trees to the west of the shippon *or (and more appropriately)* inside cattle sheds on the adjacent farm approximately 60 metres to the north-east of Mill House Farm.

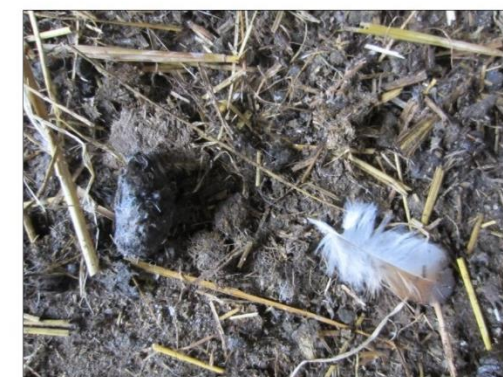
- 3.4.4 Inside the adjacent stone barn are three areas of fresh (< 1 month old*) Barn Owl pellets (2-3 pellets in each pile with associated faecal splashes and feathers). Faecal splashing is also present down the internal side of the stone walls, refer to **Photo 9 on Figure 1**. This concurs with the findings of report prepared by Denis Lambert dated September 2013 and submitted in connection with planning application reference 3/2013/0840 for the conversion of the barn.

Photo 9: Fresh Barn Owl pellet and feather inside the adjacent stone barn

4.2.3 Owing to the suitability of the adjacent stone barn for use by nesting Barn Owl, all actions detailed in Condition 10 of planning reference 3/2013/0840 **remain applicable** in connection with the approved conversion of the stone barn.

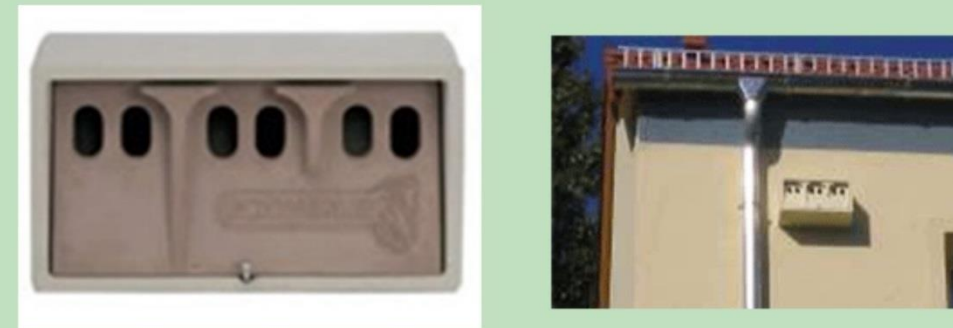
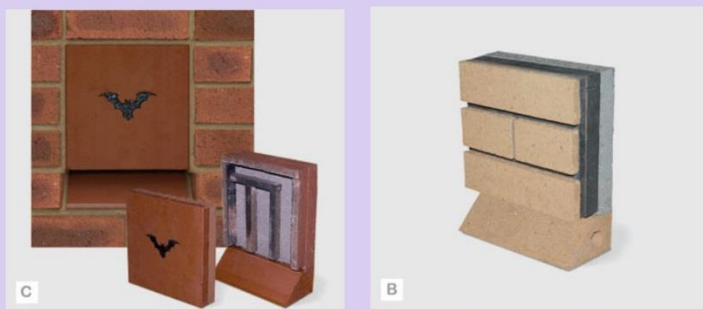
Figure 2: Plan to Illustrate Provisions for Roosting Bats and Nesting House Sparrow at the Converted Shippon

PLANT VIEW OF PROPOSED CONVERTED SHIPPON
(ELEVATION DRAWINGS WERE NOT AVAILABLE)

TWO HOUSE SPARROW TERRACE BOXES

To compensate for the loss of habitat used by nesting House Sparrow at the shippon two House sparrow terrace boxes will be installed.

PRODUCT: Schwegler 1SP House Sparrow terrace box x 2

LOCATION: To be installed on the east facing gable of the converted building. Avoid siting above doorways or windows where droppings may cause a nuisance. Avoid south elevations as high temperatures may cause chicks to over heat. Ecologist to approve final positions once elevation plans are approved.

TWO BAT ACCESS PANELS

To enhance the opportunities for biodiversity at the converted shippon two bat access panels will be installed.

PRODUCT: IBstock ENCLOSED Bat box 'c' or 'b' , or similar.

LOCATION: East or north-west facing gable ends are appropriate to provide a range of conditions. Ecologist to approve final positions once elevation plans are approved.

- 4.1.7 As habitats within proximity of the converted shippon dwelling will remain suitable for the attraction of foraging bats it is recommended, in accordance with best practice and the principles of the National Planning Policy Framework (NPPF), that two bat access panels are installed at suitable locations on the converted building, refer to **Figure 2**.
