**BAT SURVEY AT -  
26 SINGLETON AVENUE  
READ**

DATE AND TIME OF VISIT  
22<sup>nd</sup> June 2022 5.30pm

REFERENCE. Mr A Jackson.

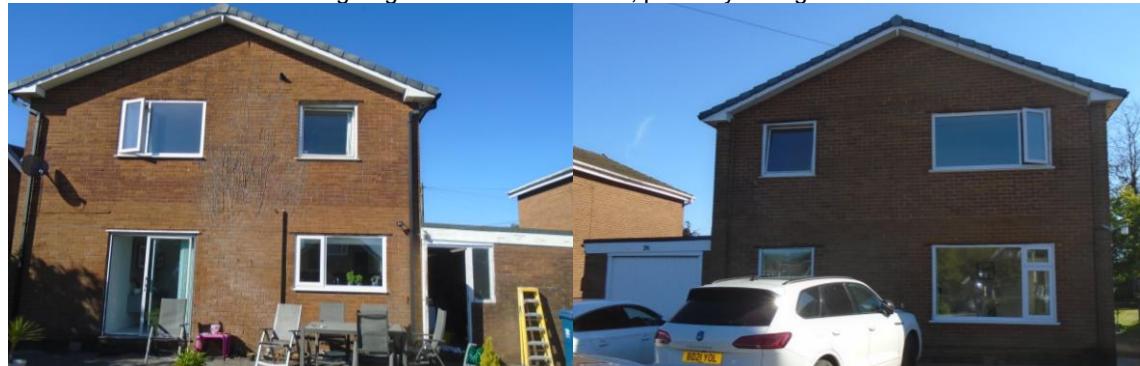
Detached house with attached garage to the side elevation, probably dating from the 1970's /80's

Rear elevation.

Front elevation

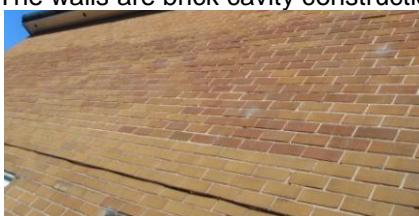
The walls are brick cavity construction.

The walls are in good condition with no cracks or crevices suitable for bat ingress .

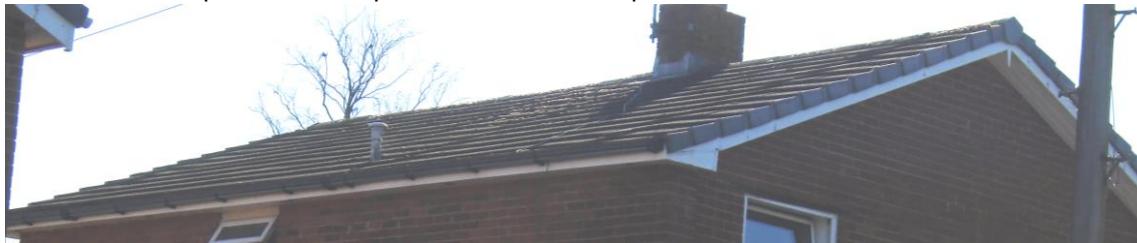
The main roof is pitched with a profile tile finish and upvc fascia and soffit.

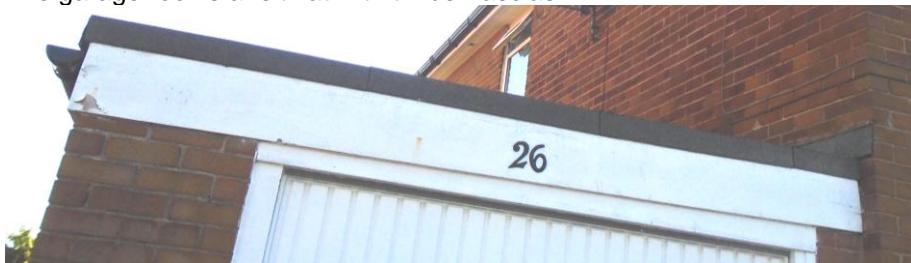
The garage roof is a felt flat with timber fascias

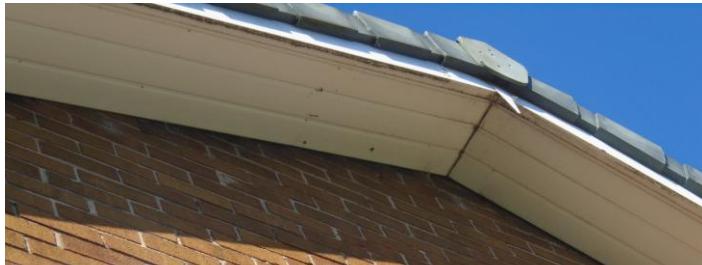
The roof tiles are tight fitting with no gaps or slipped tiles. The flashings to the chimney and flat roof are all tight fitting as are the upvc soffits and fascias. The flat roof is in good condition with no rips in the felt. The roof structures do not provide any cracks or crevices with the potential to provide bat roost habitat.

Gable soffits

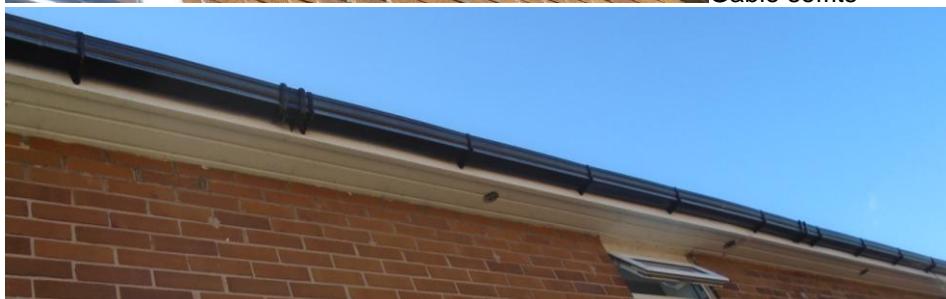
Eaves soffits

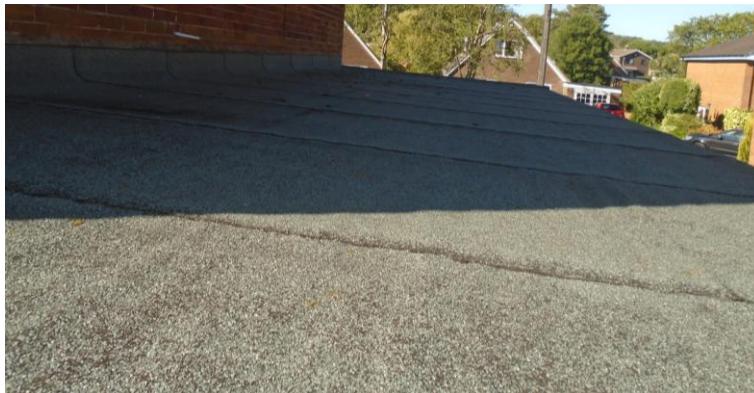
Felt flat roof

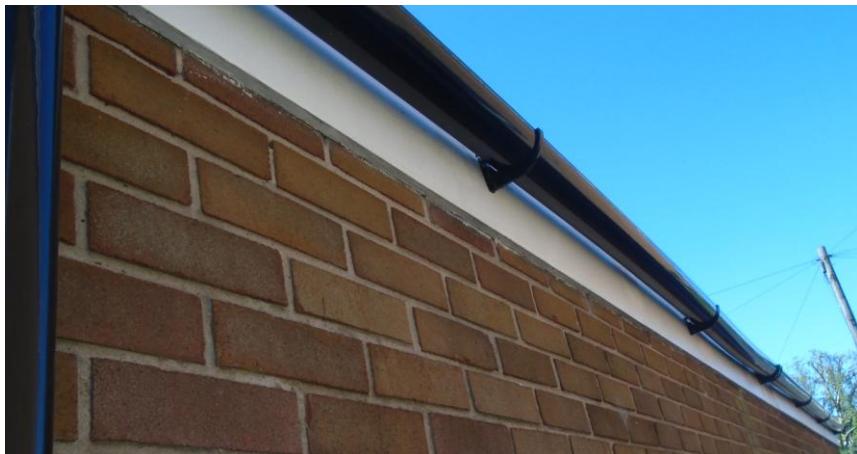
Garage fascia

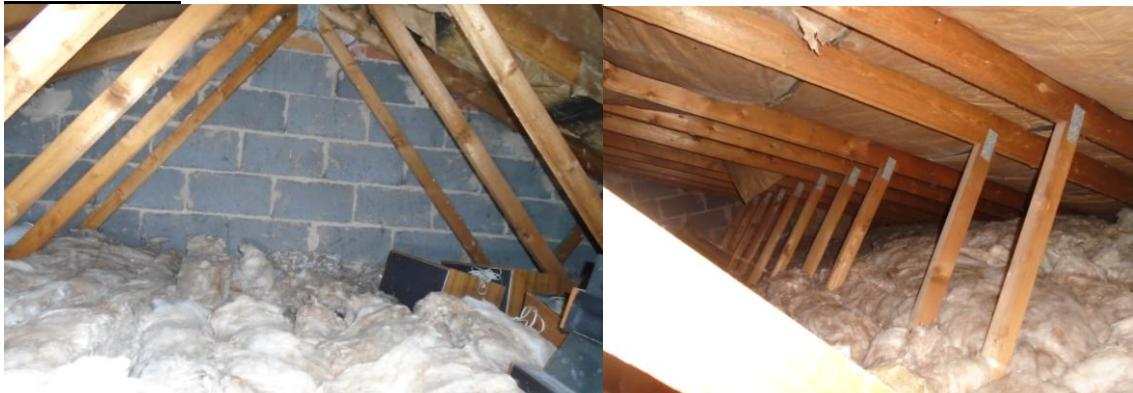
House roof space was accessed via a ceiling hatch. All the timber trusses are in good condition. The underlay was not a conventional felt and was in poor condition however the space is very clean with no evidence of any dropping or insect remains. Signs of current or historic bat presence was not found. The space does not provide any high value forage or roost potential,

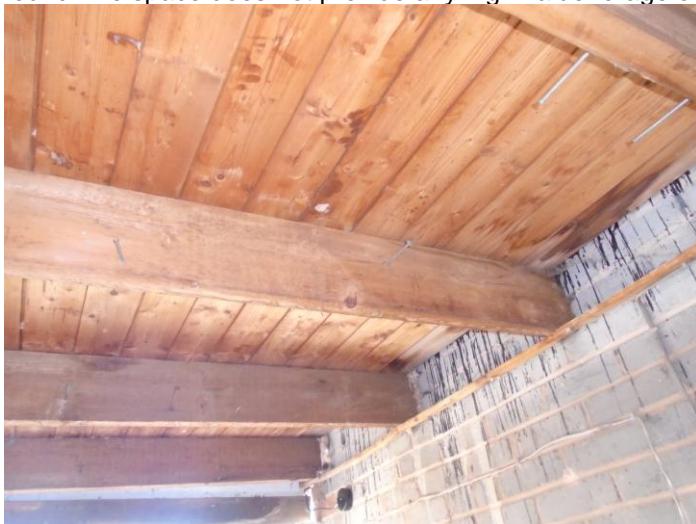
Garage roof structure

The garage roof structure was not enclosed the joists with boarding over was easily examined from floor level. All the structure was in good condition and all surfaces within the garage were clean and free from any dropping or insect remain evidence.
