HERITAGE STATEMENT

PROPOSED REFURBISHMENT OF EXISTING HOUSE AND CONVERSION OF EXISTING BARN
AT
LOWER REAPS FARM
WHINNEY LANE
MELLOR
LANCASHIRE
BB2 7EL
NGR: SD 66119 30211

Project Ref- 6590 Document Ref- HS-1.00

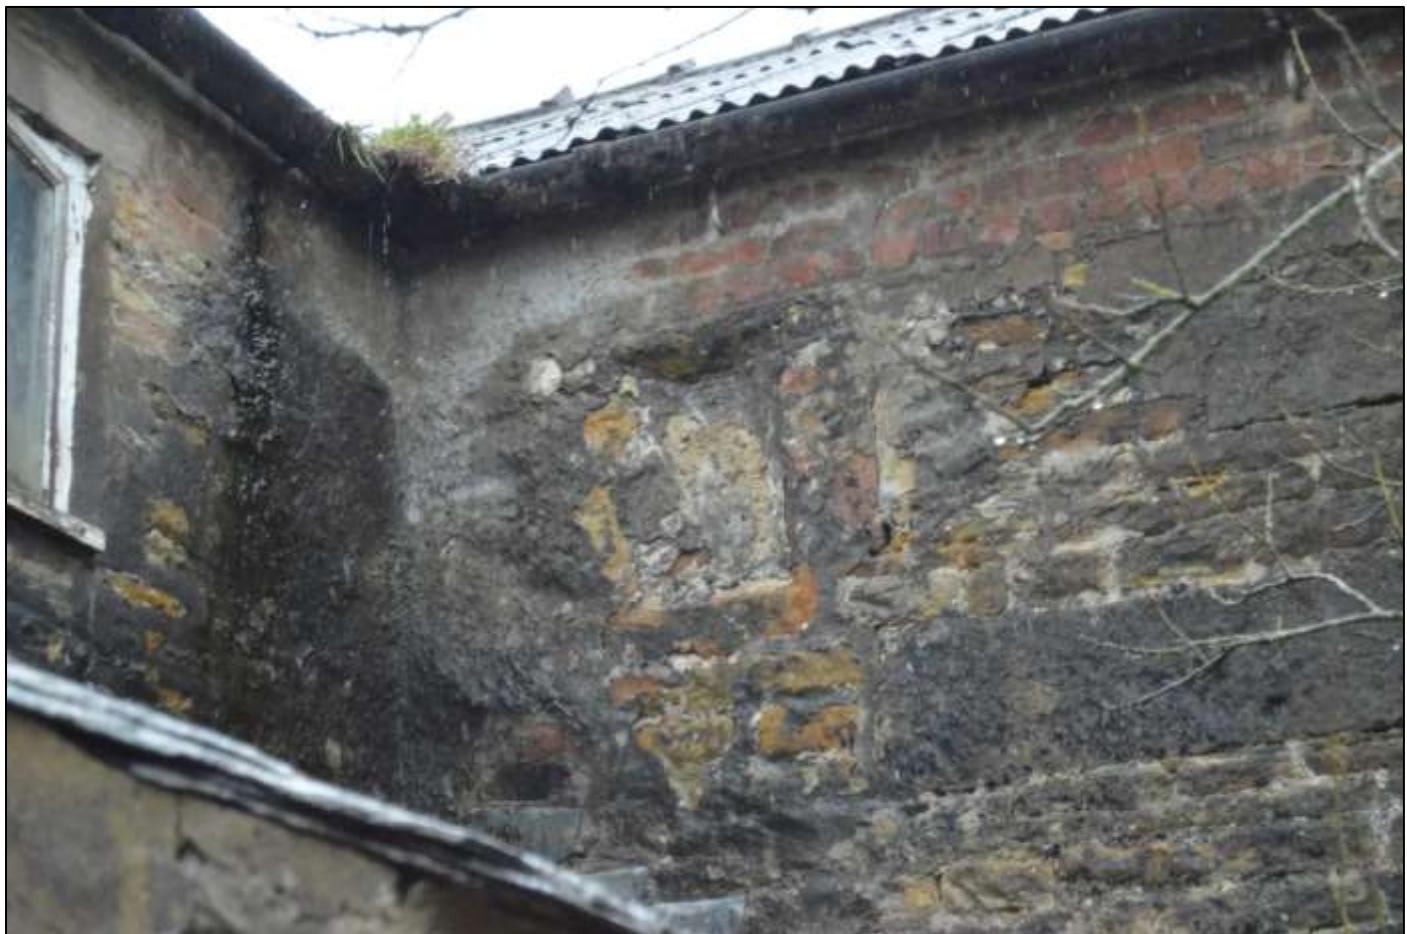
PL04: View of blocked window to the first floor of the west elevation of the cross wing.

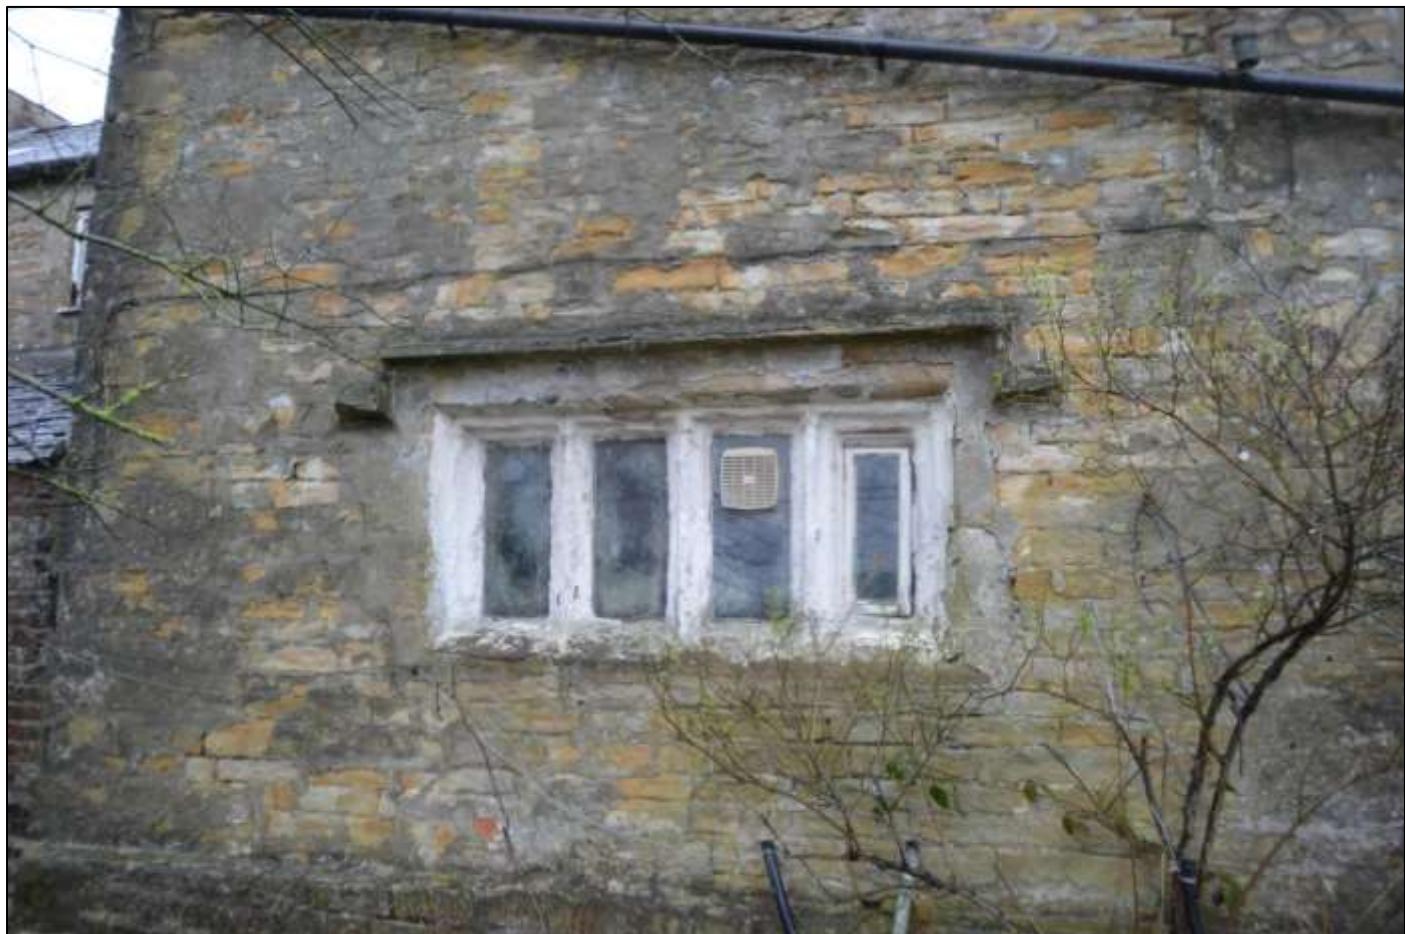
PL06: View of the four-light, stone mullioned window to the ground floor of the cross wing.

The projecting gable end to the cross wing has a 17th century 4-light mullioned window to the ground floor and a similar 3-light mullioned window to the first floor, both with hollowed chamfered mullions, surrounds, with outer chamfer and stone hoods over. Adjacent to the porch, are three boarded up windows to the ground floor. Past photographs of the building show that the eastern window once had a 6-light sash window, probably early 19th century in date and likely formed following the erection of the porch and blocking up of the mullioned window within. The remaining two windows once had 4-light sash windows. These historic windows have been removed and replaced with modern timber casement windows. A modern 4-light timber casement window is situated above the lean-to porch, with a further window, also of four lights, is present to the first floor to the west end of the farmhouse's front

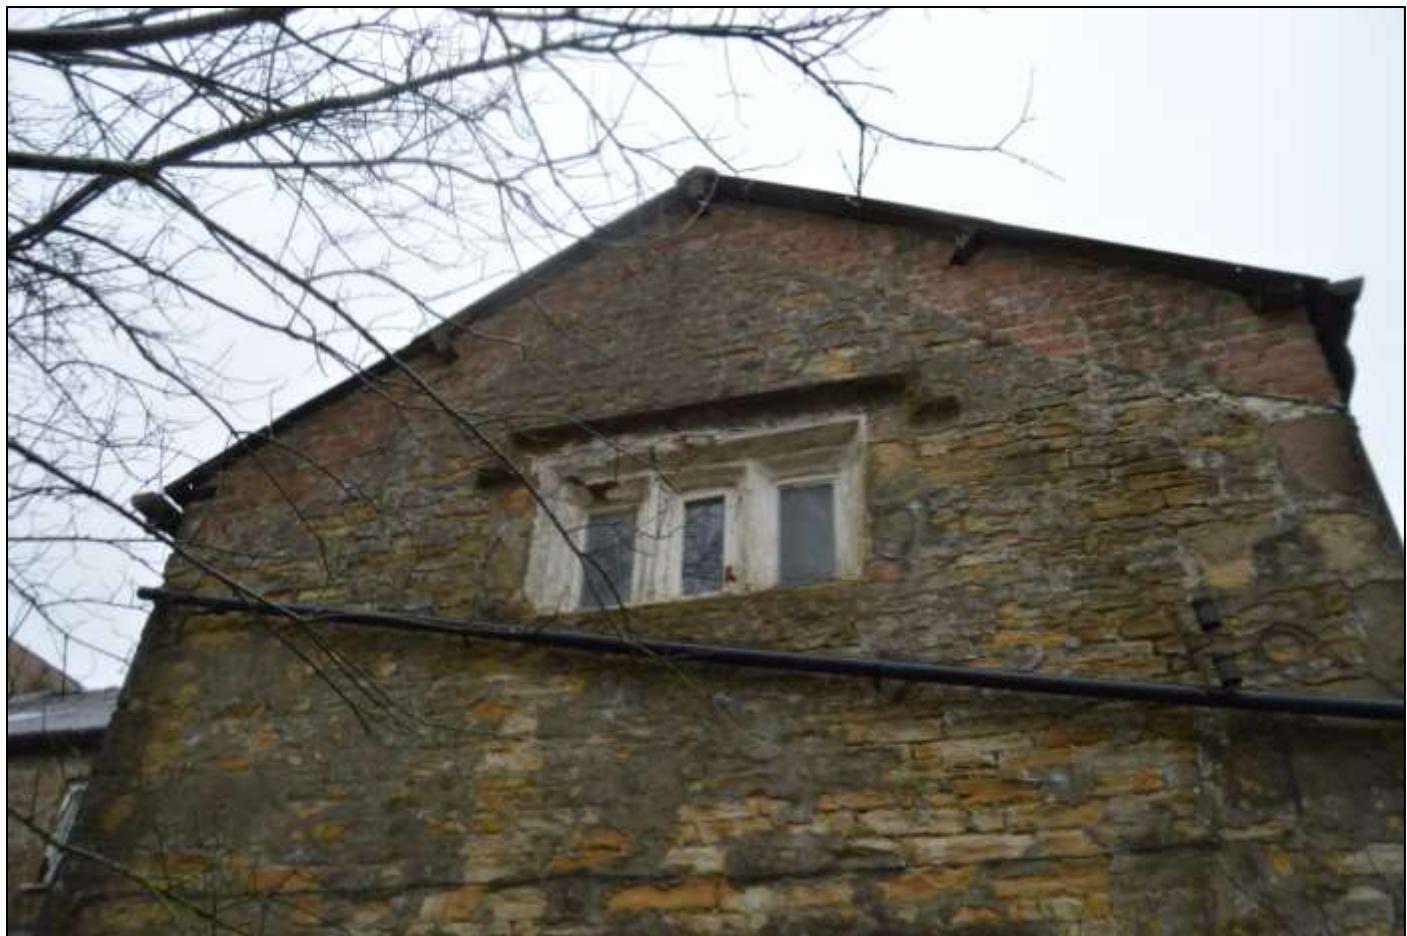
PL07: View of the three-light, stone mullioned window to the first floor of the cross wing.

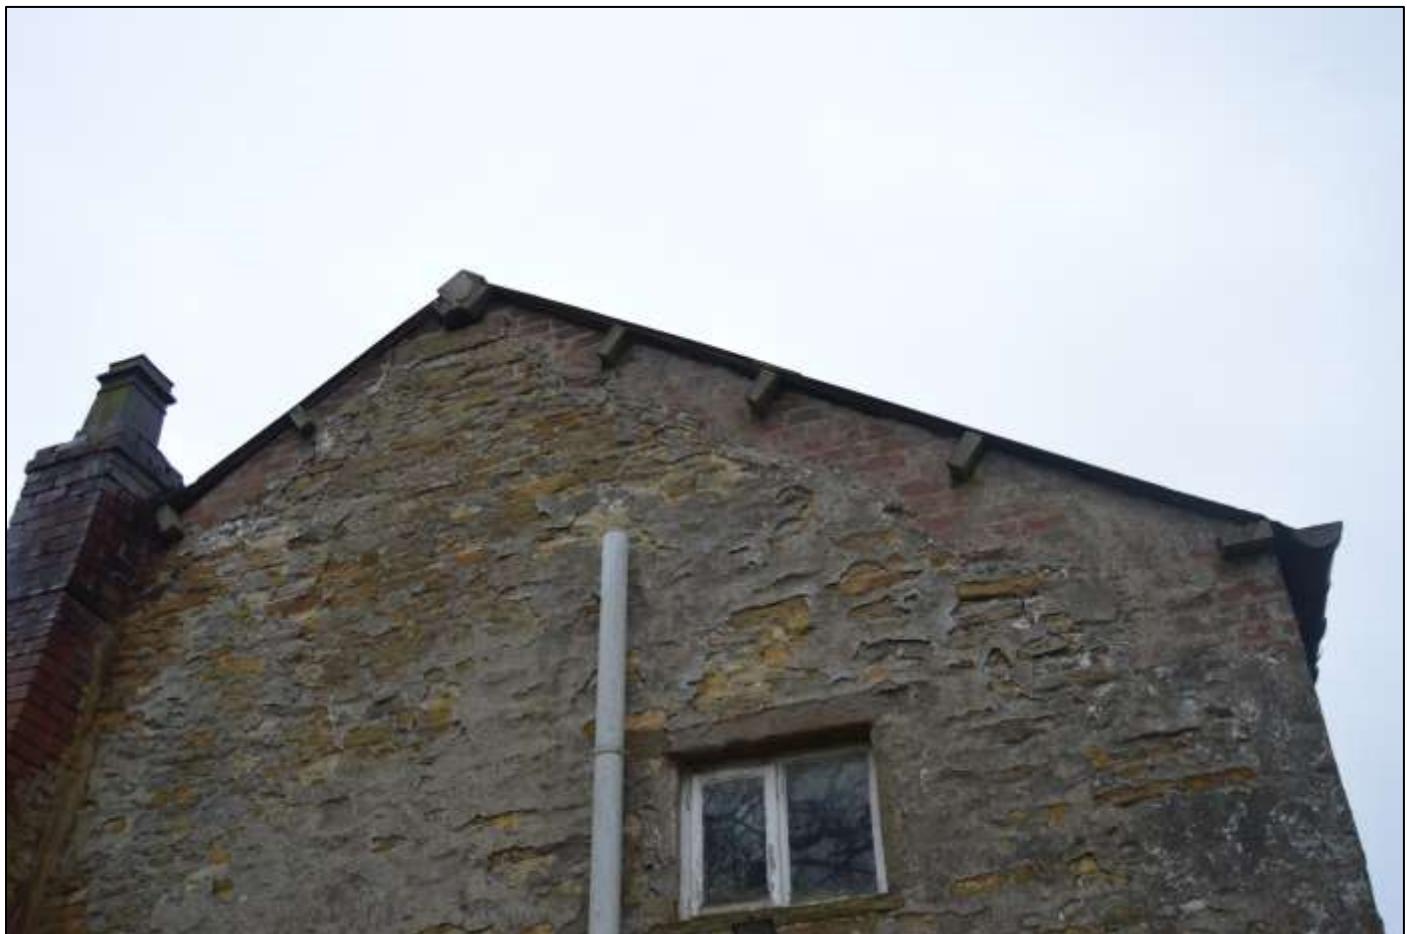
PL10: View of raised roof and old roofline to the east gable end.

The west gable end elevation, is plain in appearance, with no distinct features of interest with the exception of the raised roofline which is clear within the wall fabric. The east elevation has a little more interest and the raised roofline also remains visible. A 20th century, full height, brick chimney stack has been constructed probably to suit the adopted kitchen use of the ground floor unit at this location. A door opening has been inserted adjacent to the north side of the chimney. A stone built 19th century, lean-to outhouse / earth closet is adjacent to the south side of the brickwork stack. A modern 4-light timber casement window has been inserted over the earth closet. A 19th century window is present to the north side of the first floor with plain stone surround and blocked up window is present below at ground floor level, with a plain stone head and sill.

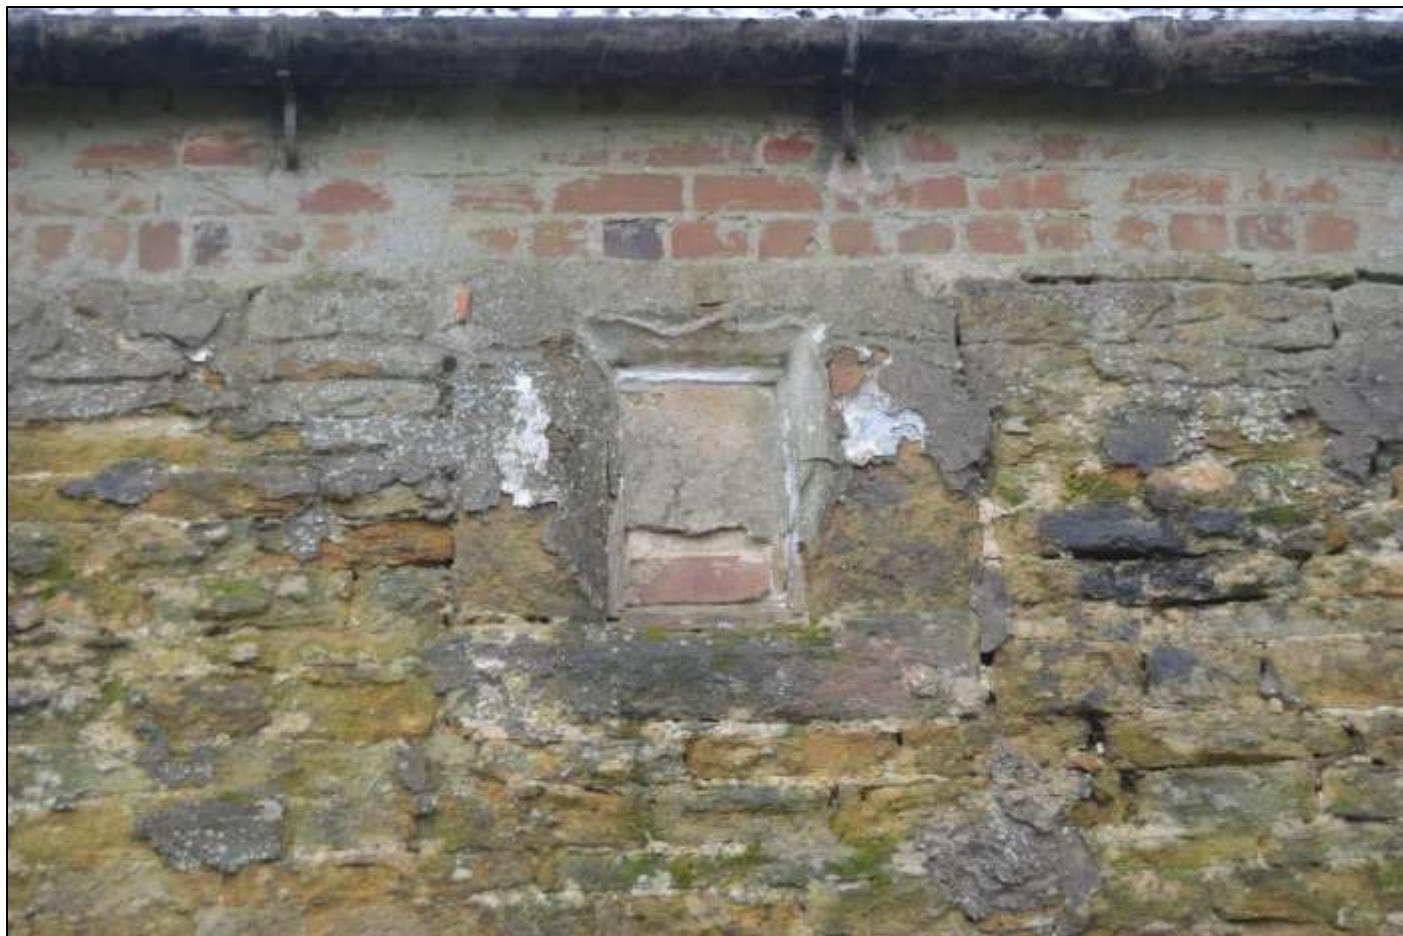
PL15: View of blocked up former staircase window to the first floor of the rear north elevation.

The rear elevation has a series of windows of varying sizes, styles and ages, the majority of which appear to be later or modern insertions. The most interesting is the small 17th century window opening with chamfered stone surrounds to first floor level and may provide an indication as to the location of the original staircase position. The window directly below to the ground floor has a large and disproportionate stone head, which is of interest and lines of dichotomy are present to each side of the stone head, suggesting a larger opening was once present, the exact nature and purpose of which has not been elucidated. A blocked opening is present to the ground floor the west unit addition, with evidence of a further blocked window noted to the west side of the stable addition.

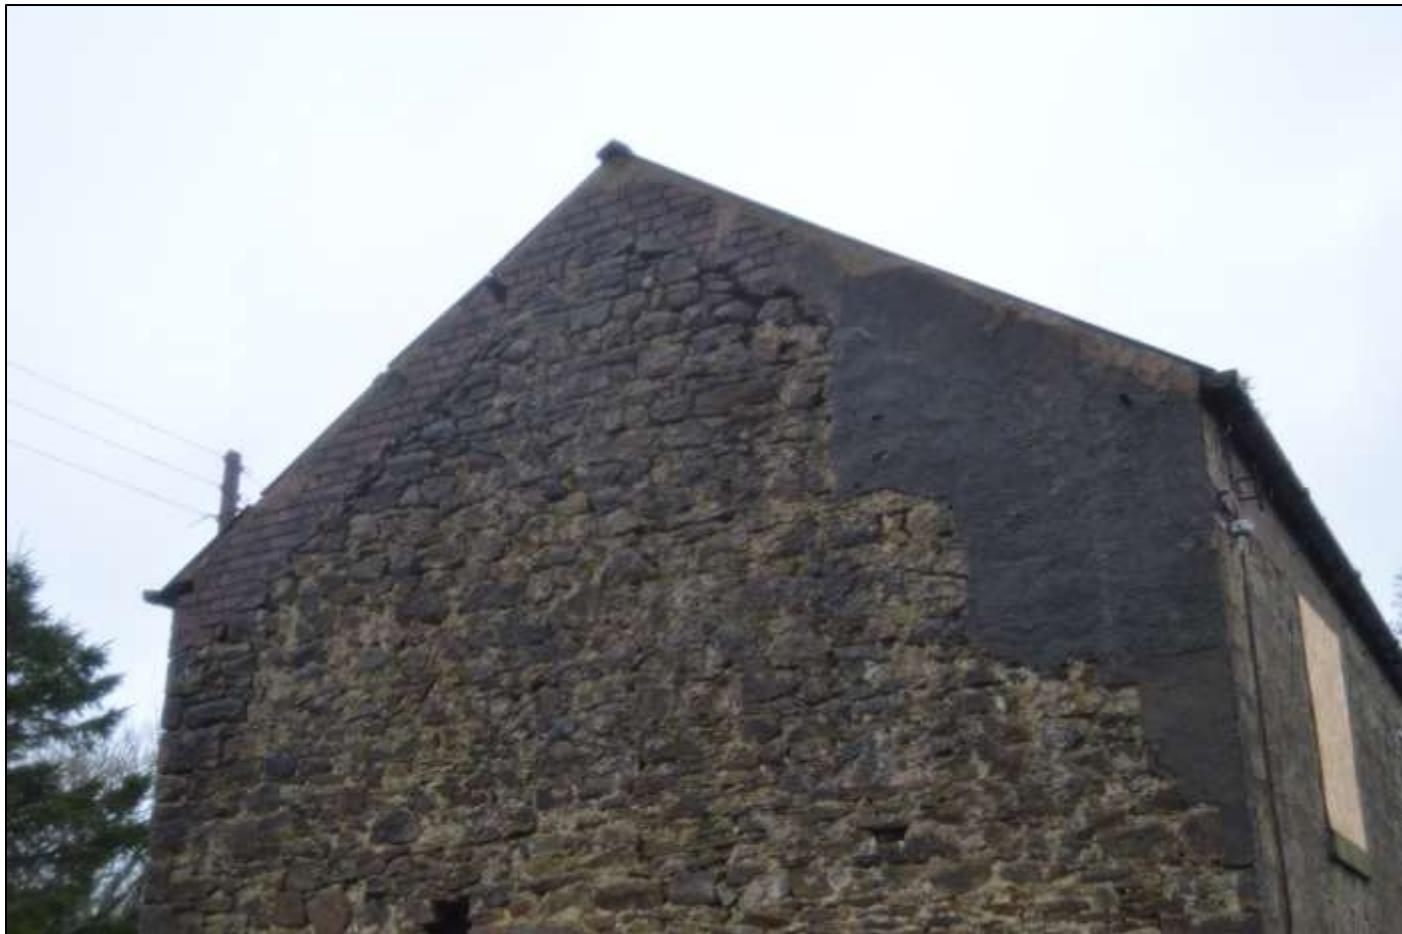
PLI 7: View of raised roof and old roofline to the west gable end elevation.

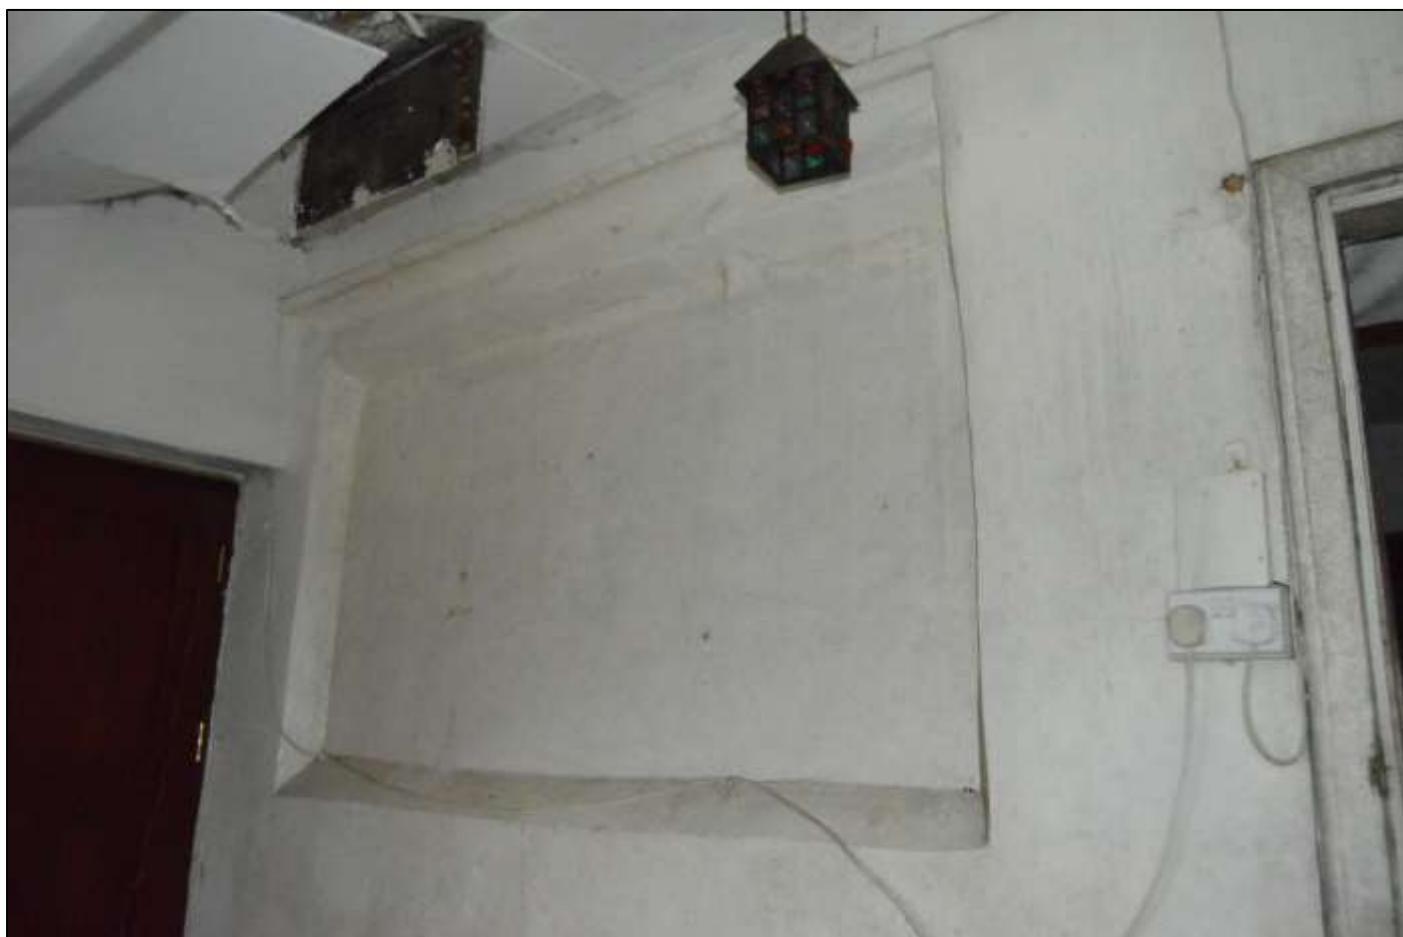
PL25: View of blocked former mullioned window from within the front south elevation lean-to.

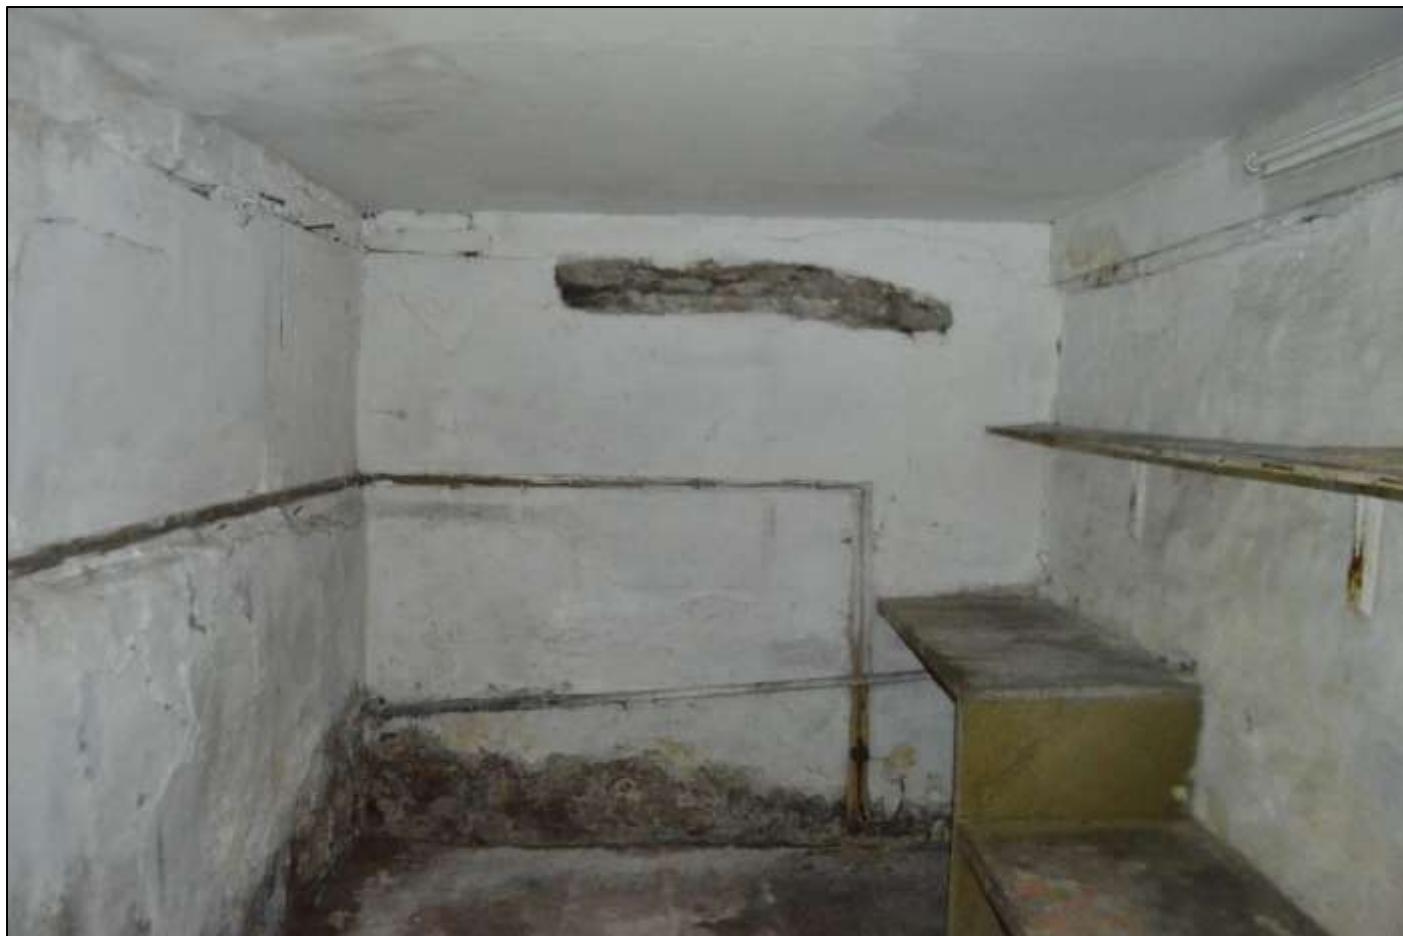
PL26: View east within the rear ground floor unit to the cross wing (note the timber lintel to the blocked window).

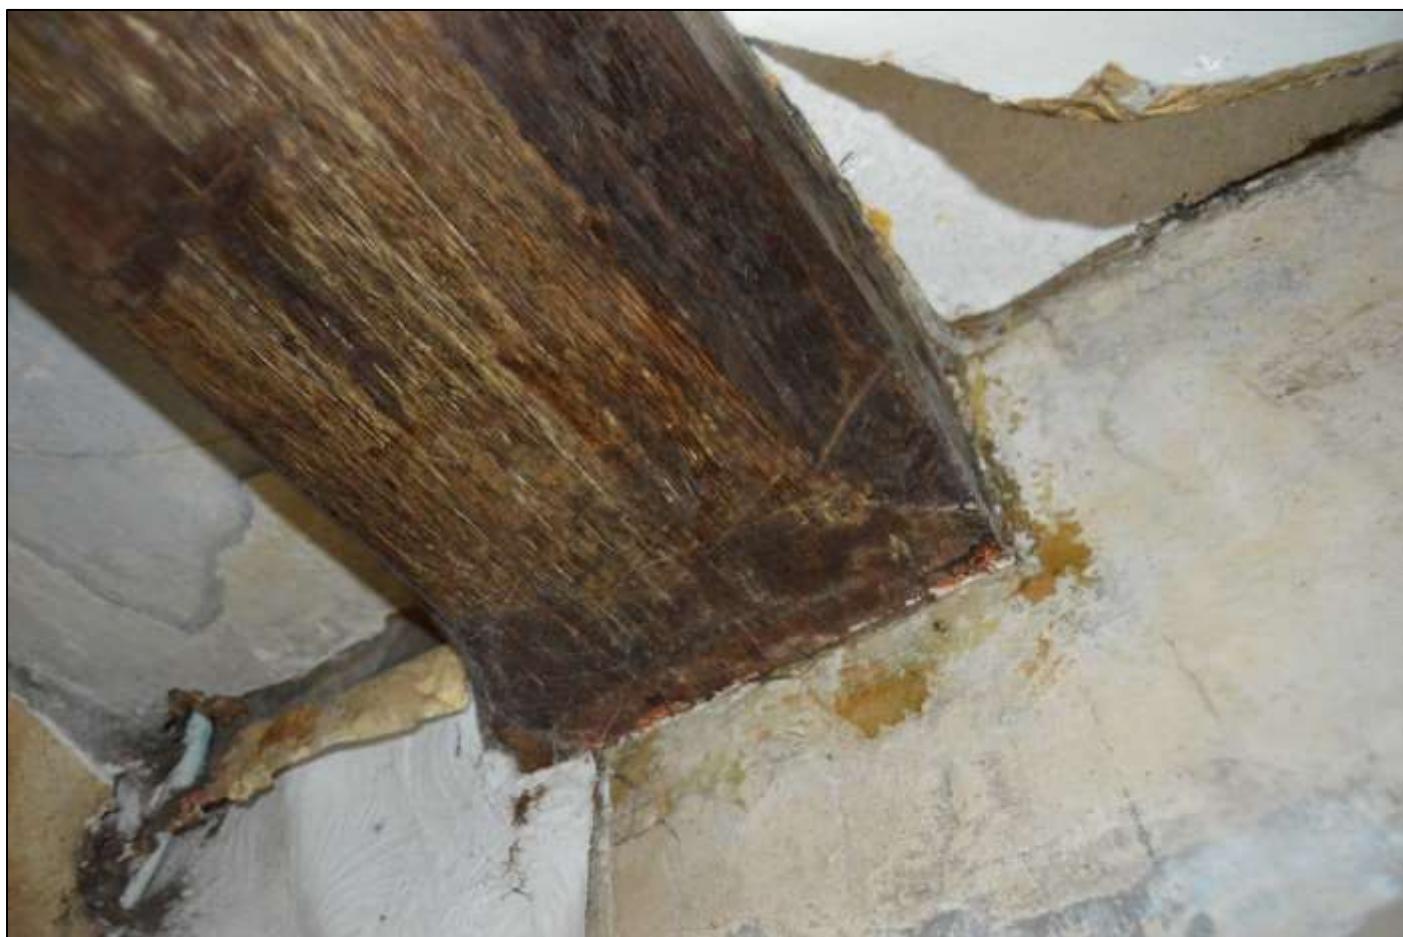
PL31: View of 17th century floor beam within the central ground floor unit, with chamfers and stops.

cross wing, again is a plank and batten door. The passageway possibly dates from the mid-20th century. A 17th century chamfered and stopped floor beam is present beneath ceiling level to the house body and runs parallel to the partition. There is no evidence that the beam accommodated a passage screen. A further timber beam is present to the ceiling however this is only of roughly converted timber, with no chamfers or stops. The house body would likely have been the only heated room in the farmhouse and a chimney breast is present within to the west wall and is likely to be original. The house body provides access into the west unit, through an inserted door opening, the chimney breast is likely to be contemporary with the building of the west addition, however the fireplace is from the 1930's. The former parlour, now a kitchen, contains the staircase which is enclosed, within a plank partition, with a plank and batten door, all of which date from the late 19th or early 20th century. The service room, adjacent to the rear of the kitchen, has a timber lintel set into the east wall denoting the location of a now blocked up window opening. The window to the rear of the service room is later.

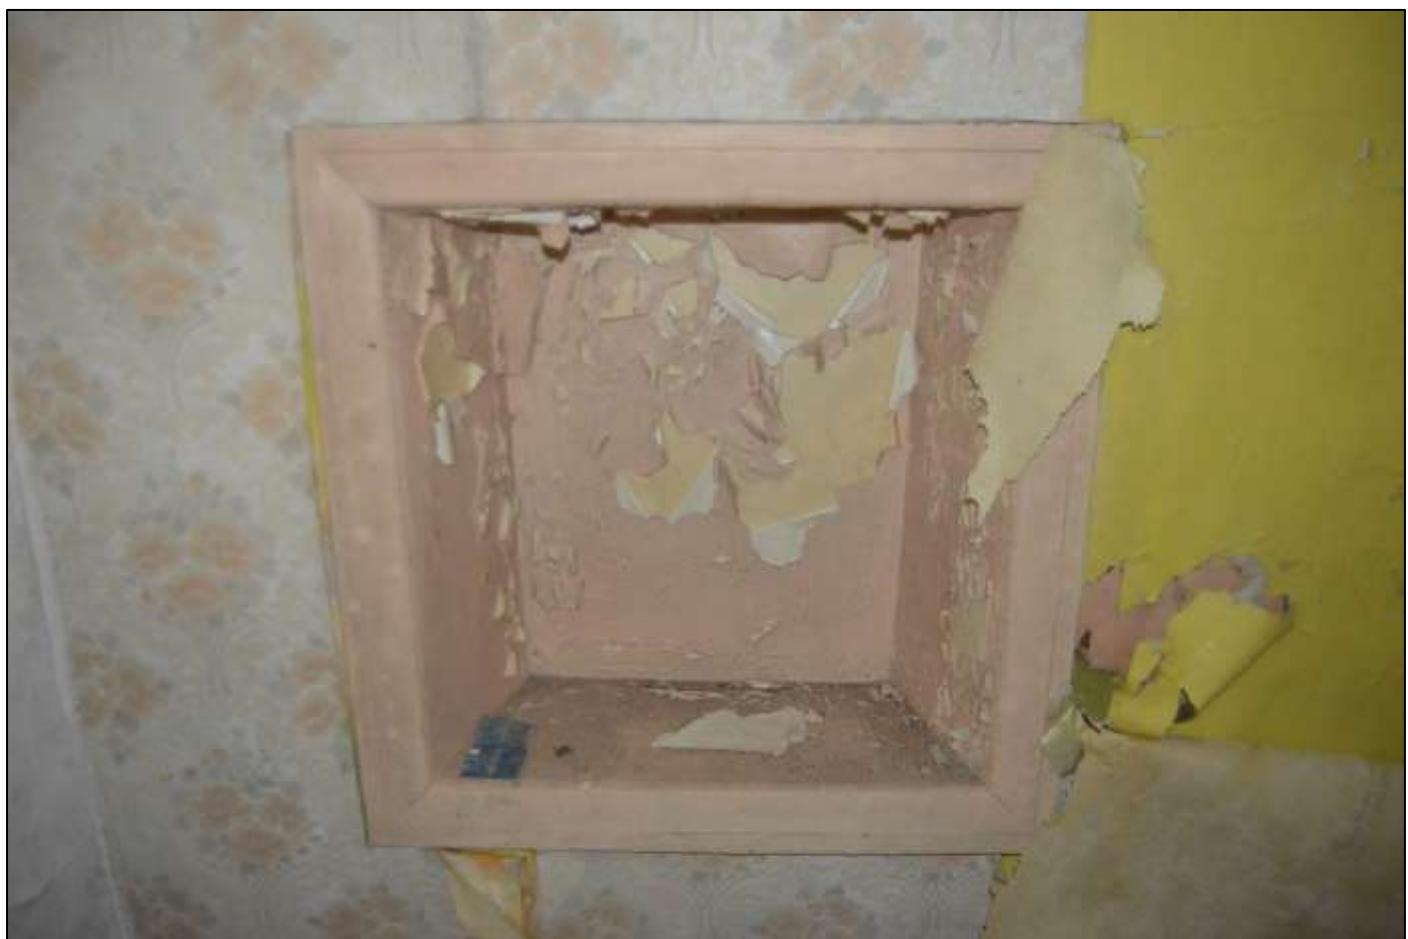
PL36: View of blocked possible former staircase window to the first-floor landing to the rear of the cross wing.

The staircase provides access to the first-floor landing, and although not original. The staircase may be in similar location to the original which is suggested by the small, blocked 17th century window to the existing landing which may be an original landing window. The first-floor unit to the cross wing has been subdivided to form a bedroom and bathroom likely undertaken in the second half of the 20th century. The exposed floor boards to the cross wing bedroom appear to be later. The first-floor level steps down from the cross wing into the landing of the main house body and could suggest that the floor structure to the cross wing has been raised, likely at the time the staircase was added. At first floor level, the main house body has been divided to form an additional bedroom, likely in the late 19th / early 20th century. The bedroom has a timber plank and batten door and later floor boards. The remains of the chimney breast to the 17th century farmhouse can be seen to the west end of the landing. Adjacent to the chimney breast is a further inserted doorway, with steps down into the first floor of the west addition. Again, this has been sub-divided to form two rooms. Two recesses appear to have been formed to the west side of each room, with a projecting section of walling centrally between, on which adjoins the dividing partition. The exact nature and purpose of this arrangement is unknown. Each bedroom is entered through a doorway with late 19th / early 20th century plank and batten doors. A fireplace is present to the chimney breast within the front bedroom; however, this is concealed.

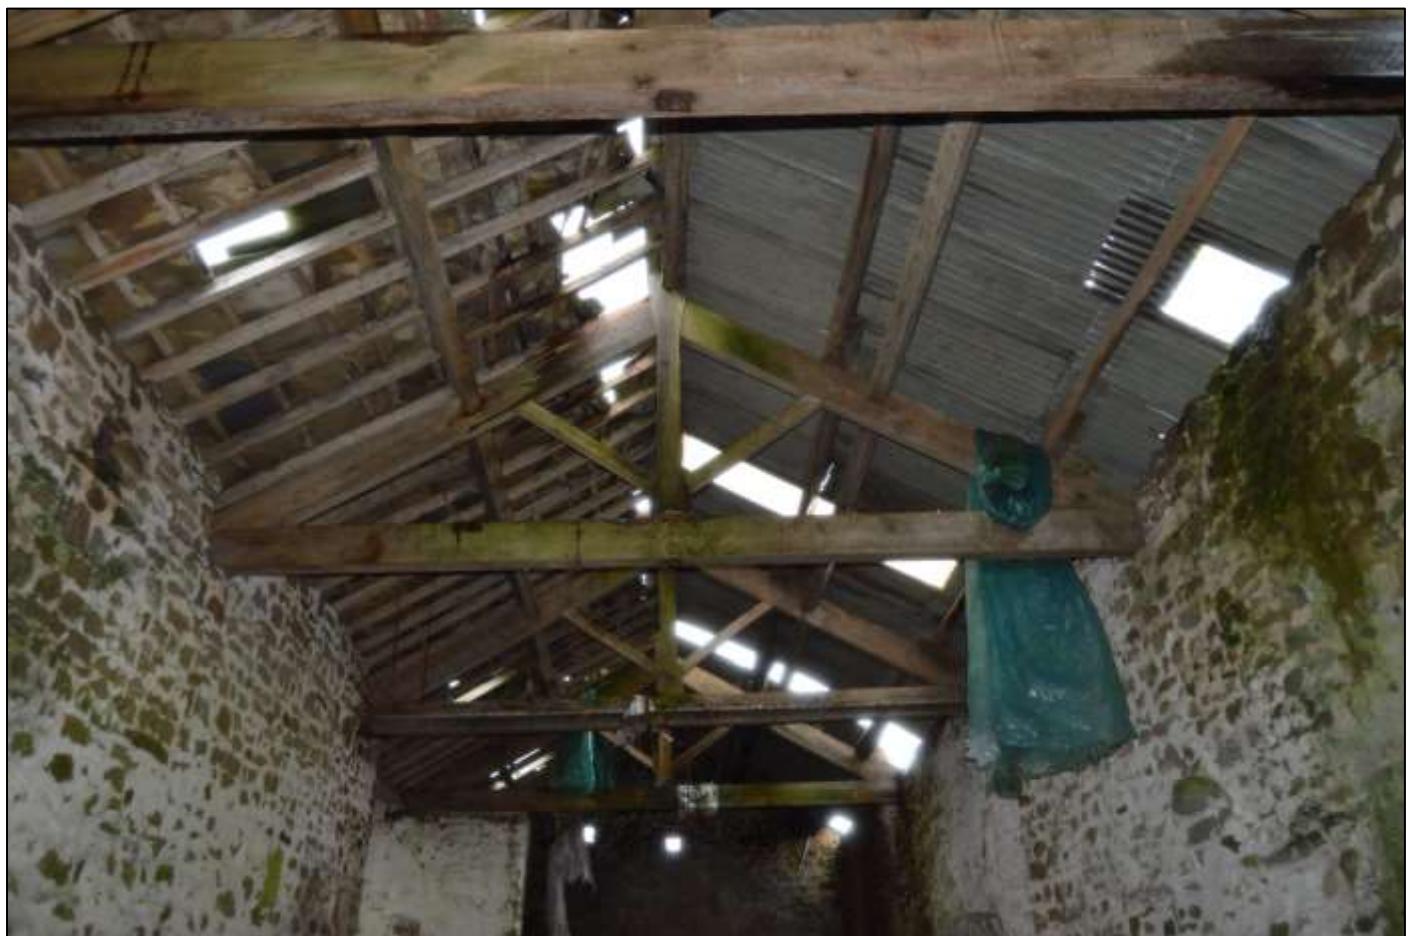
PL60: View of the roof structure over the main core of the barn.

The original five bay combination barn, now forms one single space. The presence of a forking hole present to the west gable end would suggest that a hayloft would be present to the west end of the barn, however none is present and there is no physical evidence, i.e., joist sockets, to suggest one was ever here which might mean that the sockets could have been blocked in, likely in the 20th century. A blocked window and door are present to the west side of the north wall of the barn (seen internally), with two opposing blocked up windows noted to the south wall opposite. A brick recess lies adjacent to the blocked windows in the south wall and appears to be an inserted door opening, with brick jambs which was also subsequently blocked-up. The roof structure is comprised of 4no kingpost roof trusses of sawn timber and of 19th century date and bear carpenters' assembly marks. The roof structure to the rear south roof slope is somewhat piecemeal, comprising of varying rows of sawn timber purlins onto which the profiled sheet roofing is fixed to. The north slope has a central row of sawn timber purlins, with common timber rafters and battens over, with a sandstone slate roof covering.

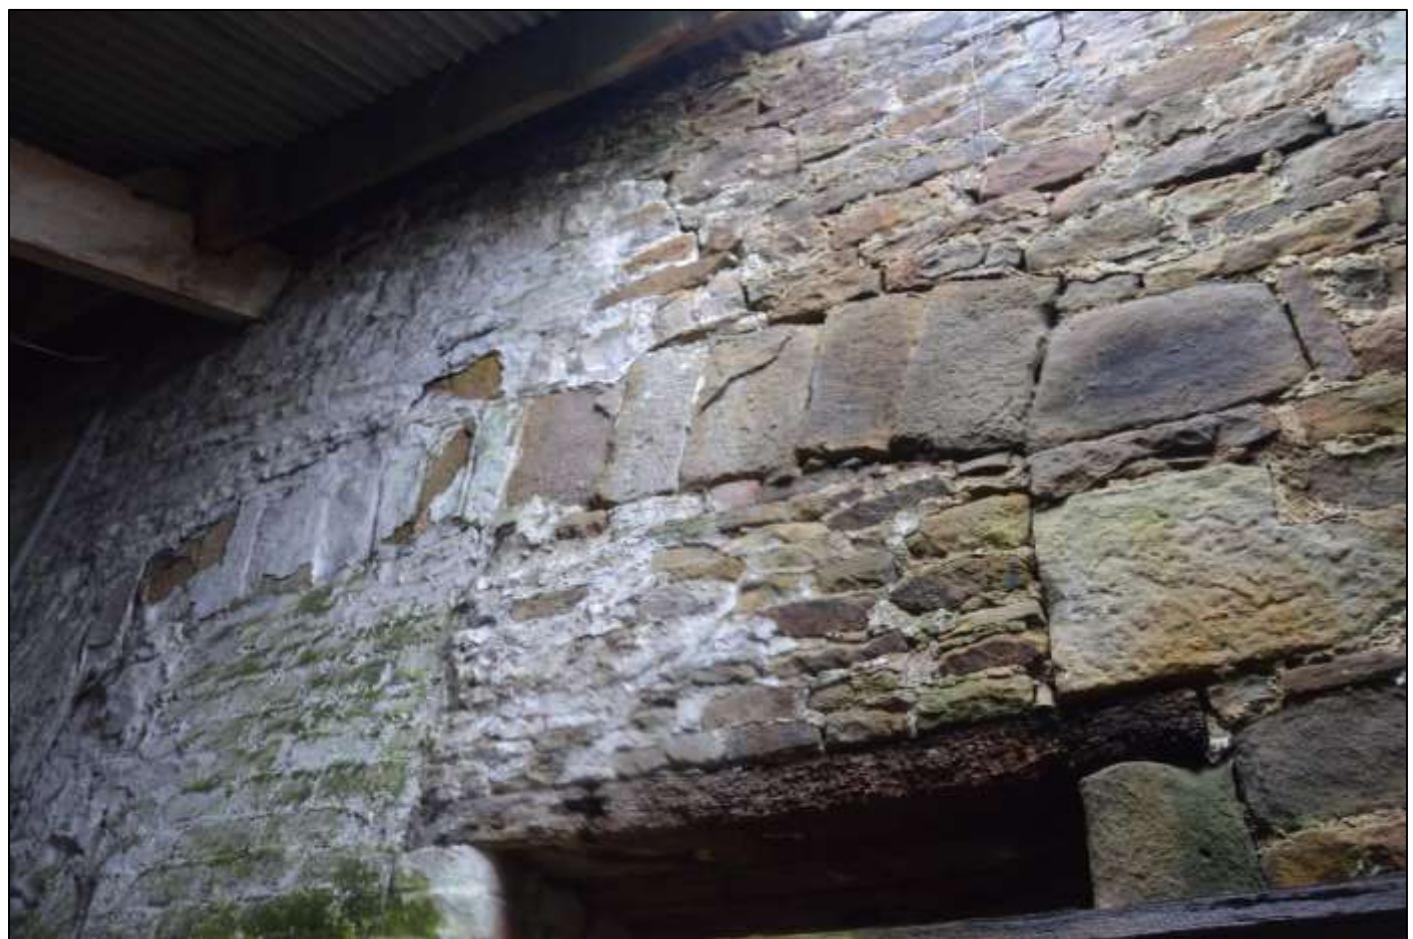
PL62: View of stone voussoirs to the blocked-up opening viewed from within the south shippion.
