**Bat Survey Report (preliminary day-time survey):
Oxenhurst Farm,
Off Back Lane,
Newton-in-Bowland,
BB7 3EE**

OS grid reference:
SD 67454 51879

Survey Date: day-time - 25/8/22, dusk - 1/9/22

Report Date: 9/9/22

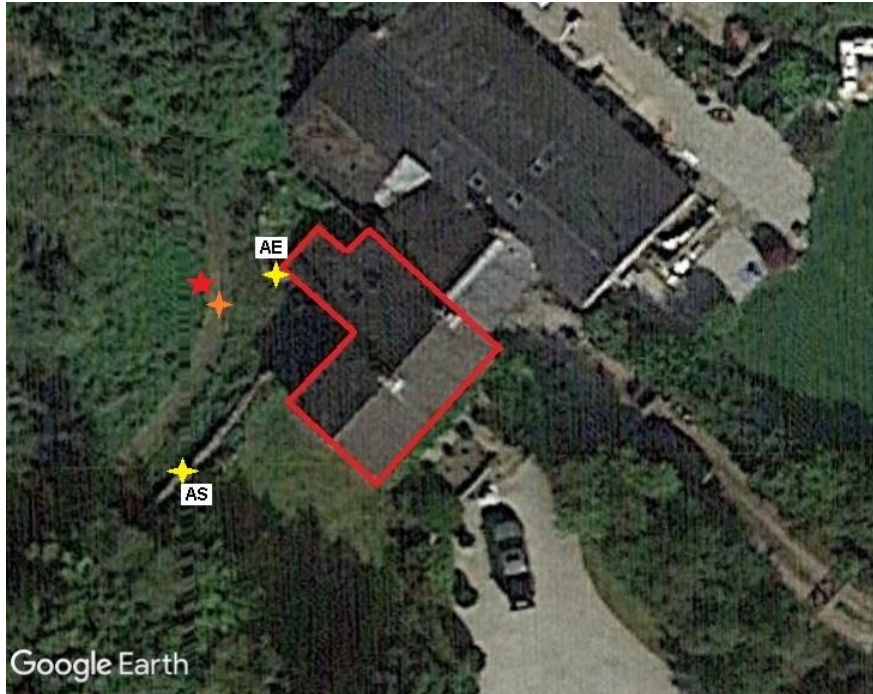
Fig. 1.

I took up a fixed position to watch for bats leaving the building. See Fig 1 below. I had the use of a heterodyne "bat detector" (Batbox Duet) to help alert me to the presence of bats and to help me distinguish the species present. I also set-up a camcorder converted to work in infra-red light, plus 2 sources of infra-red light. The camcorder screen was within my range of vision to help alert me to bat activity as darkness fell.

In addition I placed Anabat Swift and Anabat Express detectors either end of the elevation being watched. See Fig 1 below. These record bat calls for analysis on computer later. They are extra tools for helping to confirm the species present.

Key: Building outlined in red. Approximate location of surveyor shown by red star, approximate locations of recording devices shown by yellow crosses. Approximate location of camcorder shown in orange. AS = Anabat Swift, AE = Anabat Express.

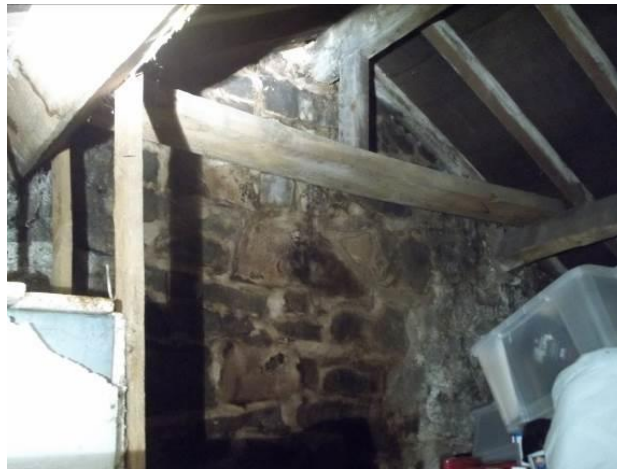
Plate 1. North-east gable end

The property has a single loft.

The concrete tile roof still has the original beams and is lined with bitumastic felt.

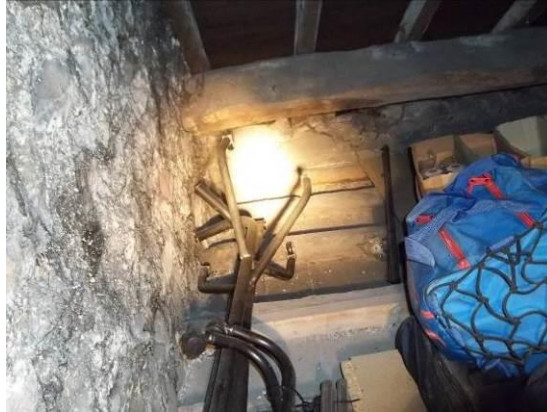
Plate 2

There is boarding below joists and insulation is absent:

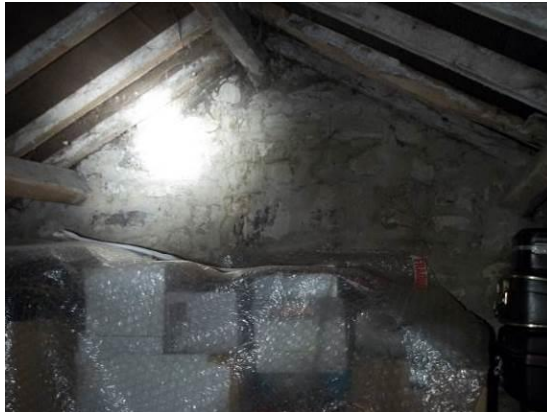
Plate 3. South-west and north-east gable ends

There was limited access to view the loft, including the exposed (south-west-facing) gable end, due to the presence of stored items:

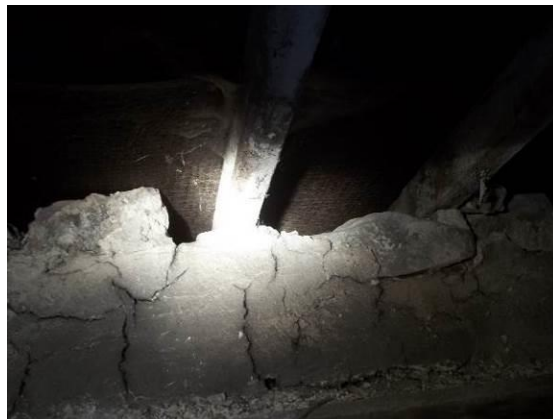
Plate 4

Bat access to the loft appeared to be limited, though the extent to which bats could enter at the eaves was uncertain:

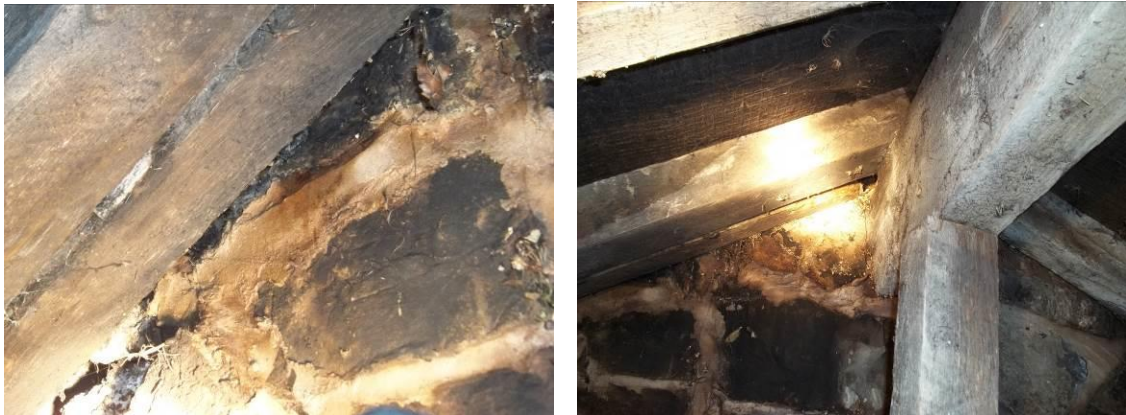
Plates 5 and 6.

There were plenty of cobwebs present but there were also the sorts of crevices between structures where bats could roost:

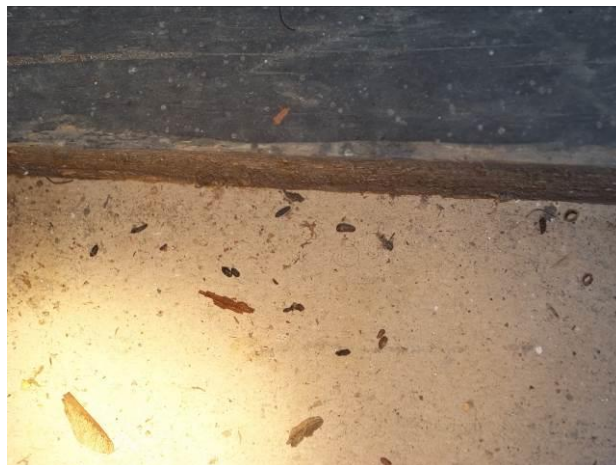
Plate 7

A few mouse droppings were discovered:

A crush-test was performed to double-check that these were rodent not bat droppings.

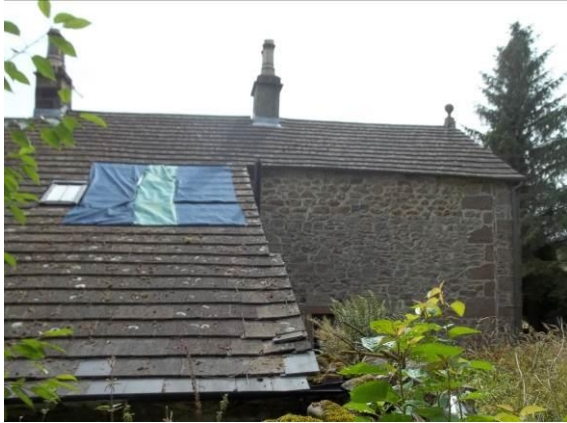
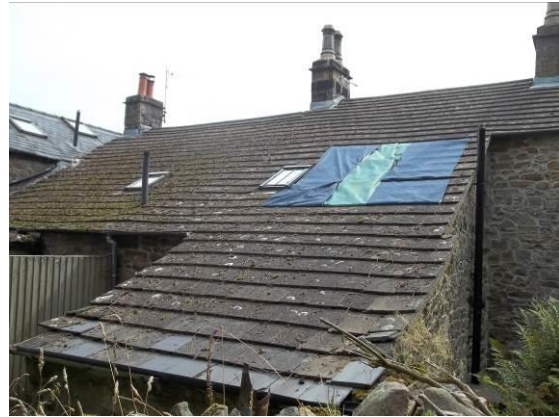
Plate 8 and 9. Rear roof

Externally, an area of damage to the rear roof has been weather-proofed. Apart from at the bottom corners of the lean-to element of the roof where tiles are damaged, the opportunities for bats to enter between roof-tiles are minimal:

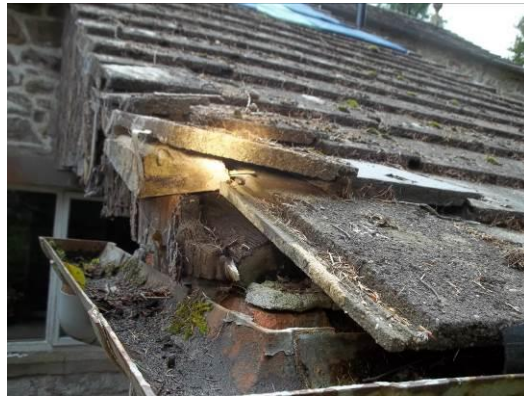
Plate 10. Northern, bottom corner of rear roof

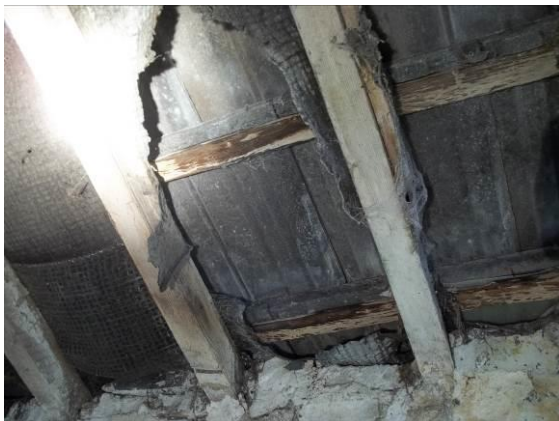
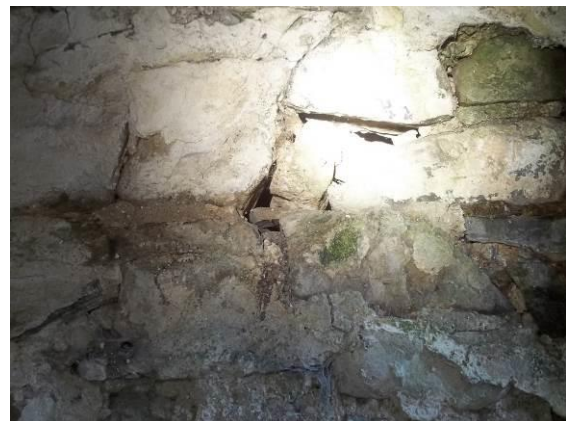
Plates 11 and 12

The back door is accessed via a covered area beneath the lean-to roof. There is bat access available between underfelt and boarding, at wall-heads and into cavities in the walls:

On the whole, the roof of this building is in good condition; or has been well sealed-by temporary weather-proofing. There is access available however between layers of the structure of the roof of the lean-to element; from beneath and where roof-tiles are damaged. There is open access for bats to enter this area in flight. There are also gaps into walls in this area. I consider there to be a risk of a bat or bats hibernating in this area.

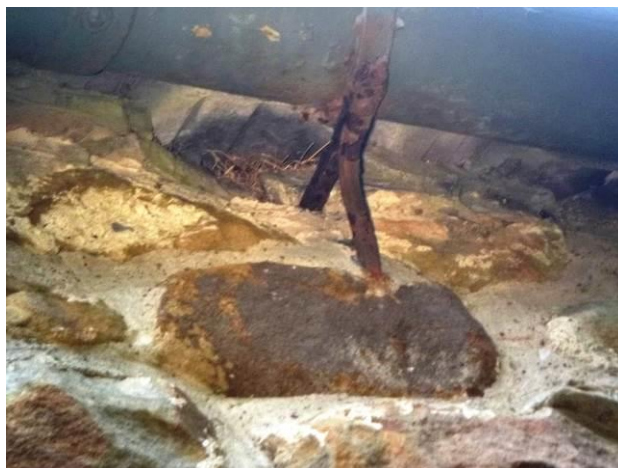
Plate 13

There is however access for bats to the wall head via the rear fascia. This was hard to photograph, but can be appreciated in the photograph below, which shows a birds' nest on the wall-head:

No sign of bat droppings was seen on the house-wall, but individual droppings could have been missed.

Where possible, Natural England expect the roost to be recreated in-situ. An appropriate gap will be needed to allow bats access to the wall-head. Access to the cavity wall should be maintained if currently present, and access between underfelt and tiles should be recreated if it was found to exist, at the time of deconstruction. Care is needed with roof lining material however. Most non-woven roofing underlay (breathable membrane) can be lethal to bats, as they can get their claws entangled in the fibres and can't then release them again. The only lining materials appropriate in association with a bat roost are traditional Type 1F BS 8747:2007 (bitumastic felt) or a non-bitumen coated roofing membrane (NBCRM) with a test certificate approved by Natural England. See Appendix 5 for more information.

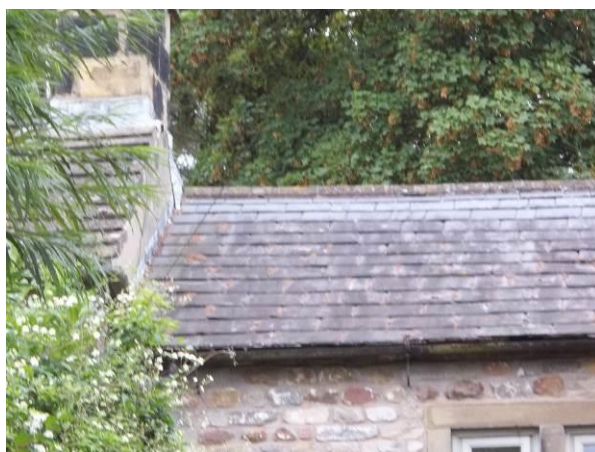
Plate 14

At the front of the property the neighbouring roof is at a lower level, but is also in good condition:

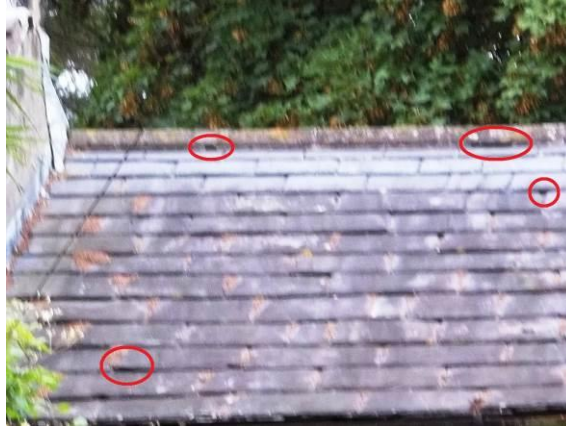
There are a few small gaps present however:

Plate 15. Examples of potential bat access gaps illustrated in red

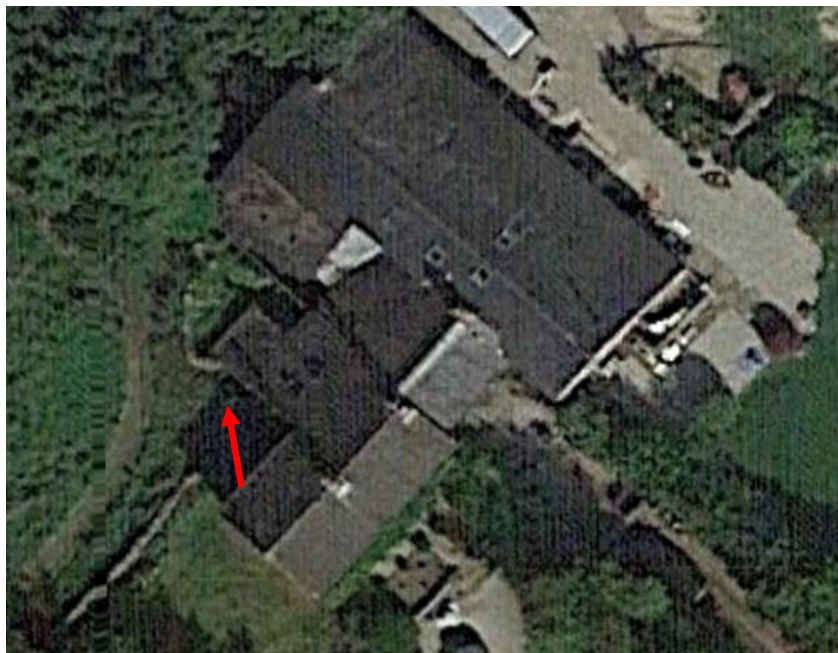
Fig. 1.

Key: Approximate flight-line of emergent bat indicated by red arrow.

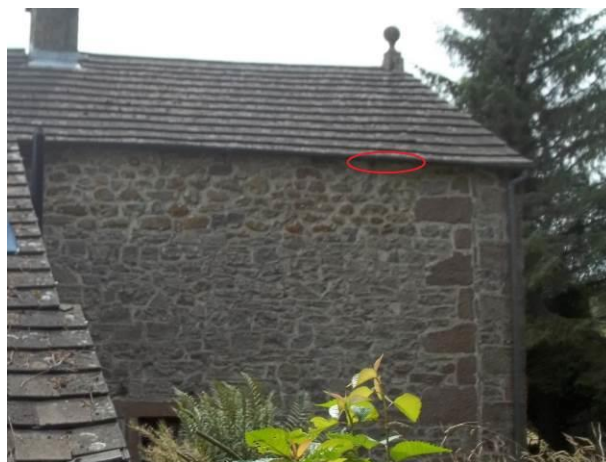
The dusk emergence survey confirmed roosting by a single common pipistrelle bat. It emerged from the rear eaves. It was likely to have been roosting within the stone wall or at the wall-head, but if access is available between roof tiles and underfelt bats will also roost in that situation.

Plate 16. Approximate bat emergence-point illustrated in red

The bat consultant must provide a tool-box-talk to the contractors as a condition of the licence, be present as the roof is removed from the vicinity of the rear eaves; and must confirm bat access has been recreated as intended. Natural England approve the provision of 'enhancements', which in this case can easily be made via bat boxes in nearby trees.
