**Bat Survey Report and Method Statement  
European Protected Species (Bats)**

**Pewter House Farm,  
Carr Lane,  
Balderstone,  
BB2 7LN**

**10.11.2023**

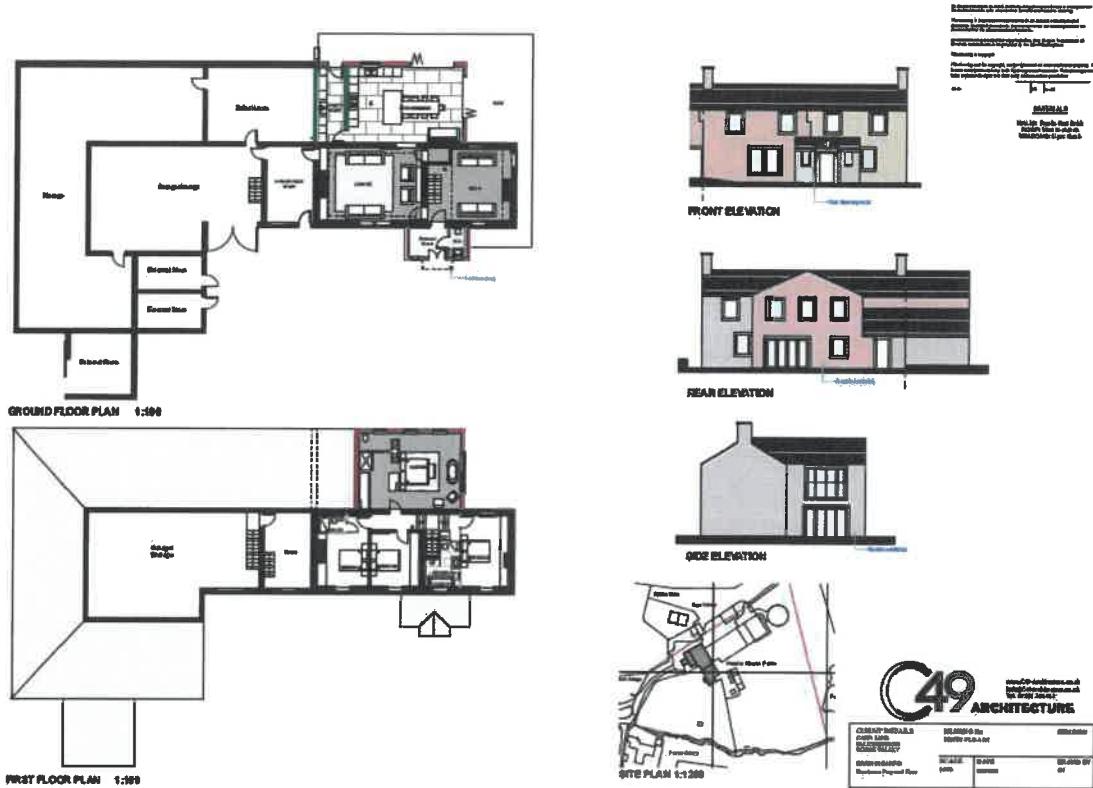
## Proposed Works

Proposed works consist of the refurbishment of the existing farmhouse with a two storey extension to the rear. It is understood that this will involve re-roofing works.

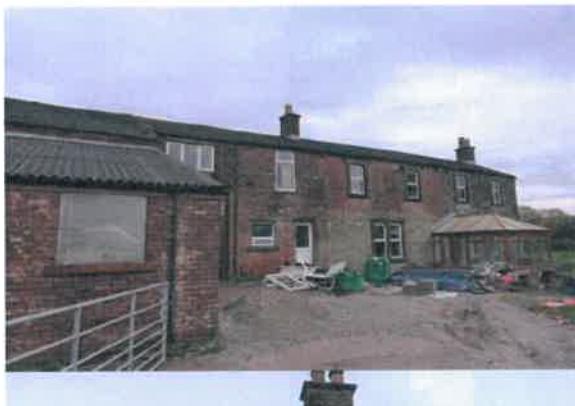
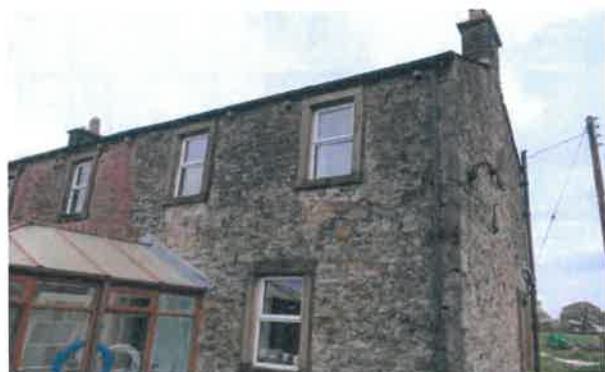
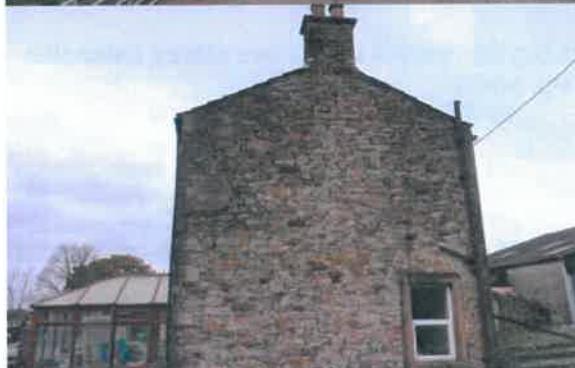
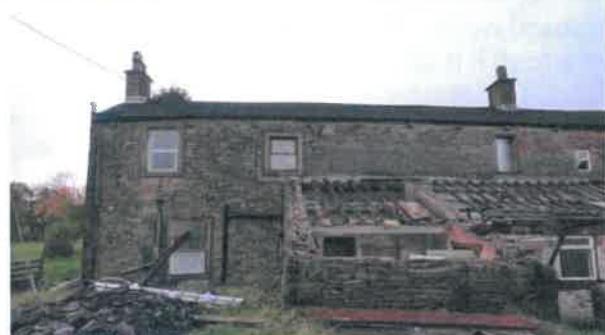
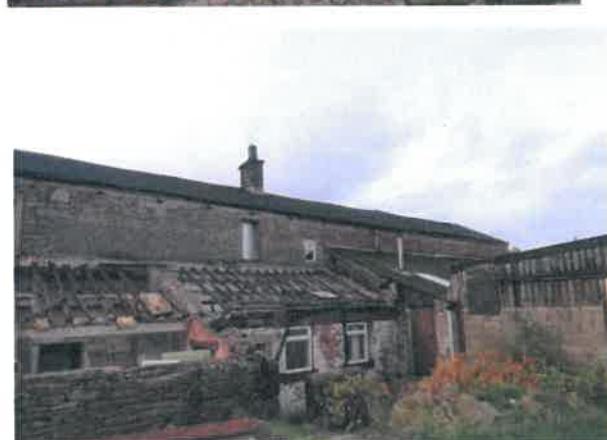
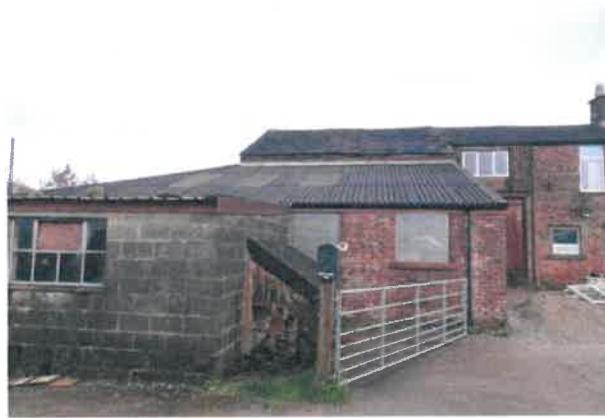
The property consists of a two storey brick and stone built farm house barn with a double pitched tiled roof, a two storey adjoining barn with stone slate and corrugated fibreboard roofs is present on the northern gable end. The farm house has a single storey extension to the rear which has had its roof removed.

External walls are generally well pointed however gaps and crevices suitable for roosting bats were noted. The southern gable end is pointed with areas of lifted lead flashing.

Roof tiles are close fitting with no obvious missing, lifted or slipped slates present. Ridge tiles are pointed and well sealed. Gaps are present behind timber fascia boarding at wall top level.

The building was assessed as offering moderate bat roost potential when surrounding habitat was taken into consideration.

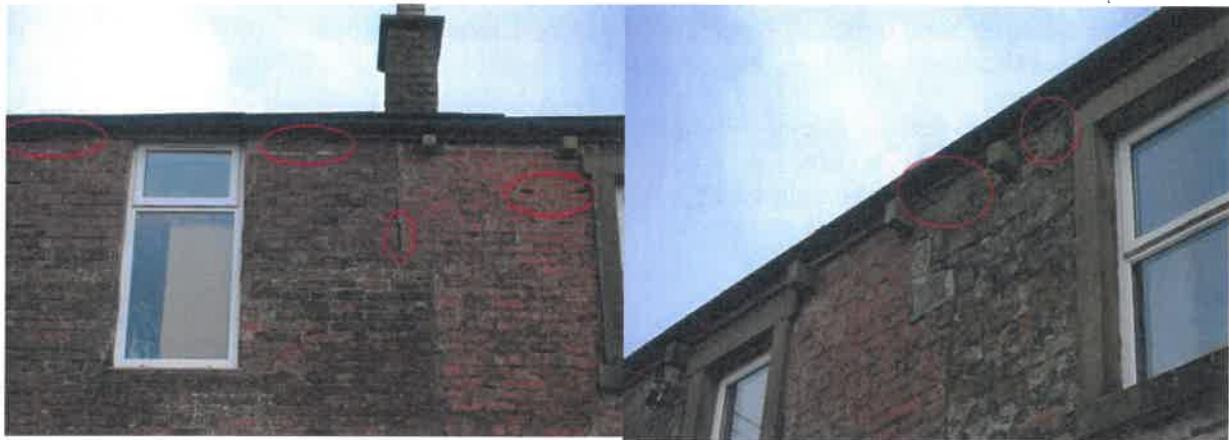
Gaps were noted at wall top level behind timber fascia boarding on the frontage of the farm house, two areas of lifted lead flashing were noted on the southern gable end. Lifted and slipped slates were present on the barn.

*Gaps in pointing and behind fascia board at wall top.*

Roof slates should be removed by hand and under supervision where necessary.

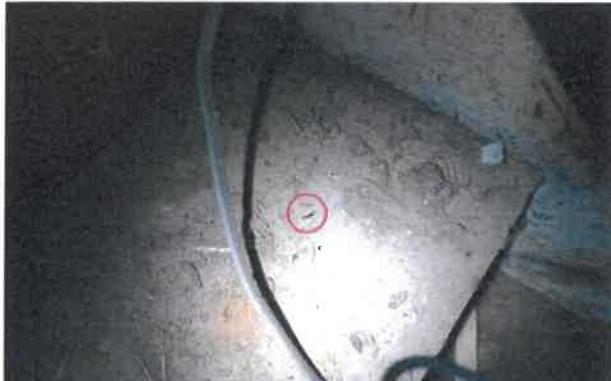
An inspection of the barn found a low number of scattered bat droppings close to the northern gable end of the farmhouse. Droppings were consistent with a low level of bat flight activity within the barn.

*Bat dropping below gable end within barn*

**No work should be carried out to roof spaces or the adjoining barn prior to further emergence surveys.**

**Surveys should be carried out by suitably licence and experienced batworkers, between May and August inclusive.**

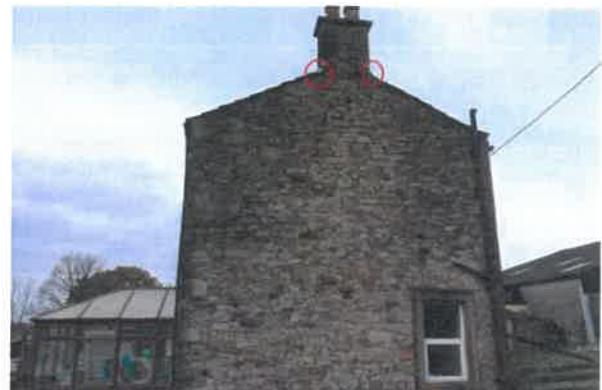
*Gaps behind flashing on southern gable*
