High Laithe
Brock Thorn, Tosside, Lancashire:
Archaeological Building Recording

Archaeological Building Recording

Archaeological building recording was carried out for Mr John Hartley in September 2006 at a barn known as High Laithe, near Tosside, Lancashire (NGR: SD 75865519), before its conversion to holiday cottages. The barn is a large stone-built structure of six bays with a good oak-framed shippon at one end, and probably dates to the early or mid eighteenth century, but carries a secondary date-stone of 1795. The records made include floor plans, a section and photographs, as well as a written account.

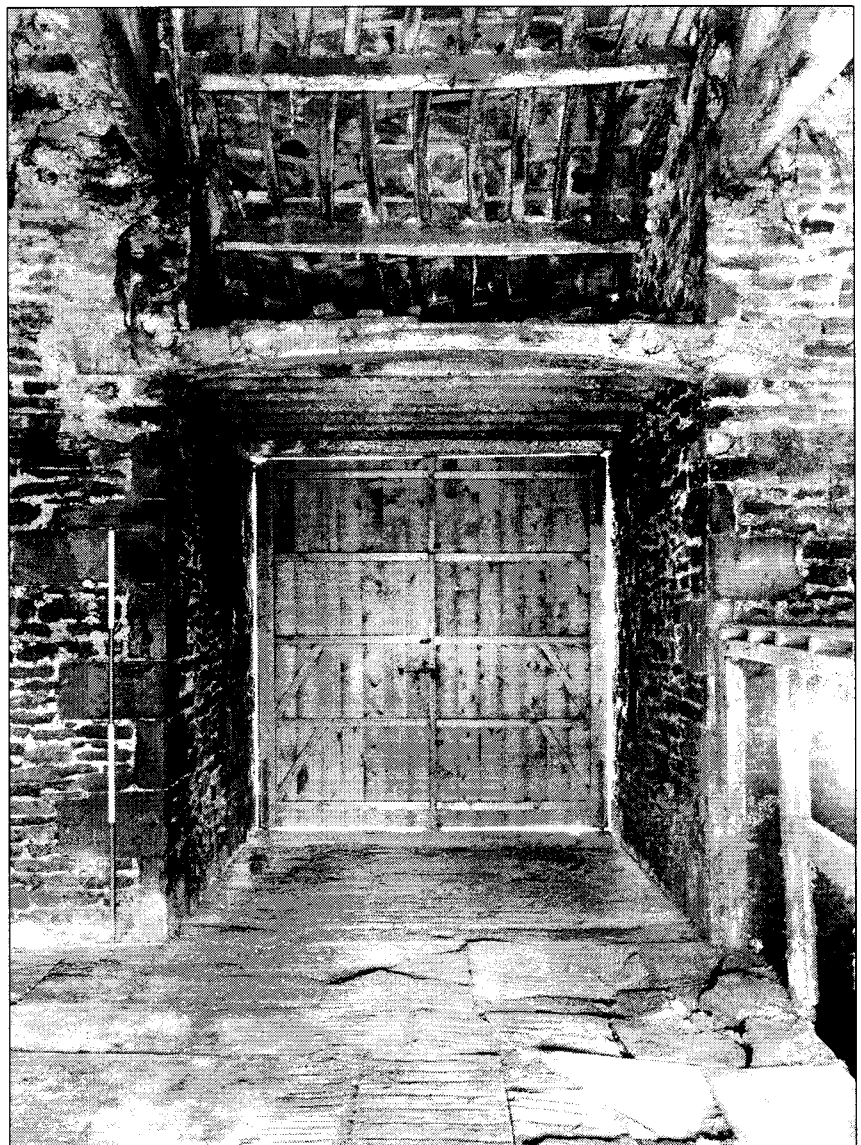
Photo 20: Interior of barn: east porch and threshing floor, from the west

- 6.6 The east porch forms the main entrance into the building and has two "lamp hole" recesses in the side walls, and a floored loft over (the joists and boards replaced), and now leads directly into the threshing bay, although previously there were doors situated between the two areas (20,21), as indicated by the sockets for harr-hung doors in the curved oak lintel. The west porch retains its doors however, perhaps the original ones, and there is graffiti on one, giving the initials H+R and the digits 18, perhaps part of a date (22-24) (see below). The loft over the porch here has a slate floor, the stone probably Horton flags rather than local sandstone. Between the two porches, the flagged threshing floor survives in good condition (25), with parallel grooves cut to give purchase to horses' hooves; it contrasts with the floor to the north, which is more roughly flagged.

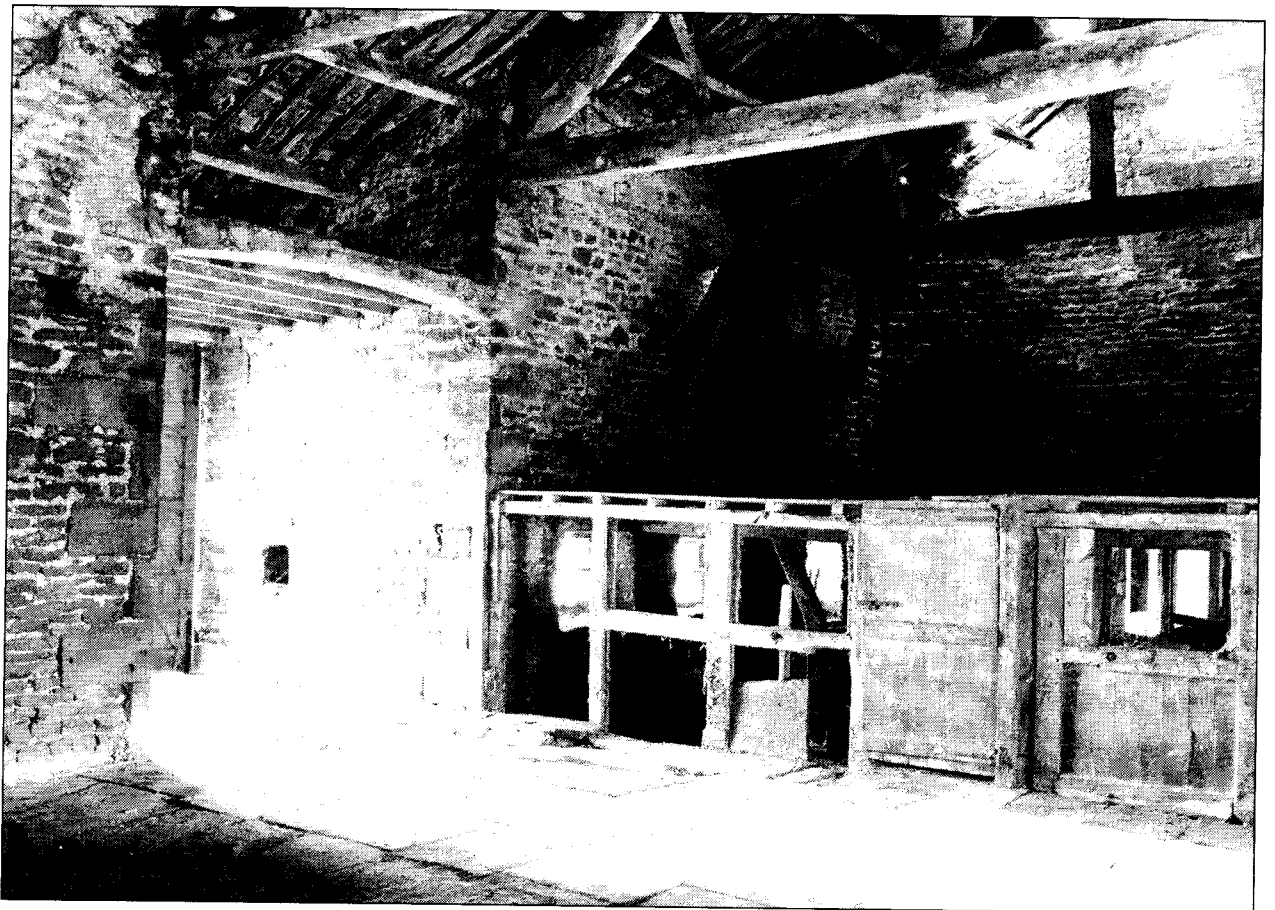
Photo 27: Interior of barn, from the north-west

- 6.7 To the south of the threshing bay the main shippon and hay loft occupy the ground floor (26,27). The shippon is formed by a framework of pegged oak timbers, principally four beams which span the building and carry joists for the loft, as well as accommodating the upright posts for the boskins which divide the stalls and the feeding passage. The partition forming the north end of the shippon has eight uprights and contains three doorways, the sections between with mid-rails. Below these rails the panels appear originally to have been slated (again with Horton flags), but above them they were left open (28,29). There is graffiti on some of this joinery, which includes the initials "RT" on a number of joist ends (30), "RB" (31), and "R+H 1841", which is perhaps by the same hand as the markings on the west porch door (32), and a door removed from the east end of the shippon has several other initials and dates including "SH", "AW 1846", and "1850" (33,34).

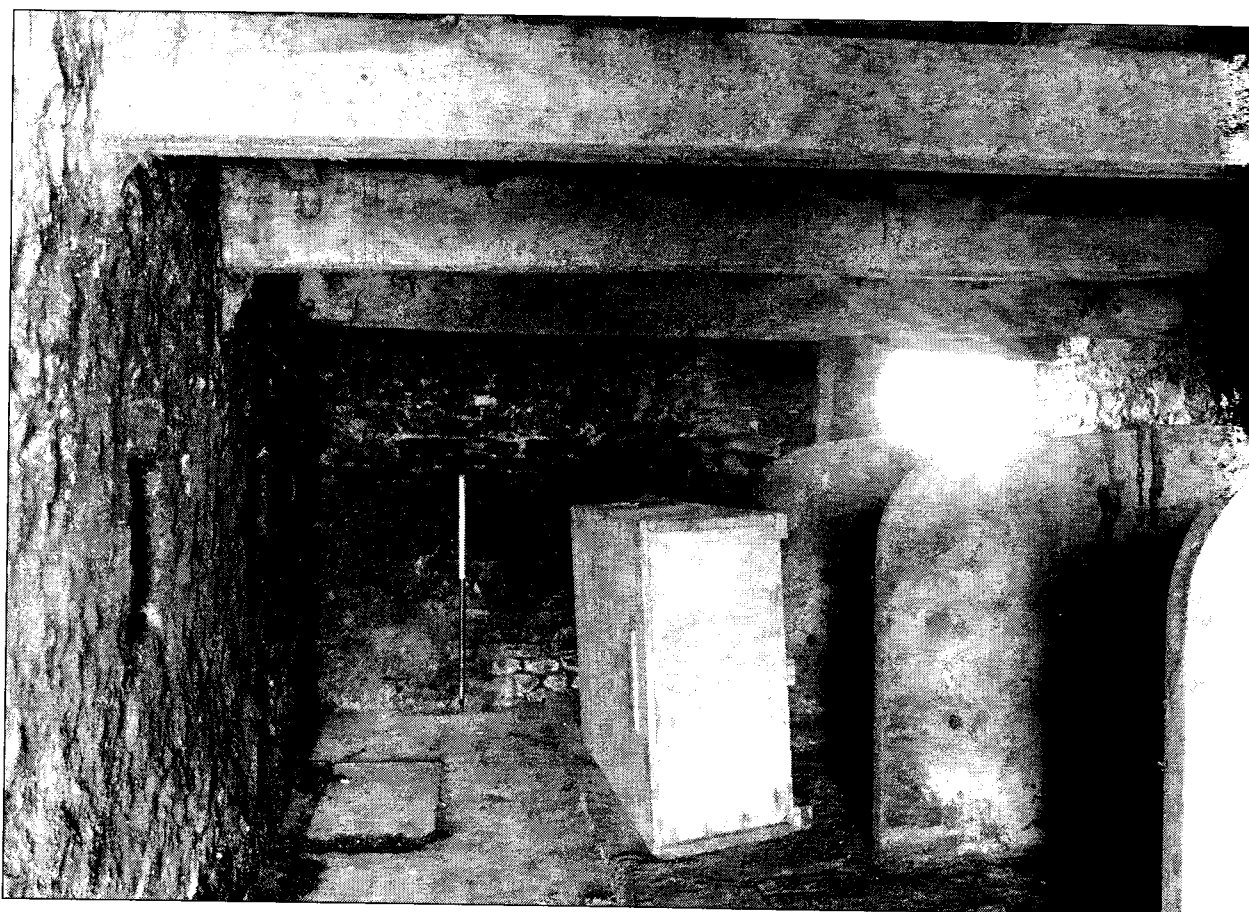
Photo 50: Interior of north shippon, from the east

- 6.10 The area to the north of the threshing bay appears to have been a storage area for perhaps crops or tools, and is open to the roof (47,48), but is bounded by a cross-wall separating a second shippon at the north end of the building (49), which also supports a hay loft. The cross-wall appears to be bonded into the east wall of the barn and the positions of the former breathers in both west and east sides suggest that it is original to the building. This shippon has concrete boskins for ten young beasts, and a concrete floor and breeze block wall defining the feeding passage by the north gable (50). However, two of the overhead beams bear mortices which may indicate the former positions of timber boskins. There are three small lamp holes in the cross-wall.

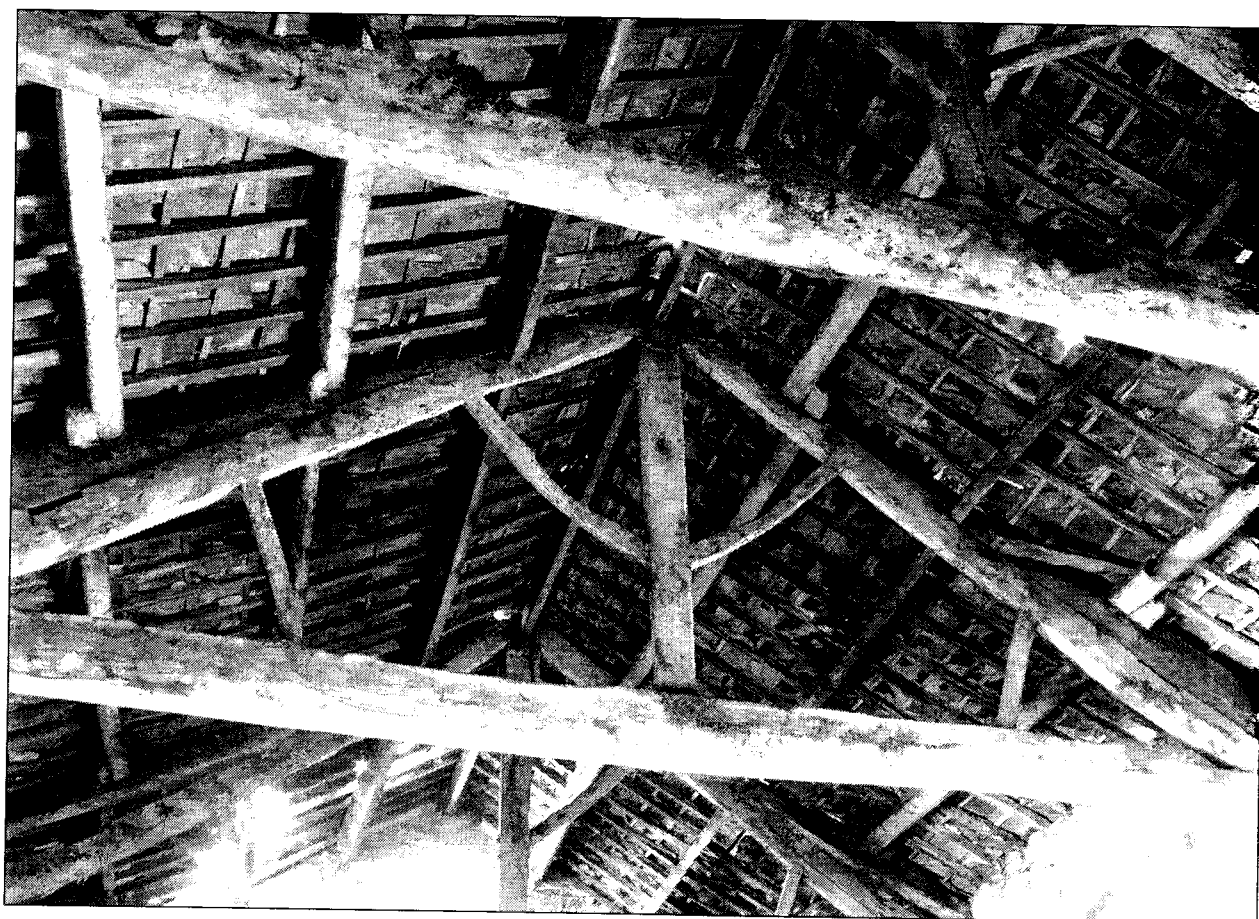
Photo 54: Roof truss in south end of barn, from the north-east

- 6.11 The barn roof is built from hardwood, probably oak, and has five trusses, all originally of the same design, with a plain king-post with angled struts, and outer struts between the tie-beam and principal rafters. There do not appear to be any bolts used in the trusses, but neither are any pegs clearly visible, although they may simply be hidden by dirt and cobwebs. There are trenchings for three purlins to each side, but because the eaves have been raised and the pitch of the roof made more shallow, later blocks or wedges have been added to the backs of the principals and with the exception of the top row, the purlins have

been re-set on these, and some of them replaced with softwood members. The form of the roof is suggestive of an early or mid eighteenth century date.
