## Preliminary Bat Roost Assessment

Site: "Bridleway", Whins lane  
Simonstone, Lancashire. BB12 7QT

28<sup>th</sup> September 2022

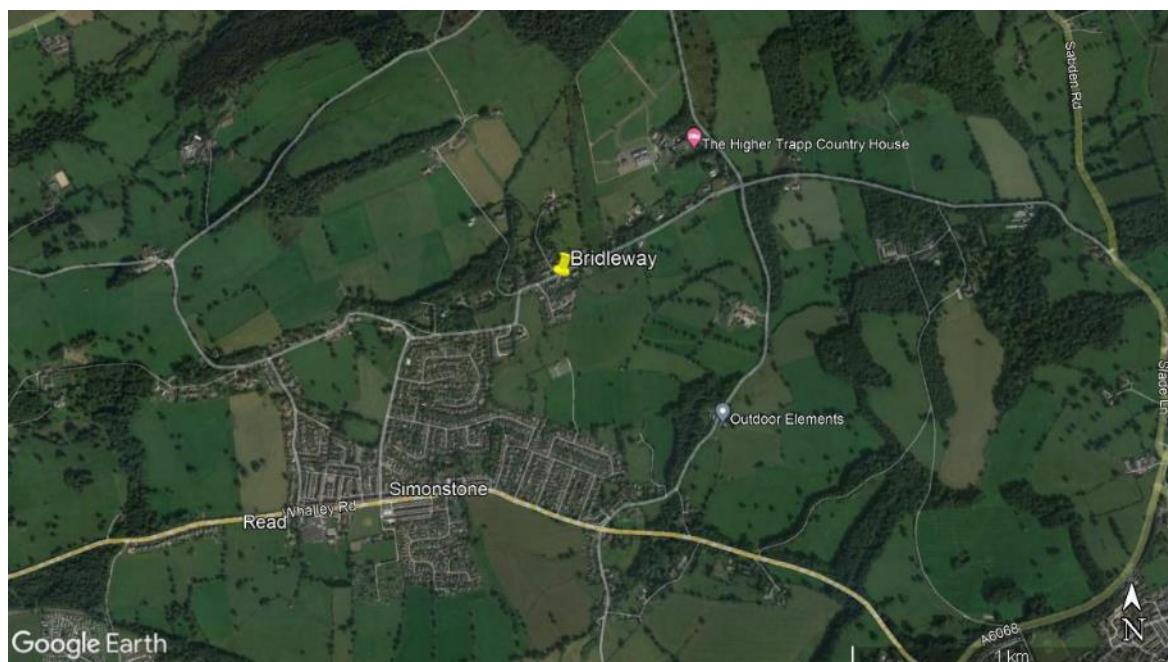
The site is located in the village of Simonstone, East Lancashire. Set in a residential area, with a surrounding rural landscape of pasture and meadows and areas of deciduous woodland, with hedges and ditches. This is ideal habitat for foraging and commuting bats.

Figure 1: Aerial photo of site, showing surrounding landscape structure

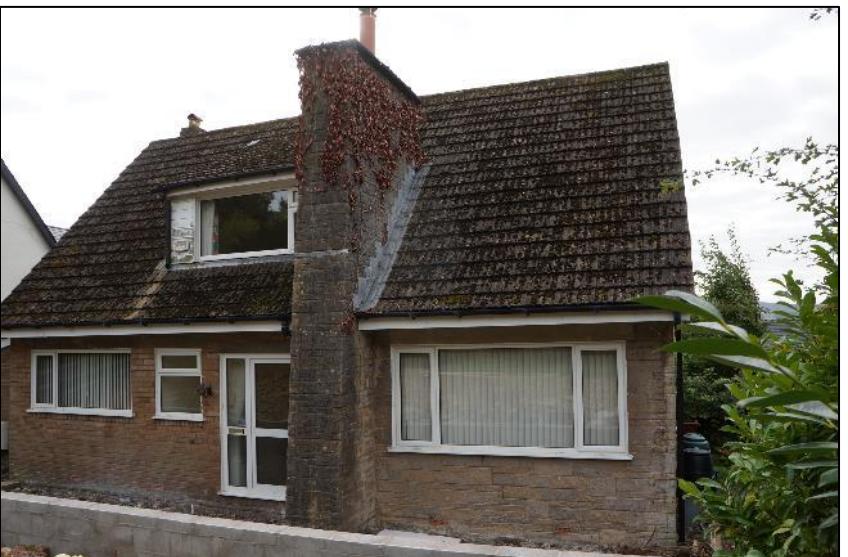
| <p><b>Building Description</b></p> <p>The building is a detached bungalow with dormer bedroom in the roof space.</p> | |

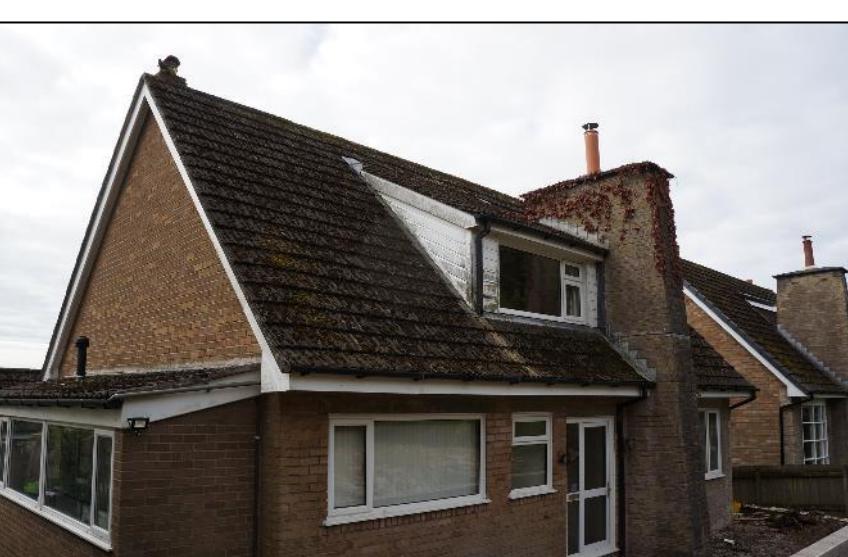
| <p>The brick walls are in a good state of repair with no gaps in the mortar.</p> <p>The windows and doors are uPVC and all close fitting with no gaps to the interior.</p> <p>The external chimney is of brick construction, also in a good state of repair with no missing mortar or gaps in the materials.</p> | |

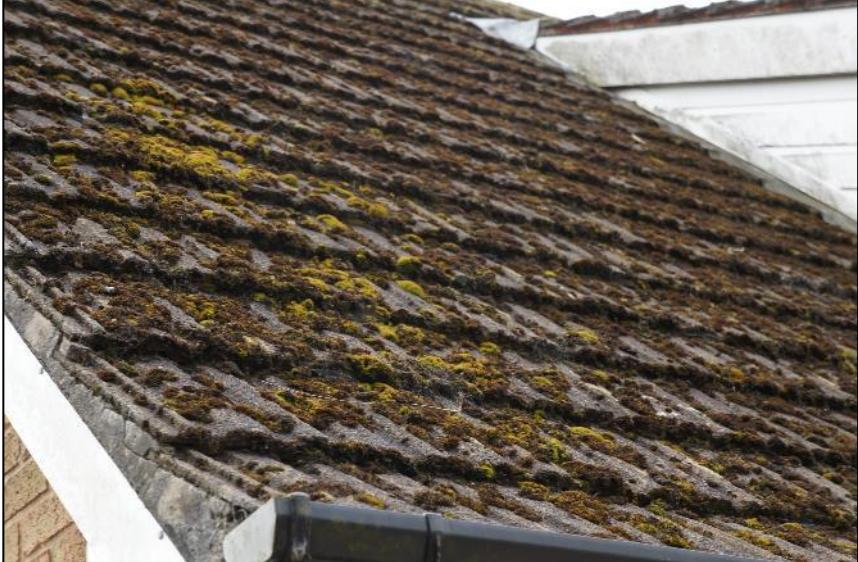
| <p>The dual-pitched roof ridge on runs west to east, and is clad in cement Marley roof tiles.</p> <p>There are no gaps or missing tiles, and the majority of the roof is covered in moss.</p> <p>The lead around the chimney and the dormer is well fitted, with no gaps beneath which would allow bats to roost.</p> <p>There are no gaps in the mortar at the eaves, or ridge tiles.</p> | <p>Photo 3: Moss covered roof on the north elevation. Showing mortar to the eaves in good condition.</p> |

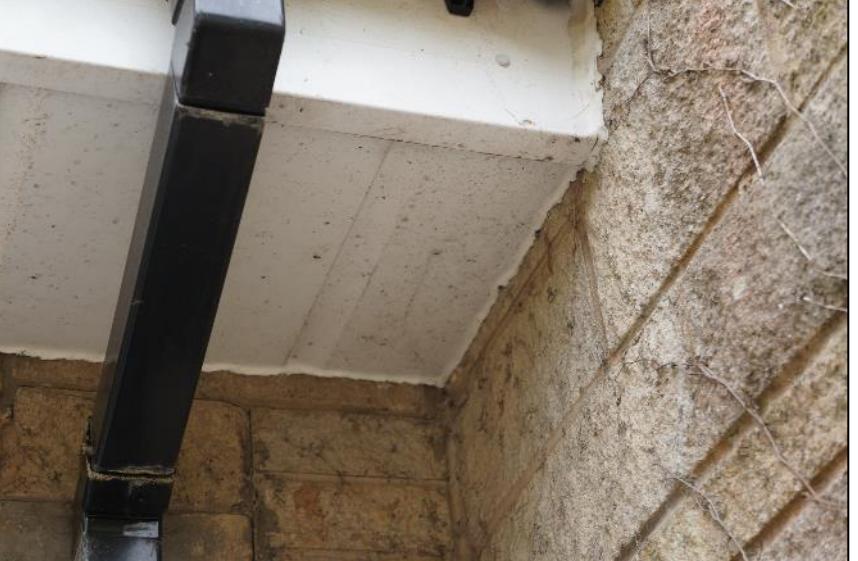
| <p>The soffits and other roofline materials are all uPVC, and in a good state of repair, well-sealed to the brickwork with no gaps.</p> | <p>Photo 4: Well-sealed uPVC soffit boxes.</p> |

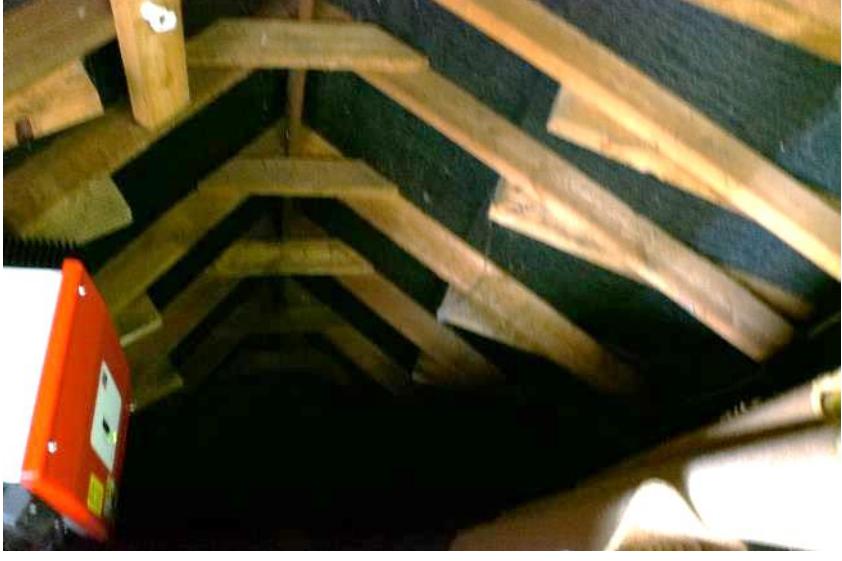
| <p><i>Interior.</i></p> <p>There is a loft space running the full length of the building. The timber and roof lining are all in a good condition, with no daylight showing through, which would be evidence of gaps in the materials.</p> | <p>Photo 5: Example of roofing materials from the interior of the loft space.</p> |

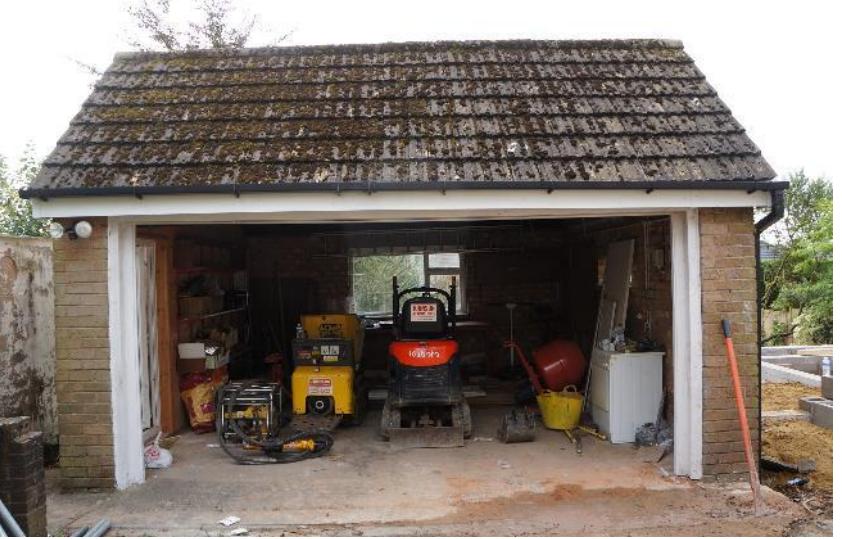
| <p><b>Detached garage</b></p> <p>To the rear (south) of the property is a brick built detached garage. The construction materials are as those used in the bungalow, and area also in a good state of repair.</p> | <p>Photo 6: Detached garage to the south of the bungalow.</p> |

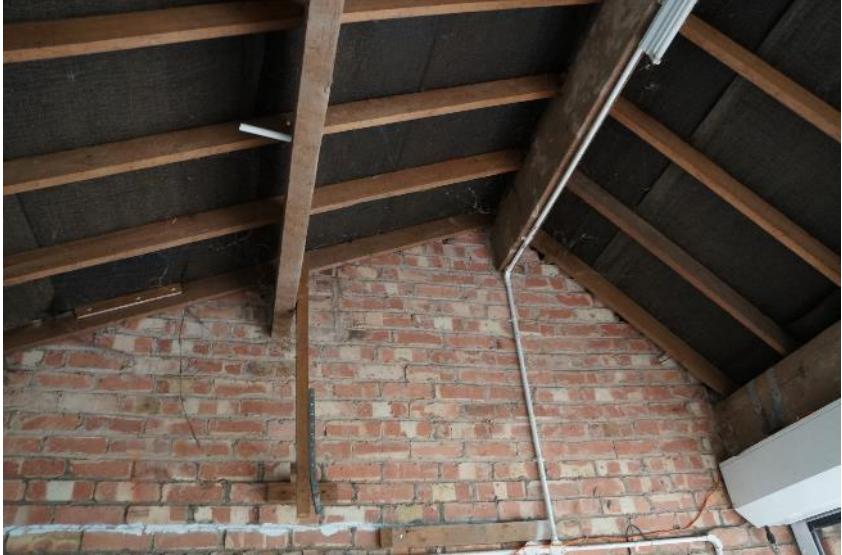
Photo 6: Detached garage to the south of the bungalow, interior.

| Internally the garage is open to the roof materials. | A photograph showing the interior of a garage. The walls are made of red brick, and the ceiling is supported by a network of wooden roof trusses. A metal pipe runs along the wall. The floor is not visible. |
