**BAT SURVEY AT -
84 WHALLEY ROAD
CLITHEROE**

DATE AND TIME OF VISIT
8th June 2021 9.30am

REFERENCE NO. 6410

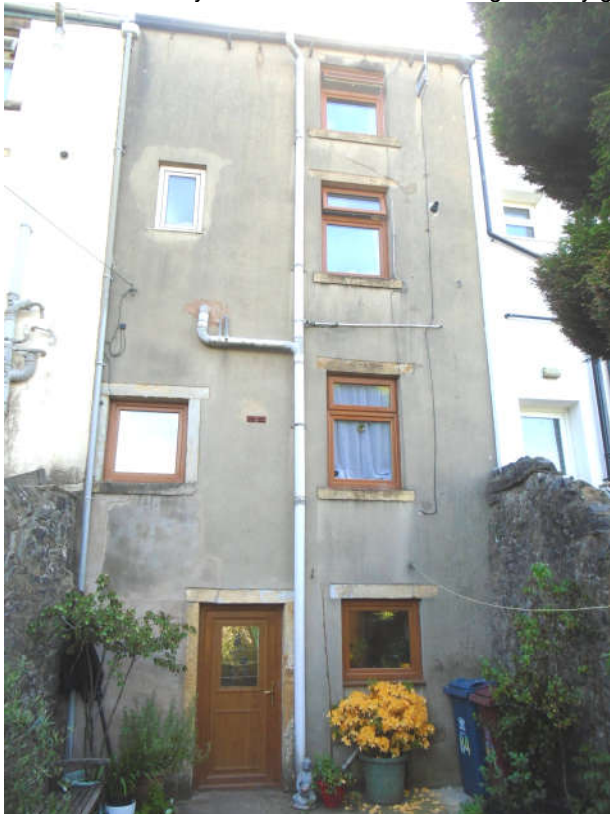
Rear elevation

A terraced 4 storey house with a detached single storey garage at the end of the garden.

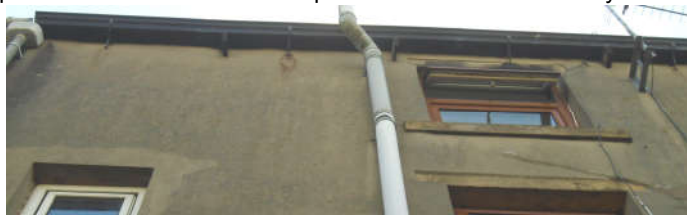
House

The house walls are stone with a smooth render finish and stone sills and heads. The garage walls are prefabricated concrete with a pebble dash finish externally.

The render on the walls of the house is in excellent condition with no possible access points.

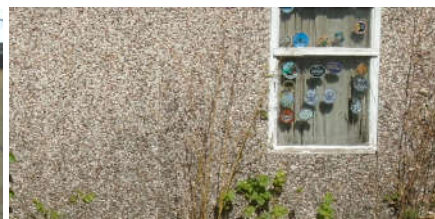
Garage walls

The garage walls are in perfect condition with no possible access points.

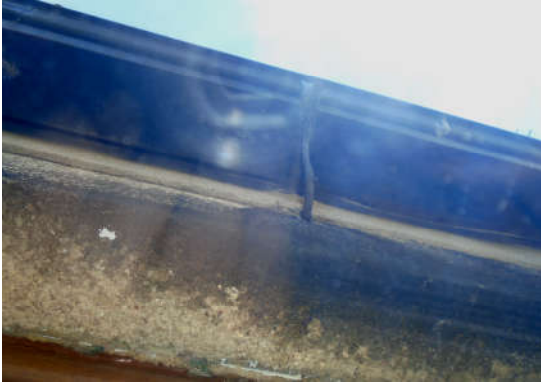
The main roof was examined from the ground with the aid of binoculars and the eaves from the second floor windows. The slates were in excellent condition and very tight fitting, the ridge tiles were well pointed. The eaves were closely inspected from the second floor windows, the slates were very tight fitting at the abutment with the wall, and the gutters were fixed close to the wall. No access points in the roof were found.

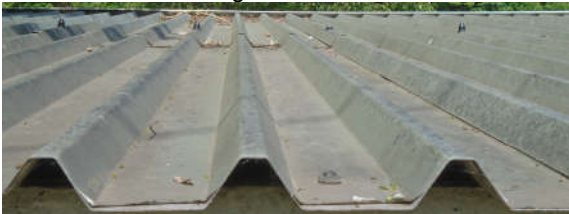
The Garage roof sheets were very tight fitting and in good condition, access points were formed in the rear elevation in the corrugations.

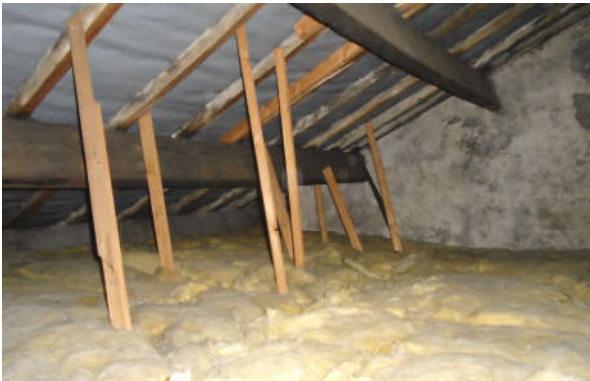
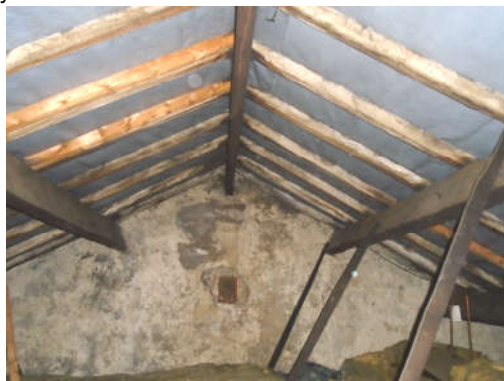
The house roof void was accessible, the timber purlins and rafters were in reasonable condition with no areas of rot or cracks/crevices. The underlay is very new indicating the house has been re-roofed relatively recently. The insulation quilt is very clean with no dropping or insect remains. The space did not provide any potential roost habitat and no evidence of current or historic use by bats could be found.

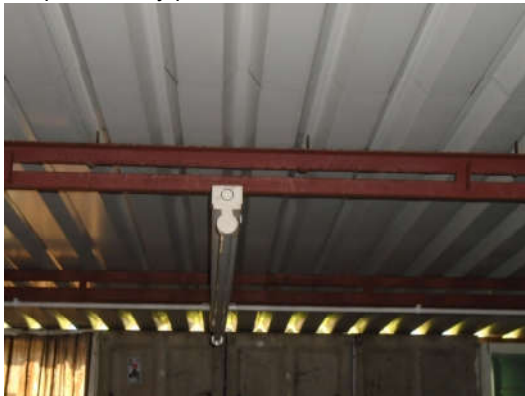
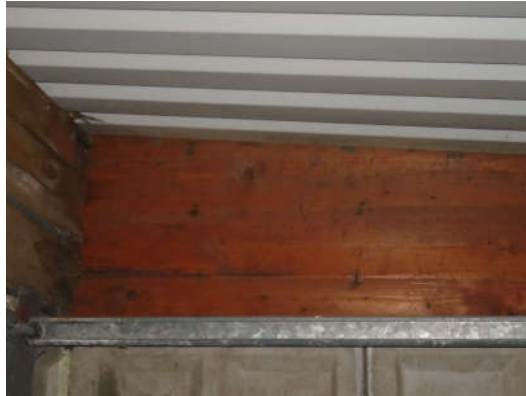
The garage roof did not have an enclosed void, the sheets were fixed directly to steel purlins. The structure did not provide any potential roost habitat.
