# Crow Trees Barn, Crow Trees Brow Chatburn, Clitheroe Lancashire

**HERITAGE STATEMENT**  
**Report EH218/01**

## Heritage Statement for Mr Peter Baker

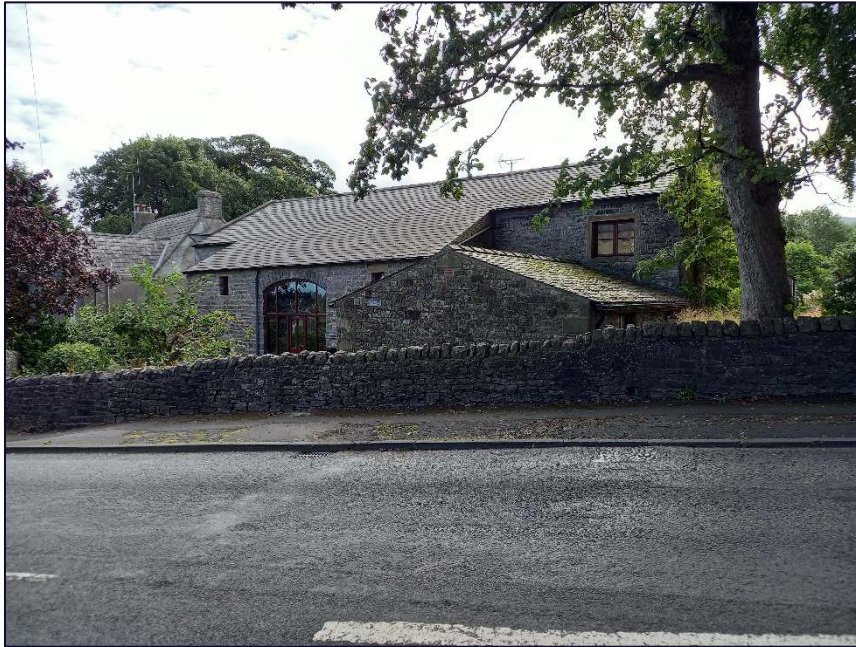
Plate 1: Crow Trees Barn as seen from the opposite (north) side of Crow Trees Brow

(north-west) side, and is roughly coursed or uncoursed in the other elevations. The property has been converted to domestic use, but it still retains characteristics of its former agricultural function in the form of two large opposing doors and vertical ventilation slits.

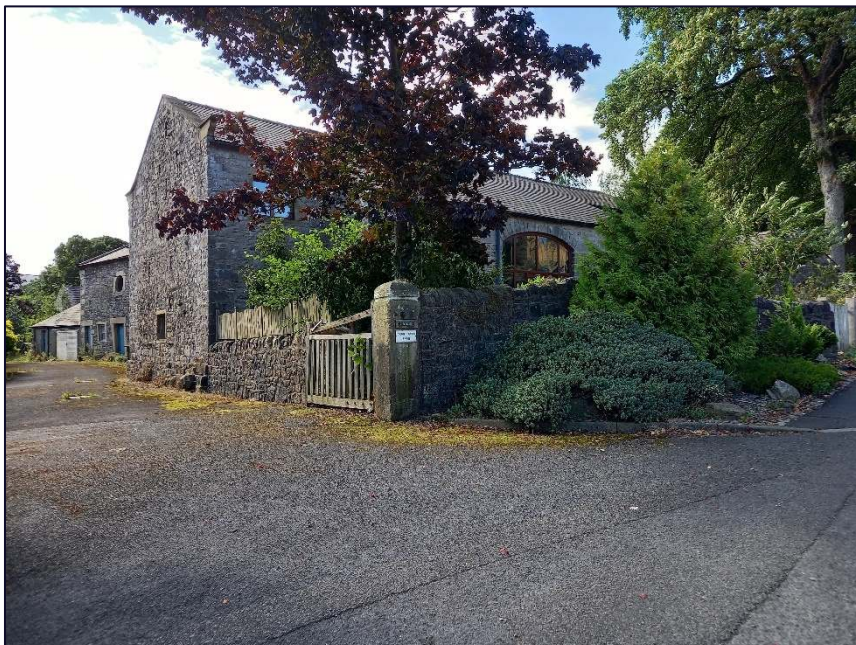
Plate 2: Crow Trees Barn as seen from the south side of Crow Trees Brow

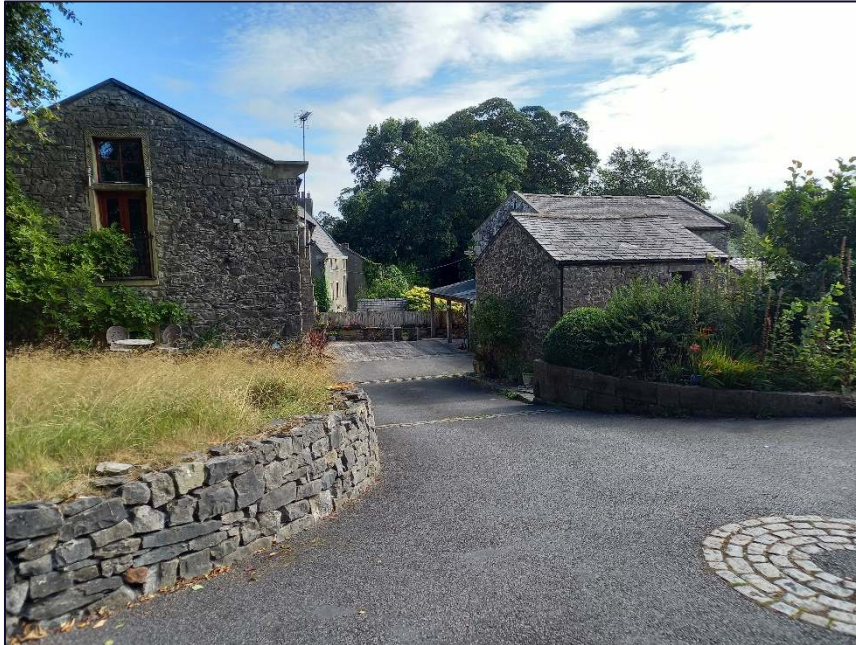
Plate 3: View looking east showing Crow Trees Barn to left of photograph, and the buildings proposed for conversion to right of photograph

- 4.3.3 The buildings proposed for conversion are located to the south side of Crow Trees Barn (Plates 3 and 4). A two-storey agricultural building extends from the south-east side of the buildings; this structure (which may have been a former stable block with hayloft above, Building D on Figure 2) does not form part of the current proposals and is now in separate ownership (Plate 5). A stone wall with wooden fence on top has been inserted between this building (Building D) and the south elevation of Crow Trees Barn, therefore the buildings proposed for conversion are not clearly visible from the east side of this fence (Plate 6).

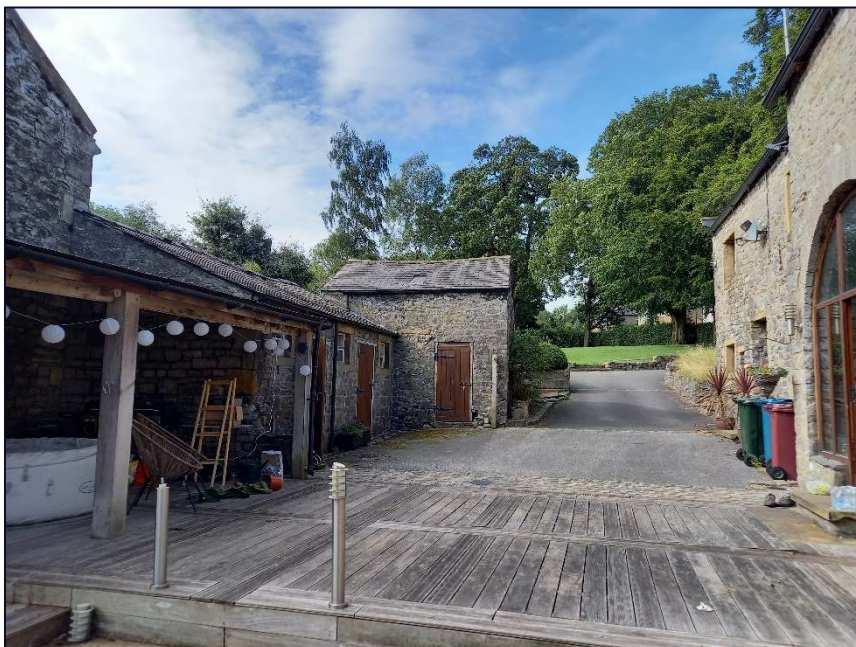
Plate 4: View looking west showing Crow Trees Barn to right of photograph, and the buildings proposed for conversion to left of photograph

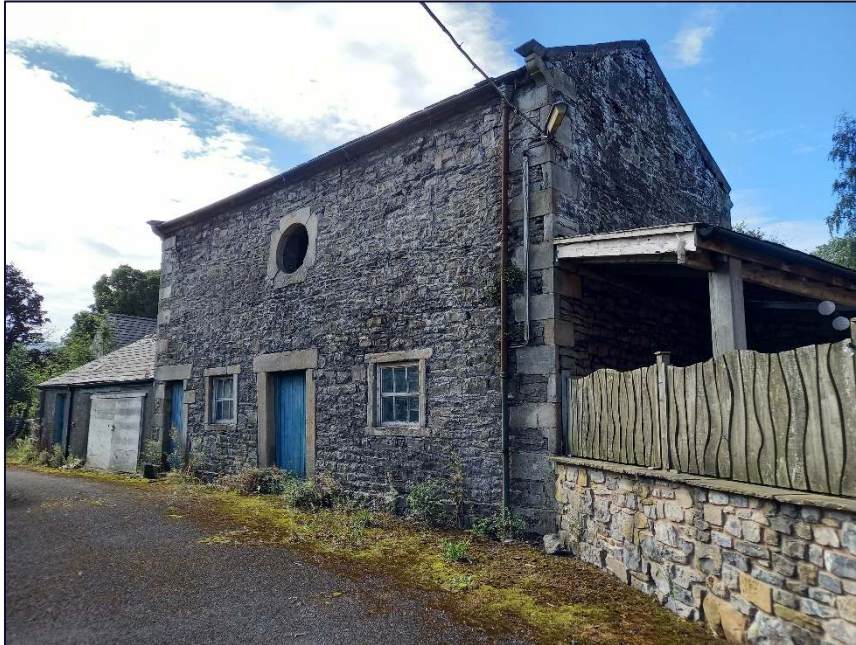
Plate 5: Possible former stable block with hayloft above (Building D on Figure 2) located to the south-east of the buildings proposed for conversion. This building does not form part of the current proposals

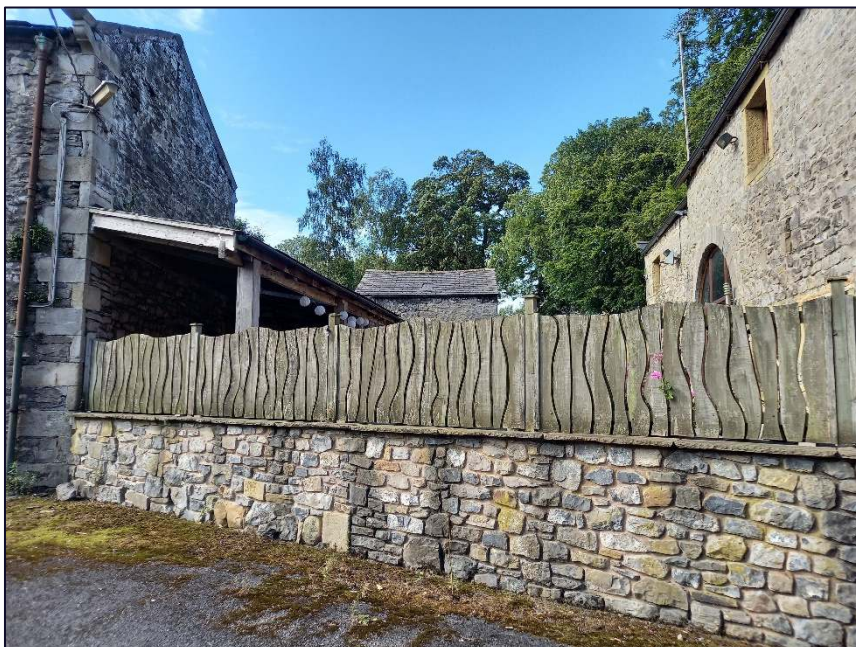
Plate 6: View looking west showing the south elevation of Crow Trees Barn to right of photograph and the possible former stable block shown on Plate 5 to left of photograph. The roof of one of the buildings (Building B) proposed for conversion is visible in the middle of the photograph

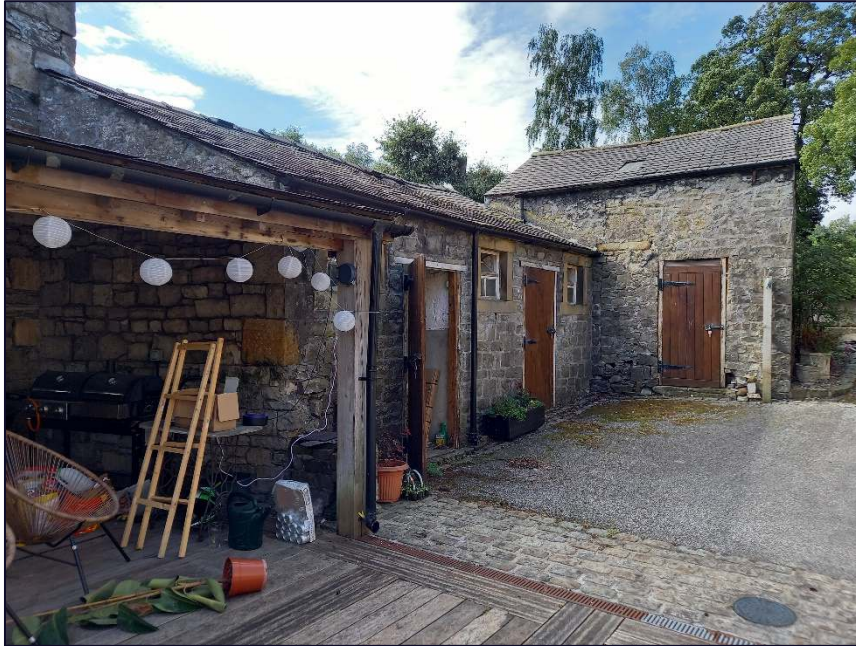
Plate 7: View looking west showing the building proposed for conversion (Buildings A and B)

- 4.3.4 The buildings proposed for conversion are L-shaped in plan and were constructed in several phases (Buildings A, B and C on Figure 5), but they are all built of stone with slate roofs (Plate 7).

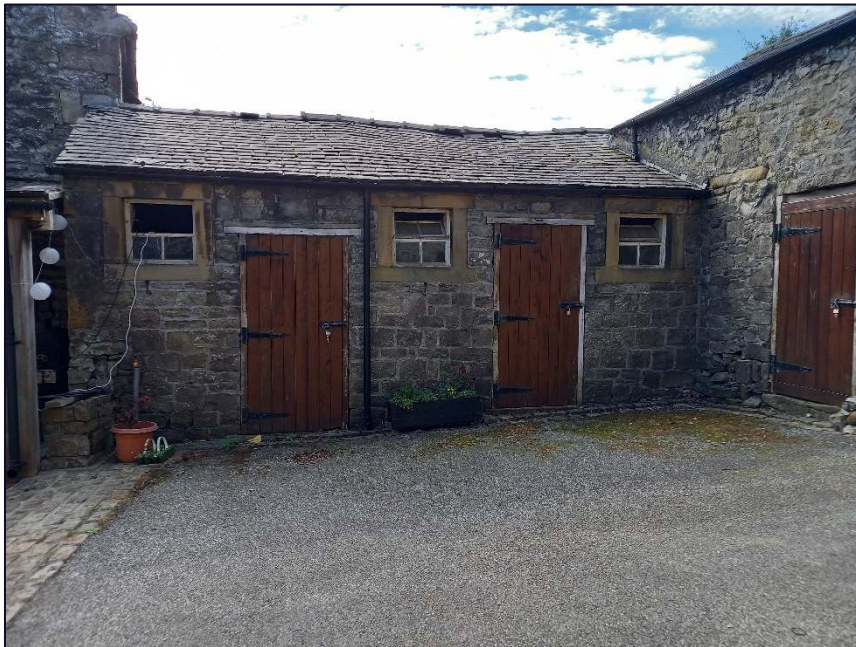
Plate 8: North-west elevation showing possible former stables (Building A)

- 4.3.5 Building A is aligned north-east to south-west and is located between Building B and Building D. Historic map evidence suggests that this building may have replaced an earlier structure, possibly pig sties. This is a single-storey structure that has been constructed of coursed and squared masonry, quite different to the other buildings that adjoin it. In the north-west facing elevation there are two doorways with modern doors, and three square windows with plain stone surrounds (Plates 8 and 9). The north-east elevation of Building A has been constructed up against the pre-existing Building D (outside the current site boundary) (Plate 10). The south-east elevation does not contain any openings, but has been whitewashed (Plates 11 and 12).

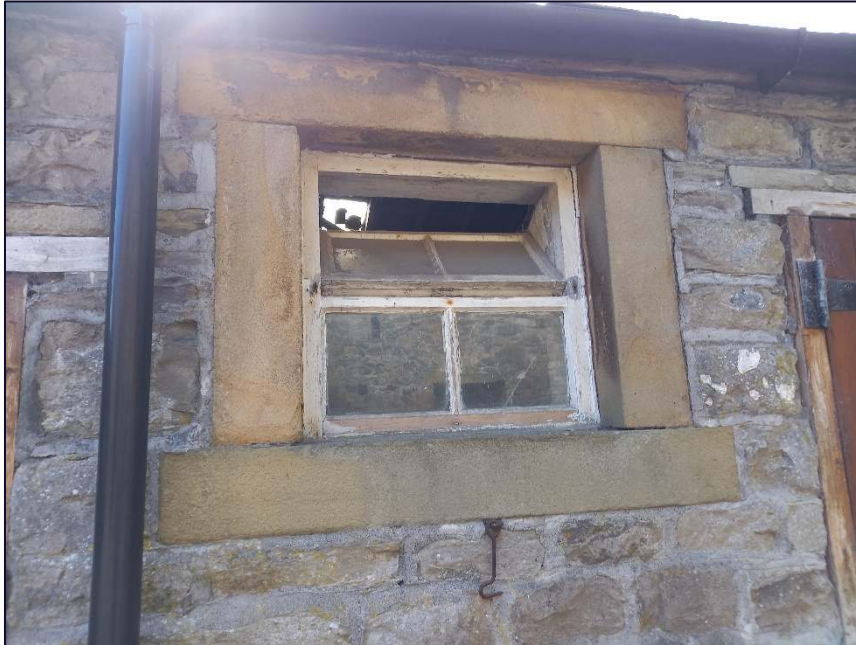
Plate 9: Detail of window, north-west elevation of Building A

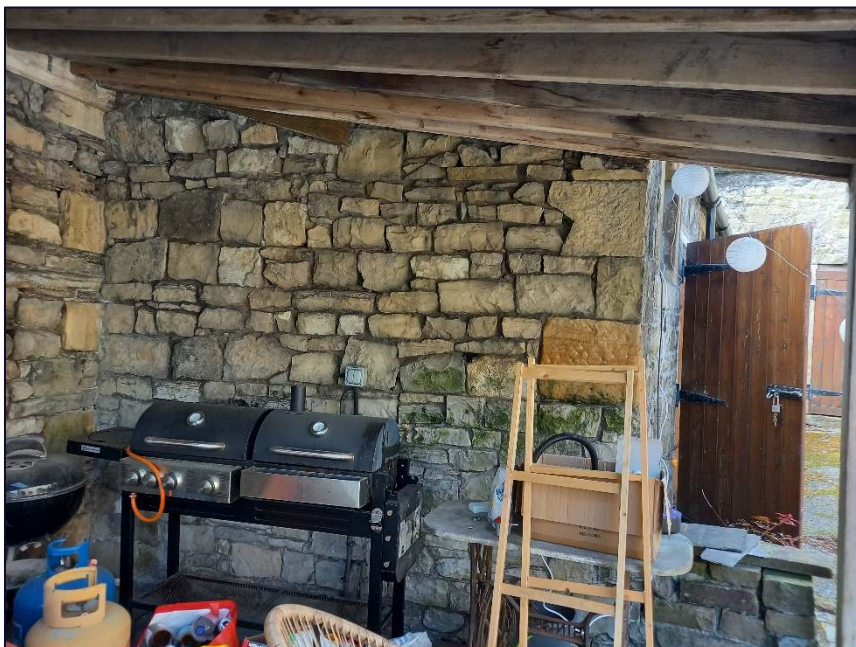
Plate 10: North-east elevation of Building A

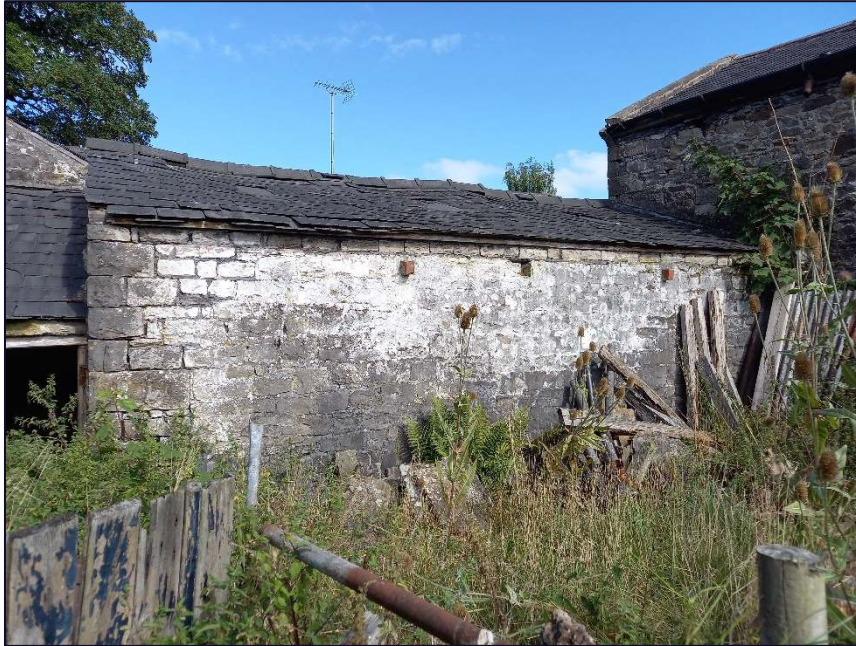
Plate 11: South-east elevation of Building A. The possible stable block with hayloft above (Building D) shown on Plate 5 is visible to right of photograph

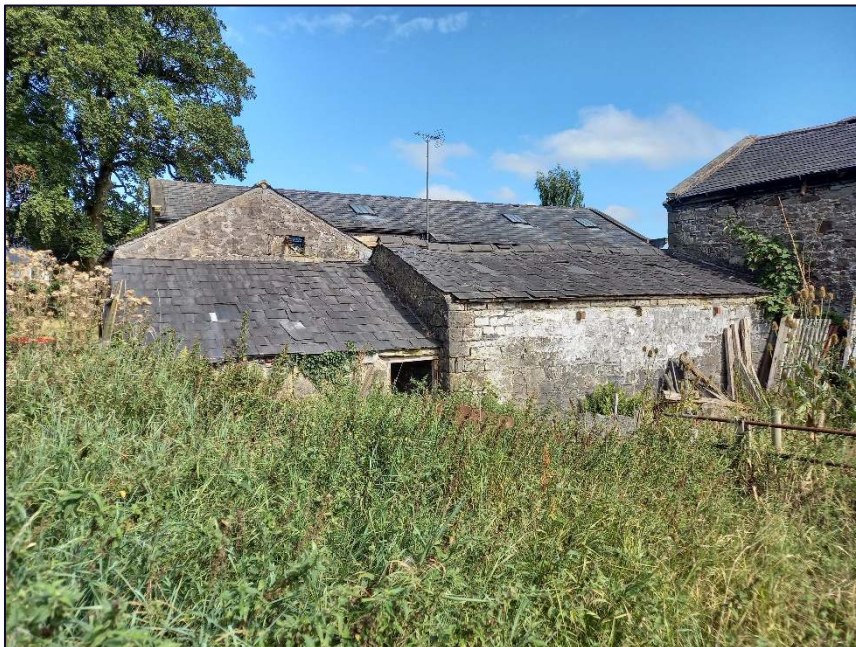
Plate 12: View looking north showing the south-east (rear) elevations of the buildings proposed for conversion

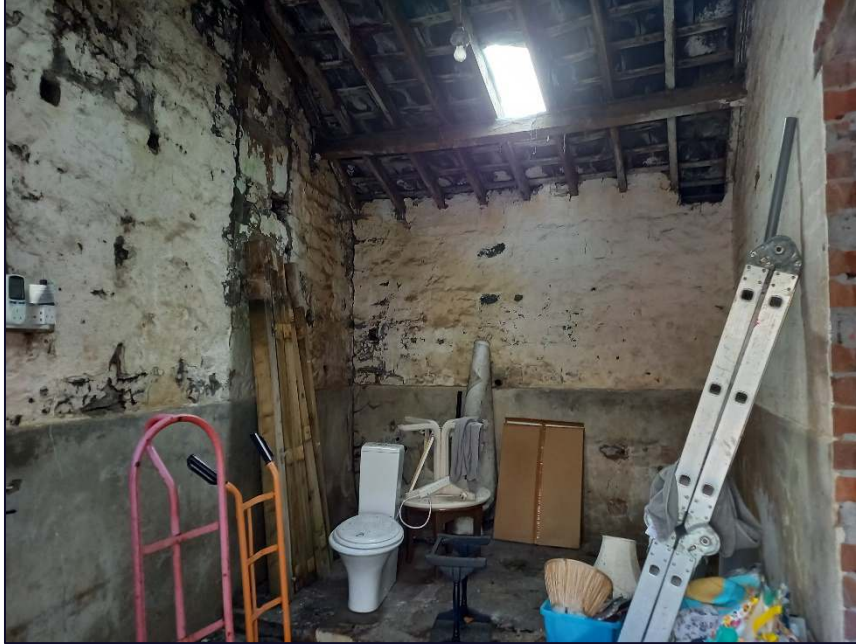
Plate 13: Interior of Building A showing plastered and white-washed walls and concrete floor

- 4.3.6 Internally, this building is divided into two spaces by a brick wall. It appears that this building may have been used for stabling as suggested by the concrete floors, presence of a manure channel, and the part plastered and part white-washed walls, although it could also have been used as a cowhouse (Plates 13 and 14). The wooden window frame which currently exist in this building have upper sections that would have opened inwards to provide ventilation, and are characteristic of an agricultural building (Plate 15). The roof is constructed of machine-sawn timber with a row of purlins to each side and skylights within the slate roof (Plate 16). In the north-east wall of this building there is a line of quoins which relate to Building D (not included in the current proposals), with another construction break in the south-west wall relating to Building B (Plates 17 and 18). These vertical breaks provide evidence that Building A was inserted/constructed between the pre-existing Building D and Building B.

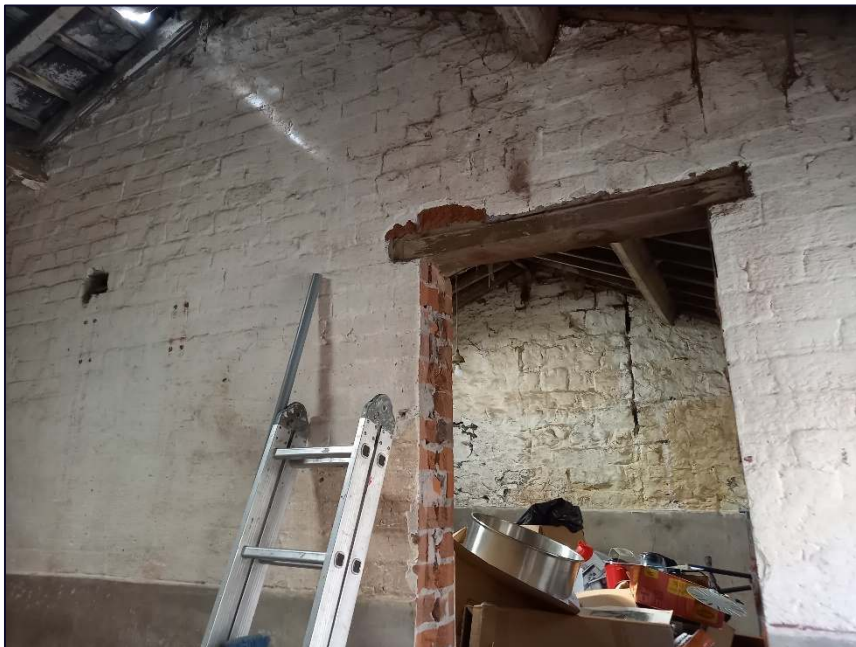
Plate 14: Internal brick wall which divides Building A into two rooms

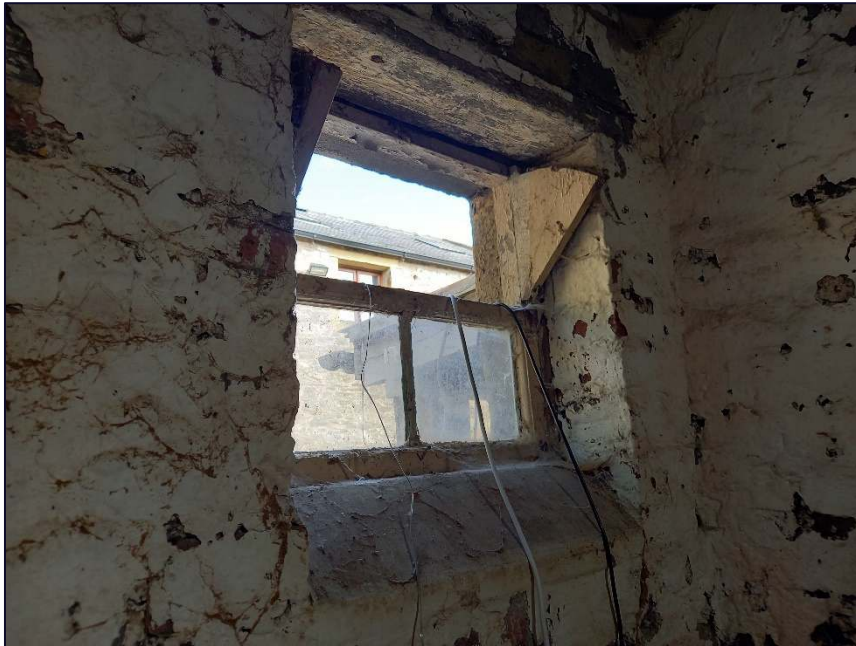
Plate 15: Detail of one of the windows with upper section that opened inwards (Building A)

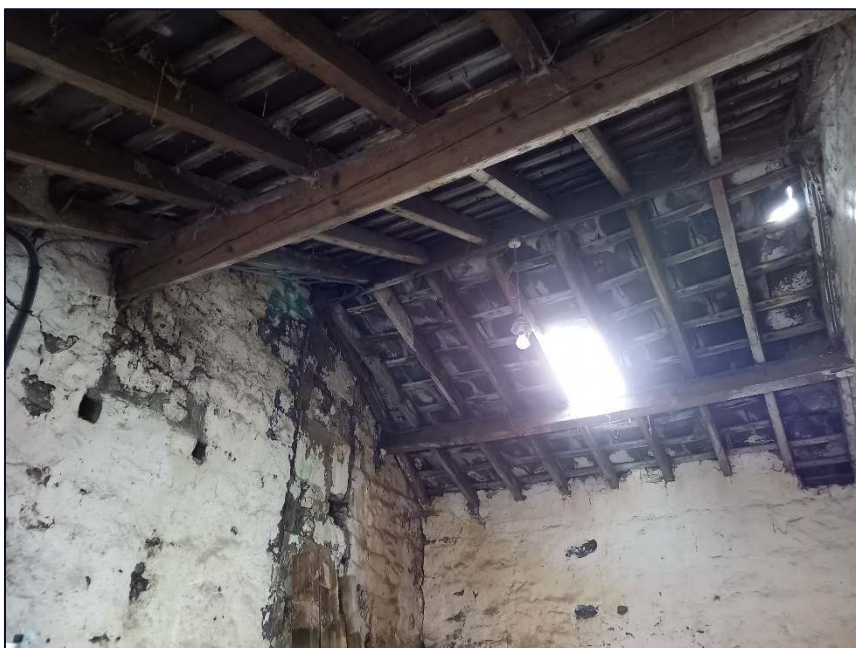
Plate 16: Detail of roof structure in Building A

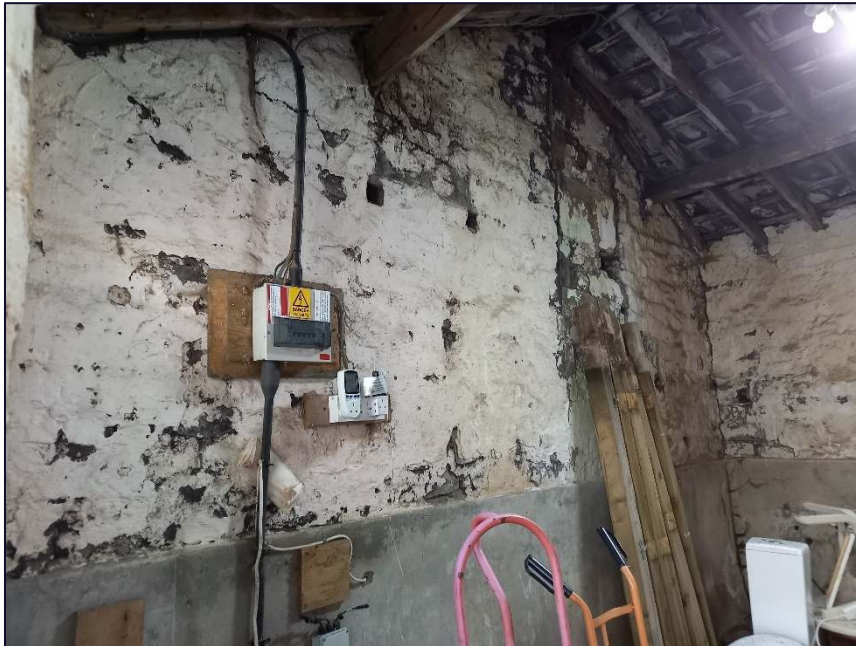
Plate 17: North-east internal wall of Building A showing the quoins of Building D against which Building A was constructed

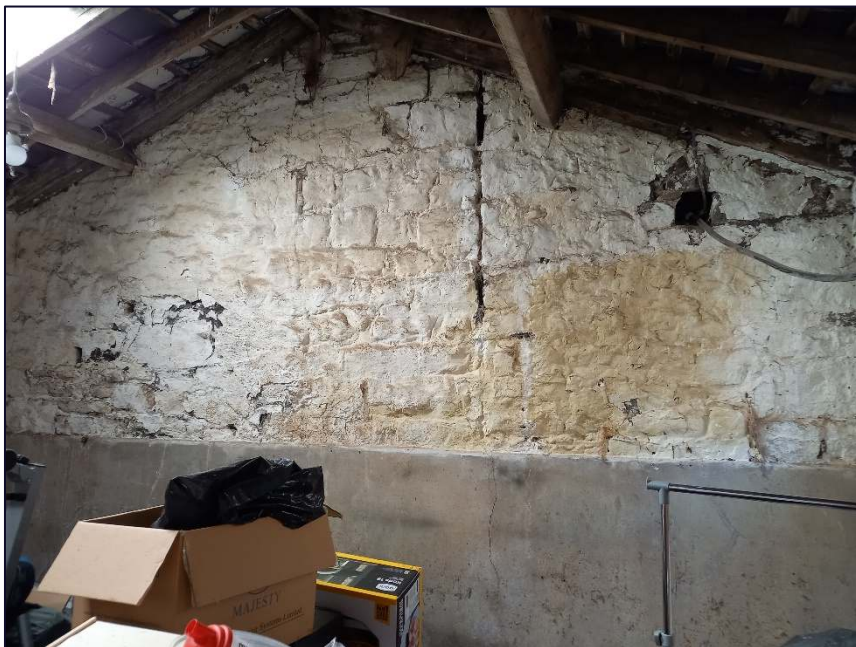
Plate 18: South-west internal wall of Building A showing the vertical construction break where Building A has been constructed against part of Building B

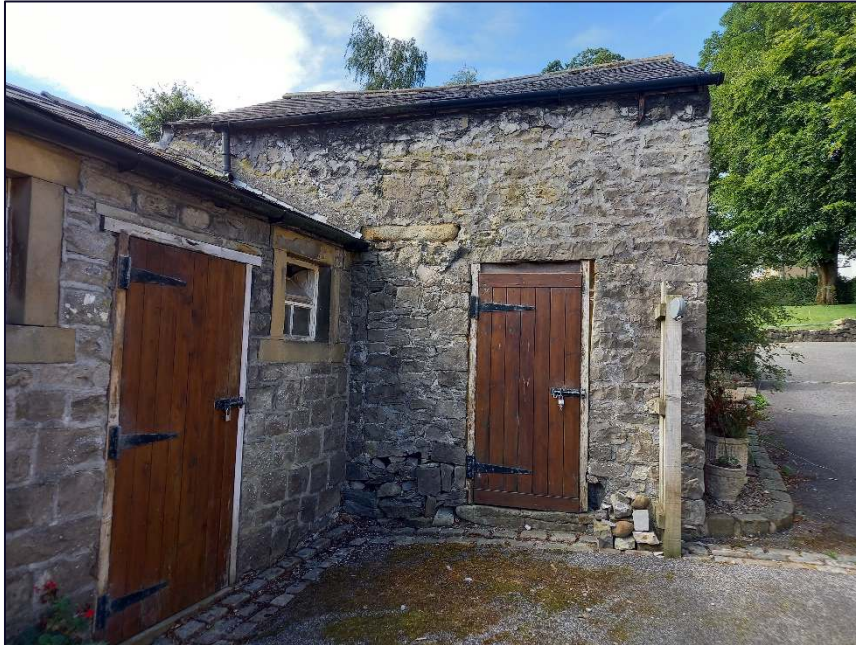
Plate 19: North-east elevation of Building B, with Building A to left of photograph

- 4.3.8 The north-east elevation of Building B has a doorway, but this appears to have been inserted, with a
-

possible earlier doorway having been infilled to its left-hand side, as evidenced by a straight line in the masonry, possibly when Building A was constructed. There is a blocked window at first floor level in this elevation, as indicated by the redundant stone sill (Plates 19 and 20). The north-west gable of Building B is featureless (Plate 21).

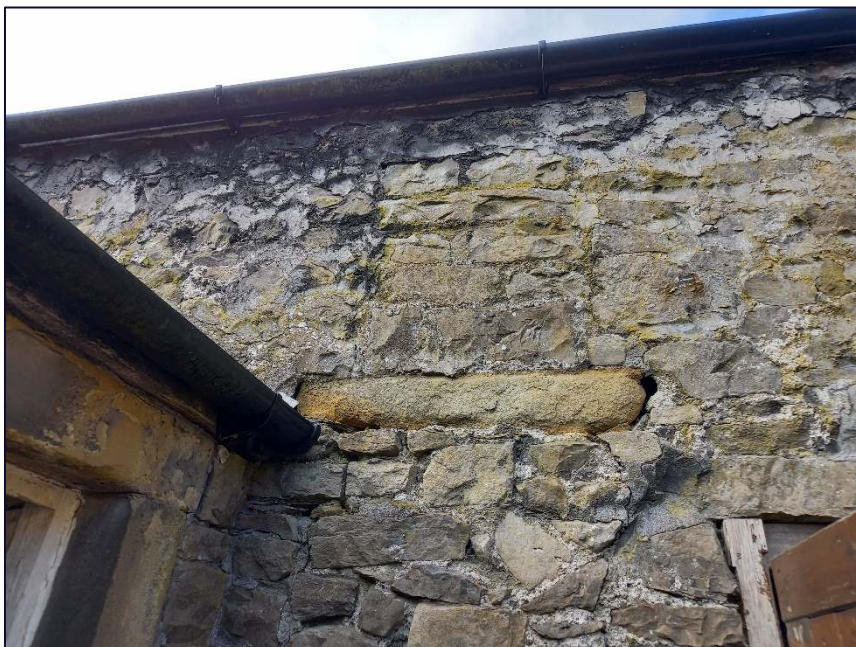
Plate 20: Detail of blocked window, north-east elevation of Building B

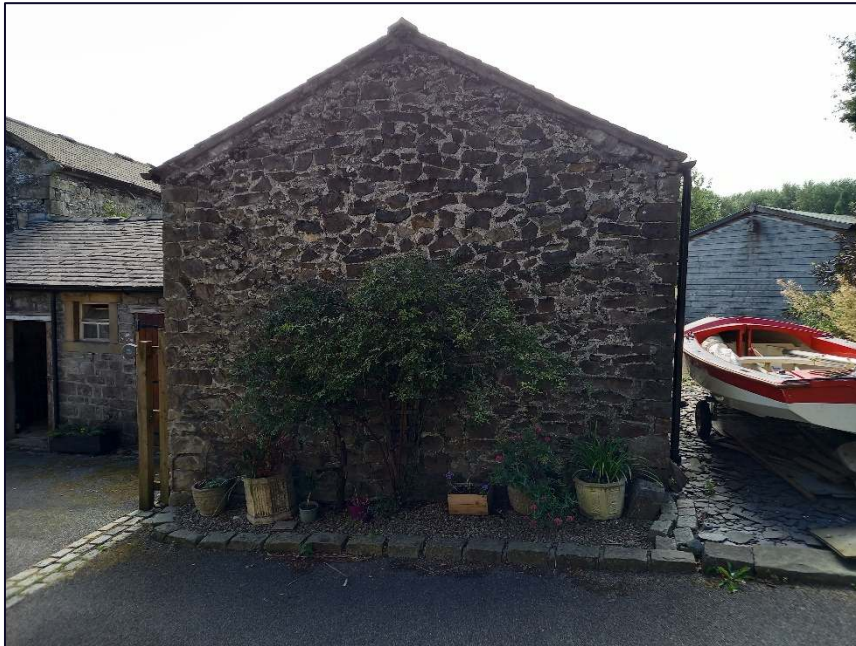
Plate 21: North-west gable of Building B

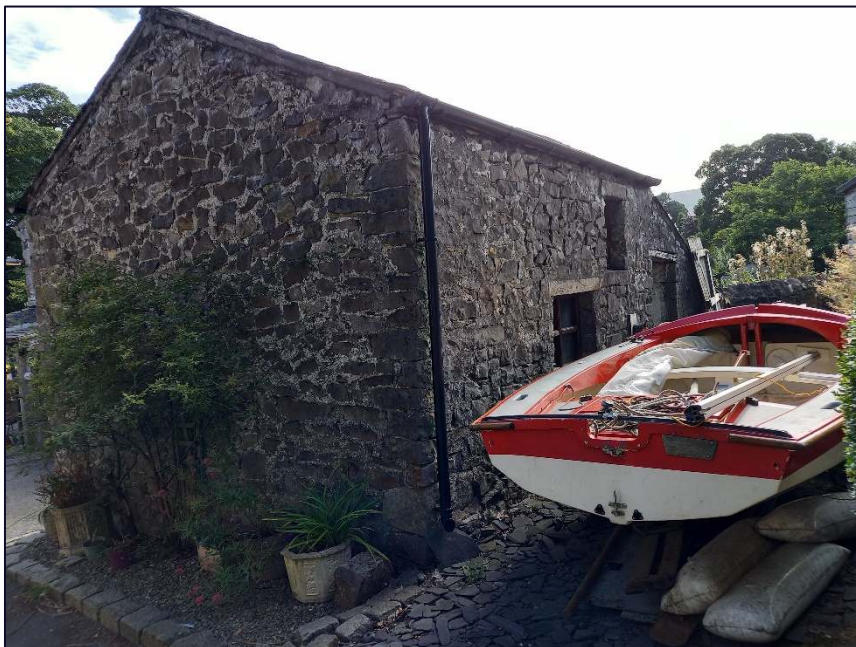
Plate 22: North-west gable and south-west elevation of Building B

- 4.3.9 The south-west elevation of Building B has a ground floor window with four-pane fixed casement window, but this appears to be inserted as suggested by the concrete sill, with an earlier ground floor having been infilled to its right-hand side (Plates 22-24). There is another window at first floor level, also with a four-pane fixed frame (Plate 23); the presence of a first floor window in this elevation, and the blocked window in the north-east elevation, indicates that internally there was formerly a first floor. The south-east gable of Building B is largely obscured by Building C which has been constructed up against it, but it was possible to note a small square opening just above the roof of Building C, which may have been an owl hole (Plate 25).

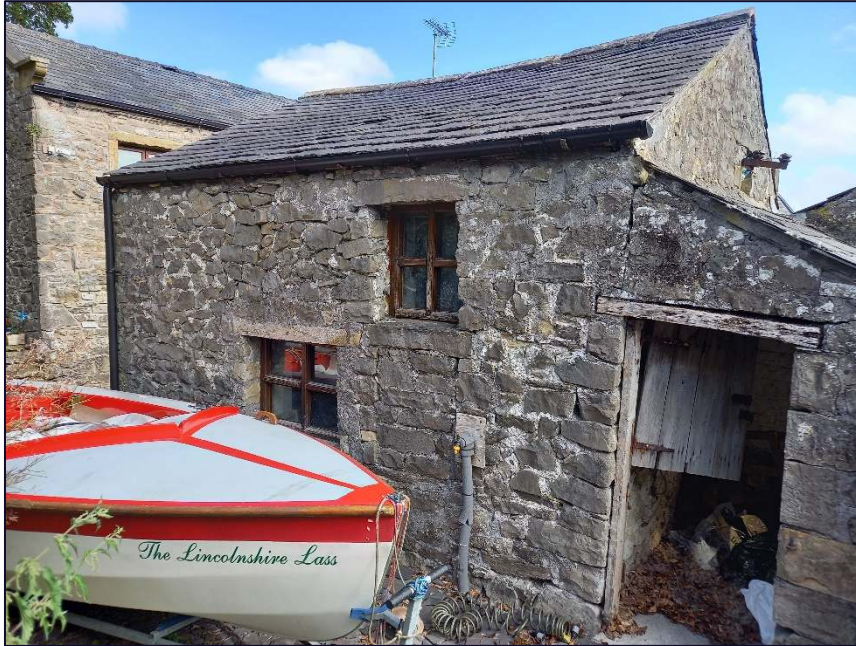
Plate 23: South-west elevation of Building B, with Building C to right of photograph

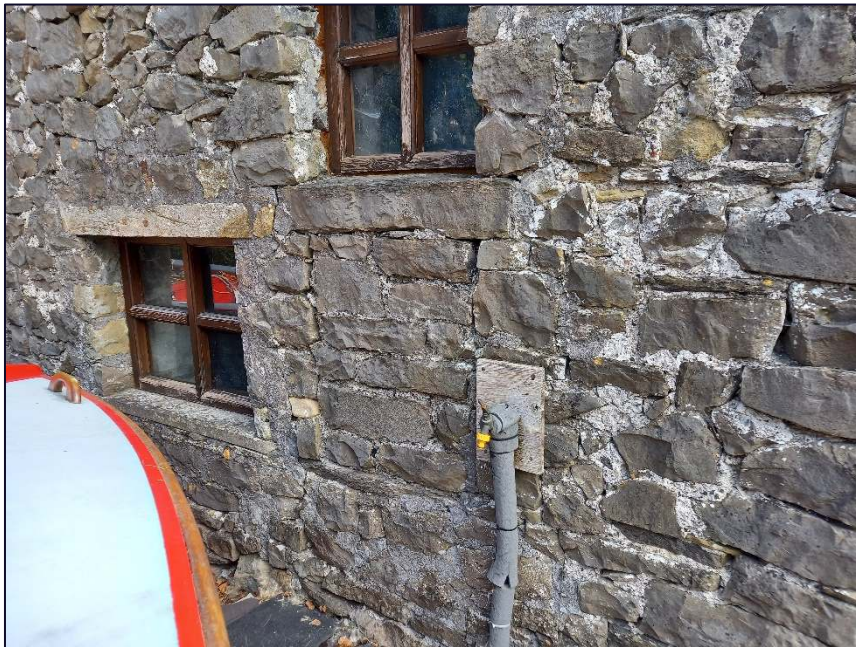
Plate 24: Blocked window, south-west elevation of Building B

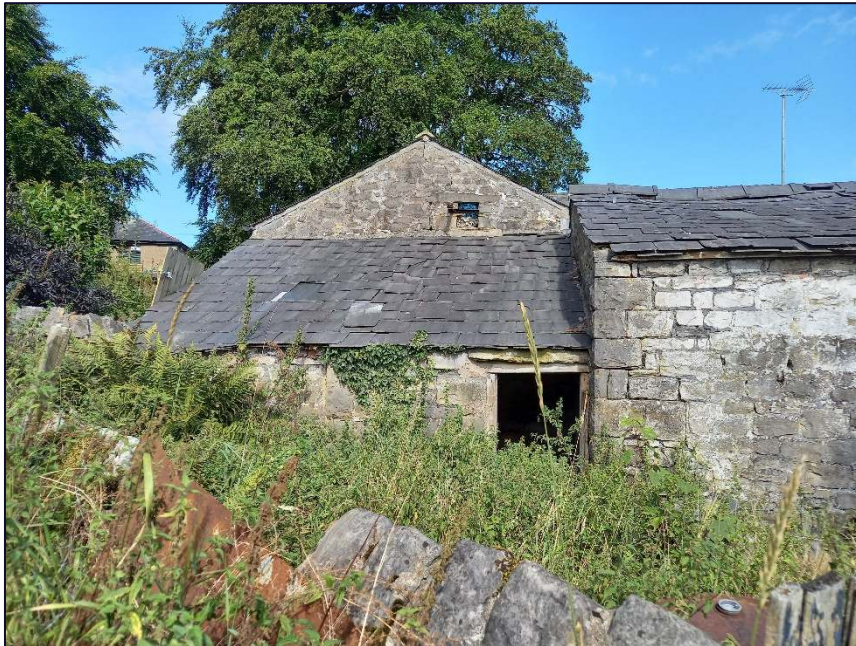
Plate 25: South-east gable of Building B largely obscured by the roof of Building C

- 4.3.11 Building C is a small, single-storey structure with monopitch roof that has been constructed against the south-east elevation of Building B (Plates 25 and 28). This building has a doorway in the south-west elevation, with alternating blocks of masonry making up the right-hand jamb, with another door present in the south-east elevation, indicating that internally it is divided into two rooms (Plates 29 and 30). There is evidence that Building C was constructed in two phases, as there is a vertical construction break visible in the south-east elevation (Plate 30).

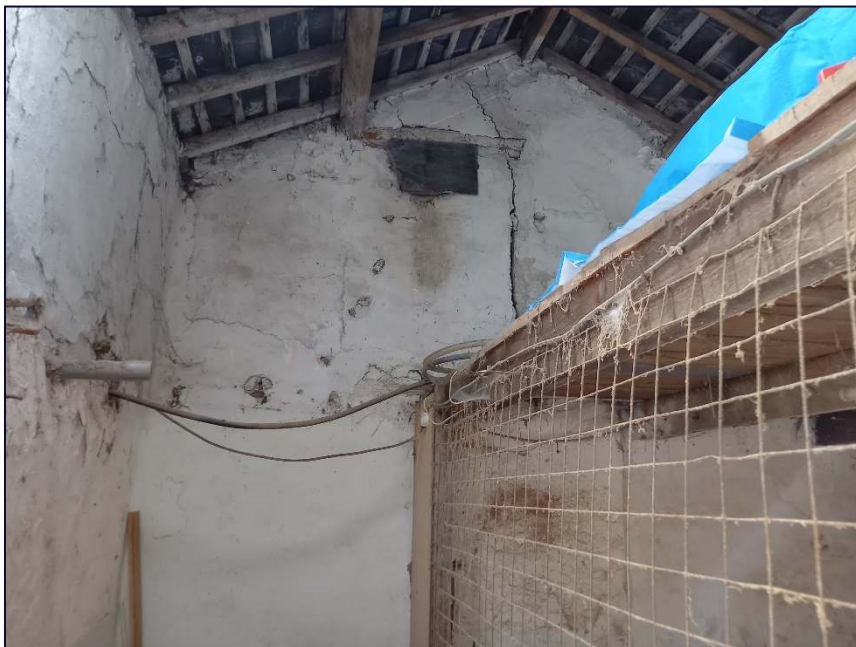
Plate 26: View looking south showing the interior of Building B

- 4.3.10 Internally, Building B now consists of one single space open to the roof, apart from a modern mezzanine floor, but there is evidence for the former presence of a first floor, as already indicated by the windows, but also by redundant joist holes. The walls of this space have been white-washed, and the floor is of concrete (Plate 26). The roof is constructed of machine-sawn timber, with a skylight providing additional light (Plate 27).

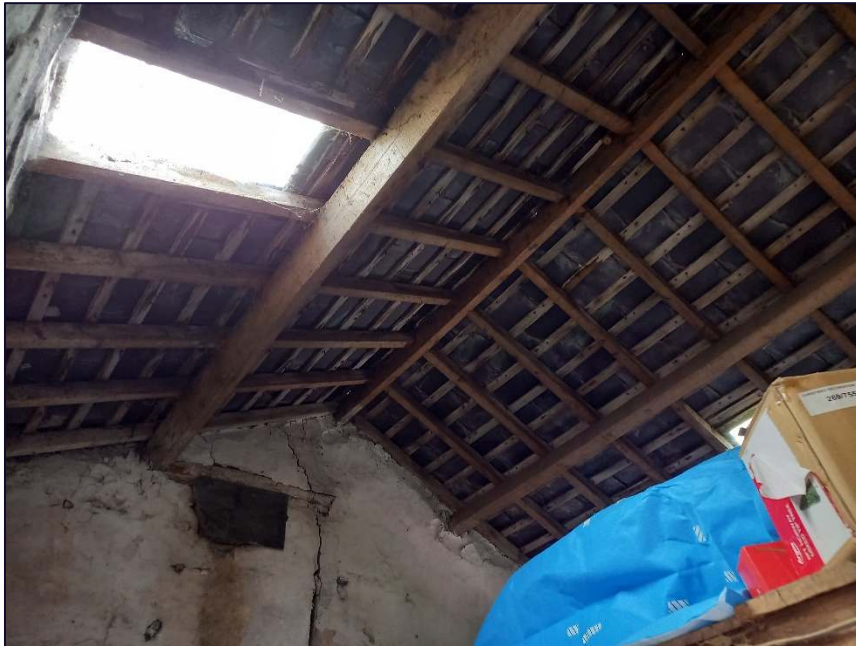
Plate 27: Detail of roof structure, Building B

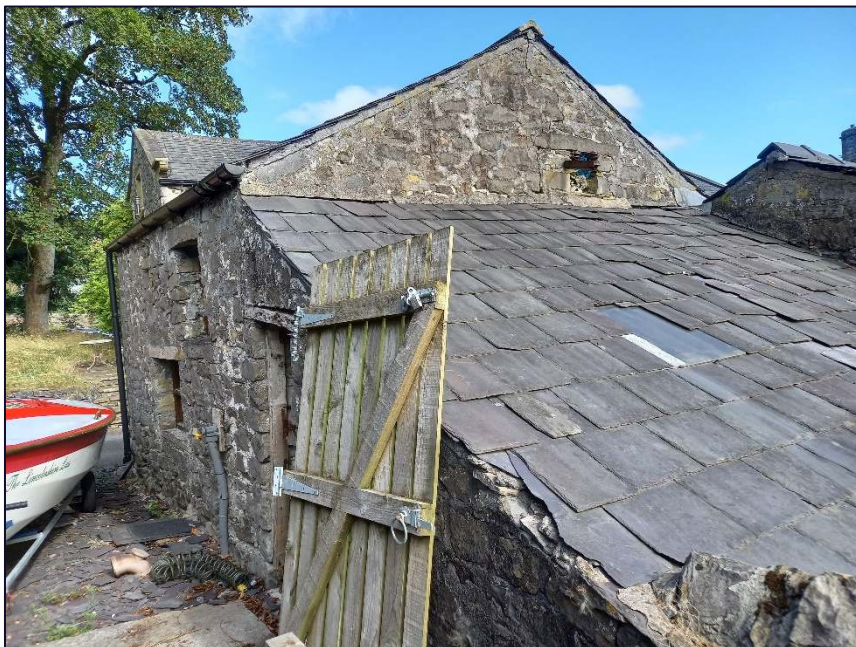
Plate 28: View looking north showing Building B with the roof of Building C to right of photograph
