BAT SURVEY AT -

KAY FOLD FARM
RAMSGREAVE DRIVE
BLACKBURN
BB1 8NB

DATE AND TIME OF VISIT
16th June 2022 9.15 am

REFERENCE NO. 6624

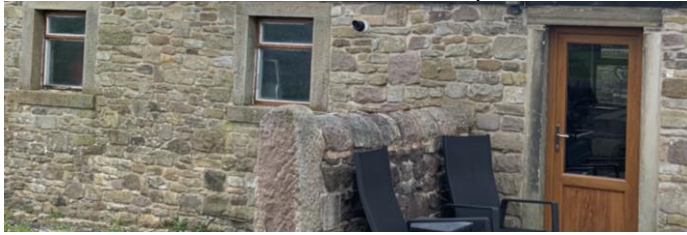
The house and (attached) garage walls (see below) are in excellent condition and very well pointed . There are no cracks crevices or access points in the walls.

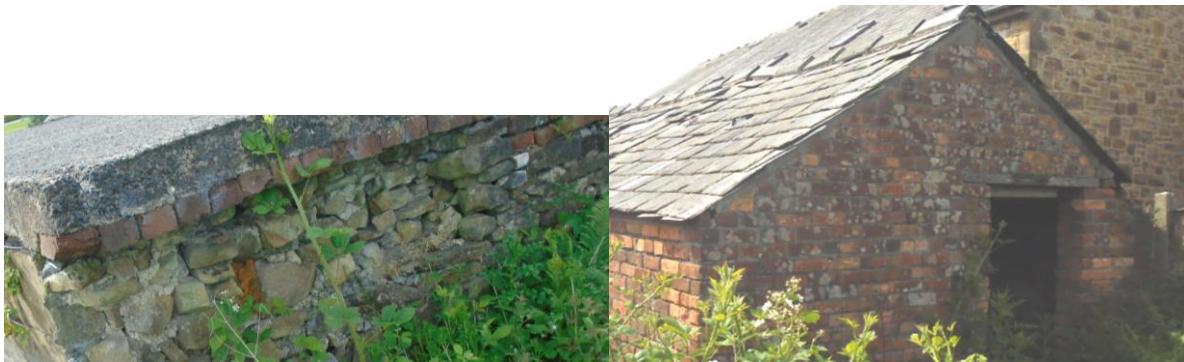
The garage side wall has some missing pointing at low level and some crevices in the random stone to the rear elevation. All these crevices were examined closely. Bats were not found to be present nor did the crevices provide high value roost potential.

The outbuilding walls to the front section being block and render did not have any cracks crevices or access points, the rear brick section however has an opening with no door, giving free access to the interior.

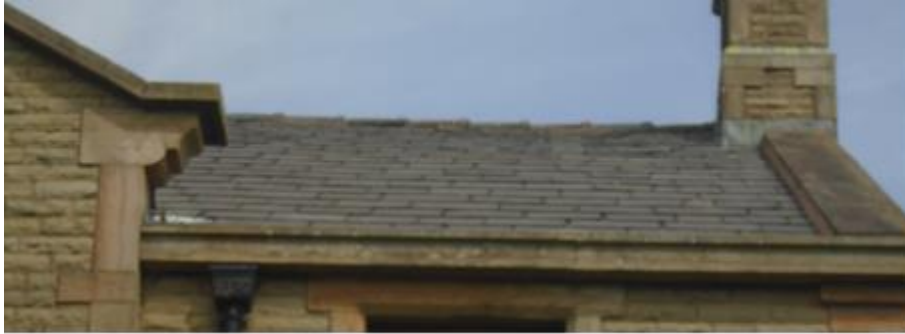
The roof of the house was examined from ground level with the aid of Binoculars. The pointing to the coping stones and ridge were in excellent condition, the slates are very tight fitting. The lead valleys were tight fitting. No possible access points were evident.

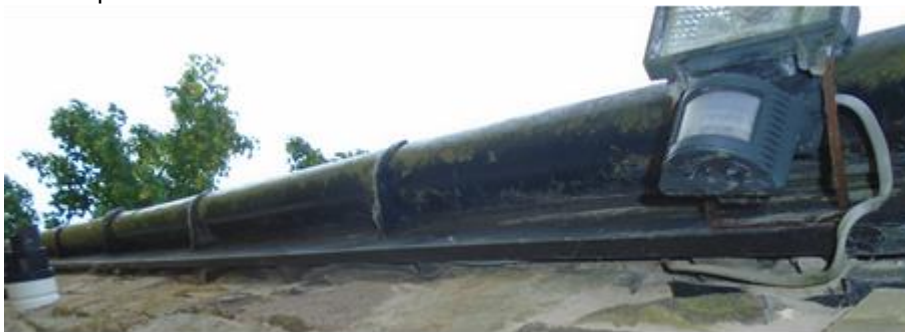
The garage roof is in good condition with all slates and ridge tiles tight fitting. There are no voids behind the flush fitting fascia's. The flashing at the abutment with the house wall was tight fitting. No Access points were evident in this roof.

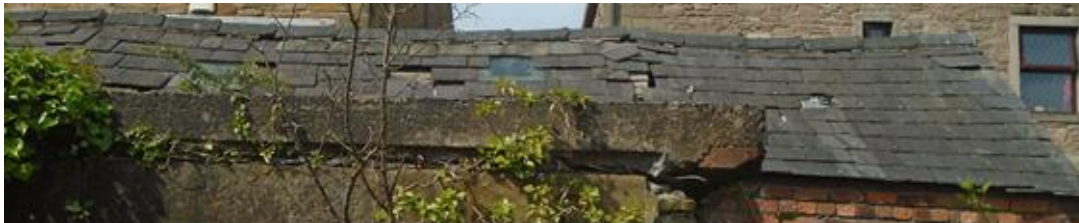
The garage roof adjacent to the outbuilding is a solid concrete slab. No access points, cracks or crevices

The outbuilding roof is in poor condition with many slipped and raised slates forming crevices . Although no access points to the interior were evident. As far as possible the single storey roof was examined for evidence of bat ingress.

The outbuilding whilst no existing or historic bat presence could be found and the location does not provide a high level of forage potential it did have access points in the roof. Due of the possibility that bats could enter in the intervening months prior to commencement of the conversion the following precautions should be followed when carrying out the work.

- Once the work commences the slates should be removed carefully by hand , if any Bats are exposed work should stop immediately and Natural England the Licensed Bat worker contacted to remove the bats from the site and care for them until it is safe to return the bats to the roof space.

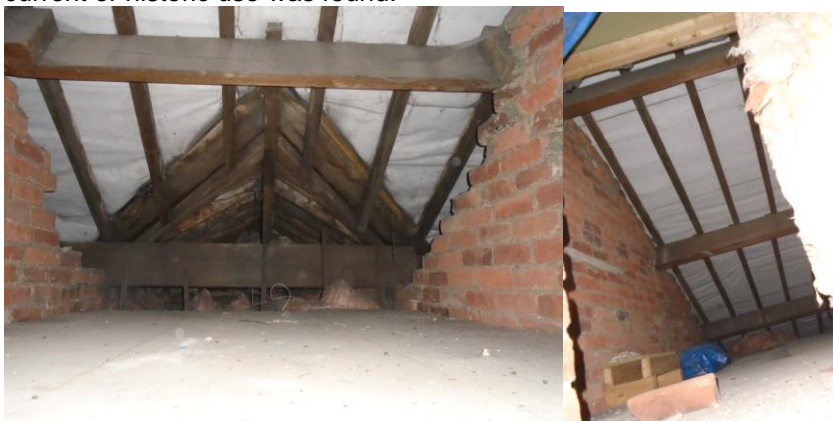
The main house roof was accessible via a ceiling hatch on the first floor landing. The roof had modern underlay but the timbers appeared to be original, they were however in good condition with no rot, cracks or crevices suitable for bat ingress. The boarded floor was clean with no dropping or insect remain feeding evidence. The space did not provide any high value roost potential and no evidence of current or historic use was found.

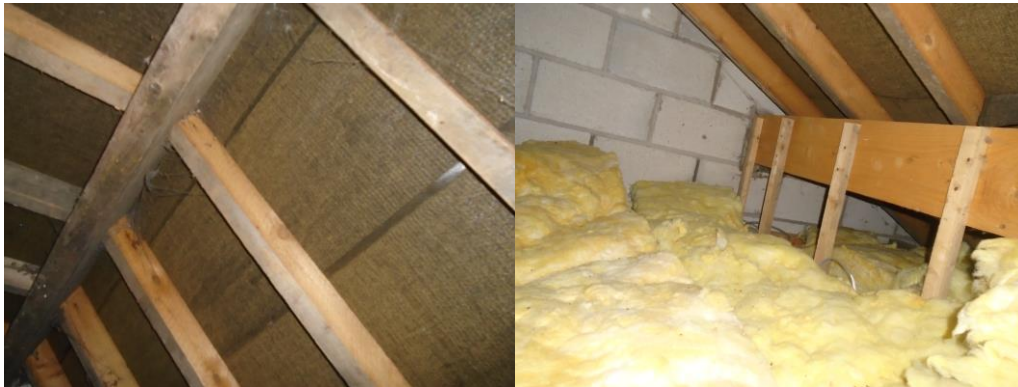
The section of roof over the utility section of the garage was accessible via a hatch. The timbers and underlay appeared to be relatively new and in good condition. No dropping or insect remain feeding evidence was found. The space did not provide any high value roost potential and no evidence of current or historic use was found.

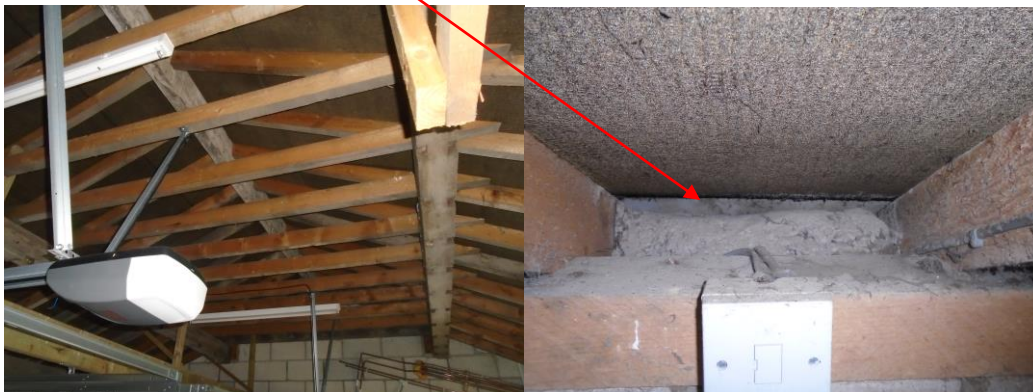
There was no enclosed roof void over the garage, the timber trusses were fully visible and it was possible to examine closely, all were in good order with no signs of rot, cracks or crevices. The underlay is in excellent condition with no rips or tears. The eaves were well sealed, the roof structure did not provide any roost potential for bats.

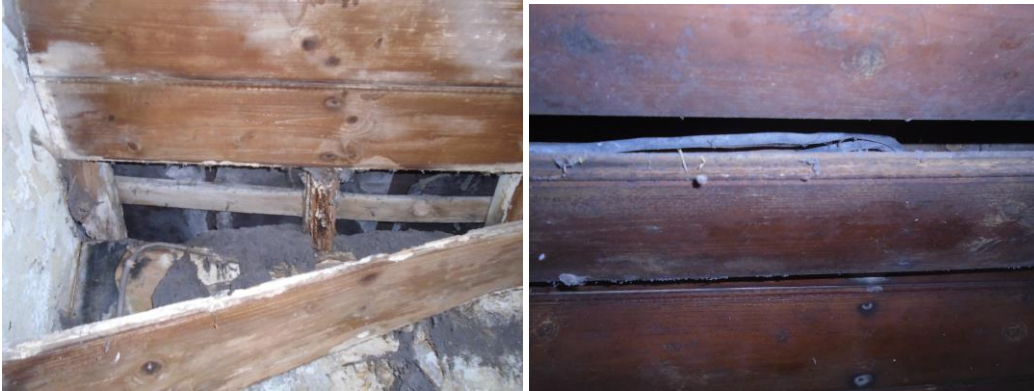
No rot was evident in the timbers however some of the boards were warped at the ridge and a dislodged section was present in the first section. It was possible to examine any gaps with the endoscope see below.

Gaps in the boarding to the first section of the outbuilding. Inspection did not reveal any current or historic bat presence.

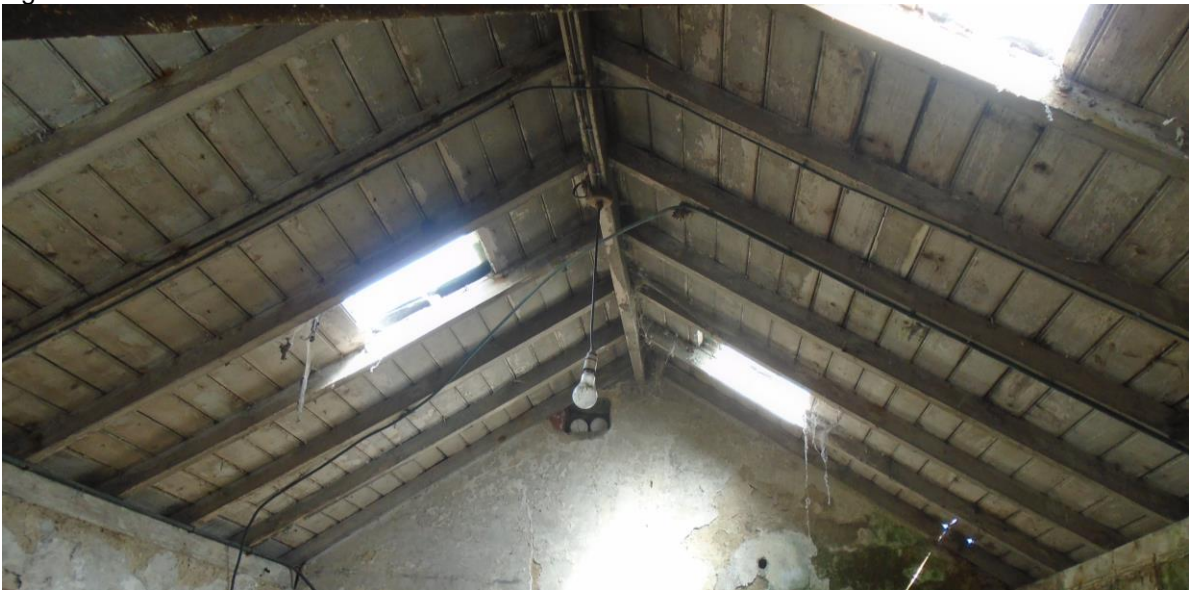
The second section with the sarking board ceiling was in average / poor condition however there was no significant signs of decay or dislodged boards. No high value roost habitat was present. nor any signs of current or historic use.

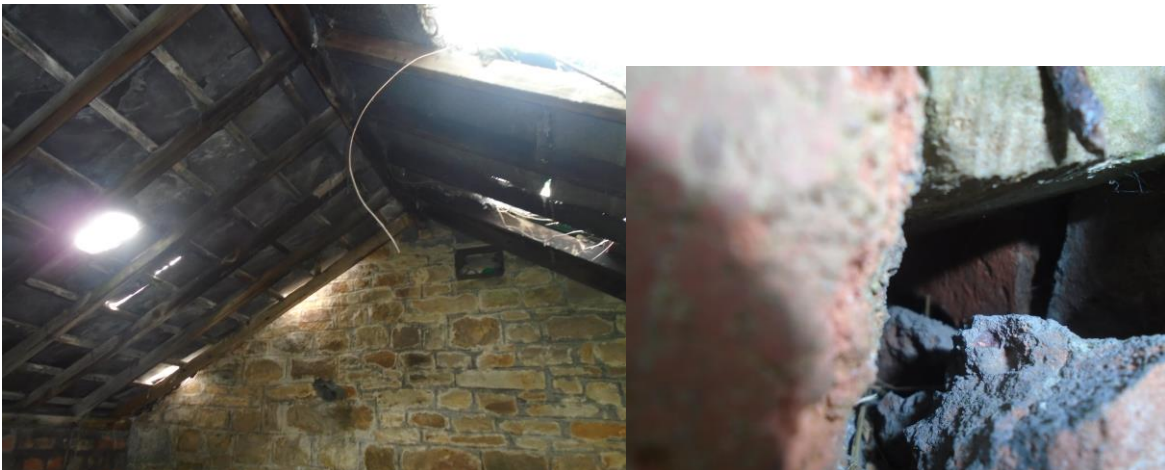
The end section of the out building is slate laid over timber rafters and battens, there are numerous gaps in the slates. All the structure is easily examined. No suitable bat habitat was present. However a bird nest with young could be heard although not seen in a wall cavity to the north east corner of the building.

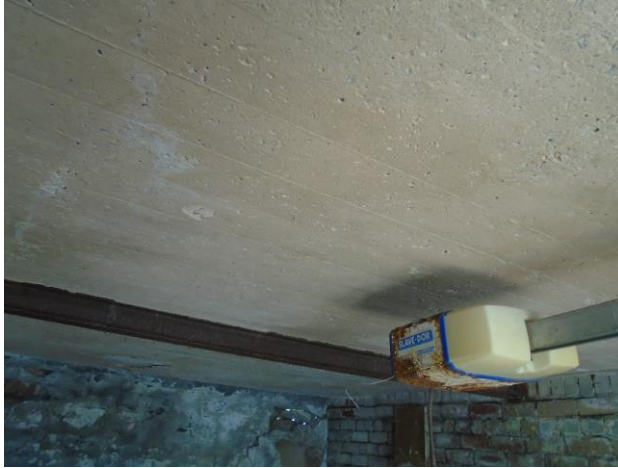
The underside of the concrete garage flat roof provides no habitat for bats.
