Bat Survey Report and Method Statement European Protected Species (Bats)

Reasonable Avoidance and Mitigation Measures

**Millhouse,
Clitheroe Road,
West Bradford,
BB7 4SH**

07.10.2022

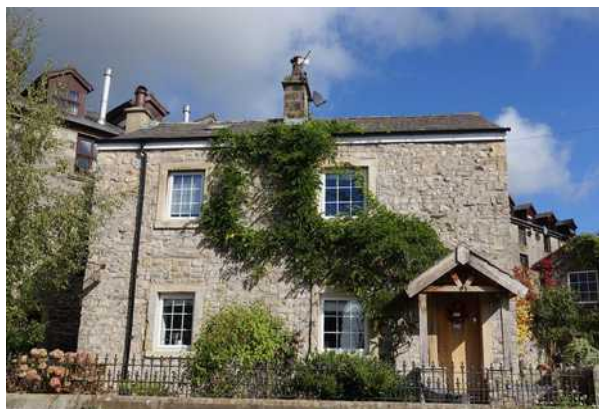
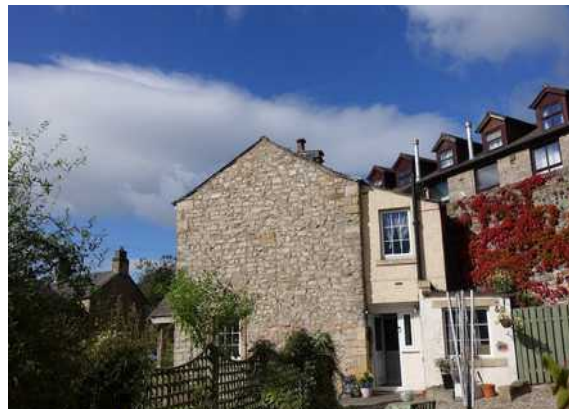
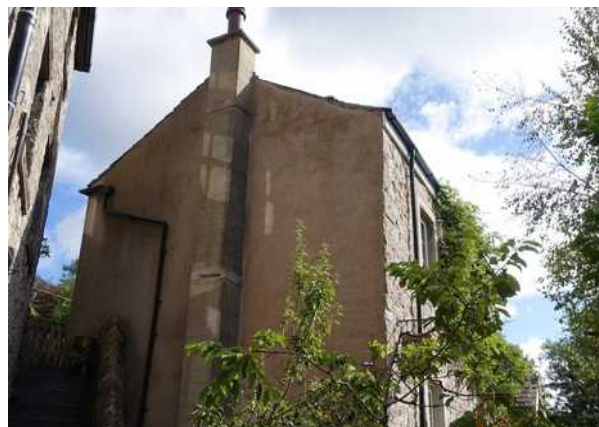
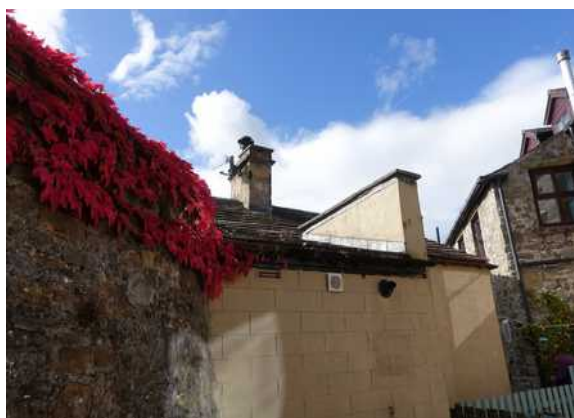
The property consists of a traditional stone built two storey house with a double pitched stone slate roof, the building has single storey extensions present to the rear.

Walls are pointed and partially rendered with no obvious cracks, gaps or crevices present. Roof slates are generally close fitting with no obvious lifted, missing or slipped slates present. The ridge is generally pointed and well sealed. Internally the property has vaulted ceilings with roof lights present. Some gaps are present behind fascia boarding.

The property was assessed as offering negligible to low bat roost potential.

Roost potential is limited to gaps behind fascia boarding, and it is likely that the presence of bats would be limited to non breeding low conservation value roosts. It is proposed that a precautionary emergence survey be carried out prior to works commencing to confirm absence of roosting bats.

It is recommended that a precautionary emergence survey is carried out prior to works on the main roof to confirm absence of roosting bats.
