**BAT SURVEY AT -
11 WARWICK DRIVE
CLITHEROE**

DATE AND TIME OF VISIT
29st April 2022 10.00 pm

REFERENCE NO. 6616

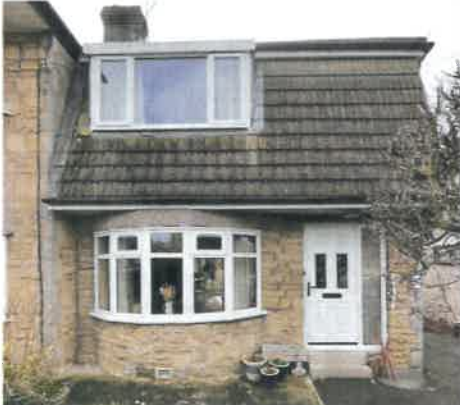
Front elevation

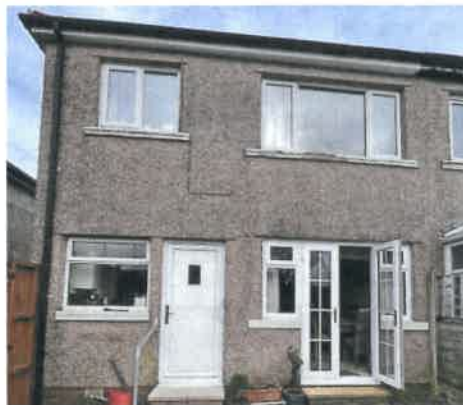
Rear elevation

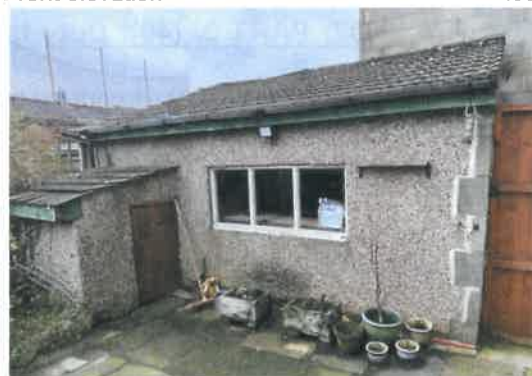
Side elevation of the Garage

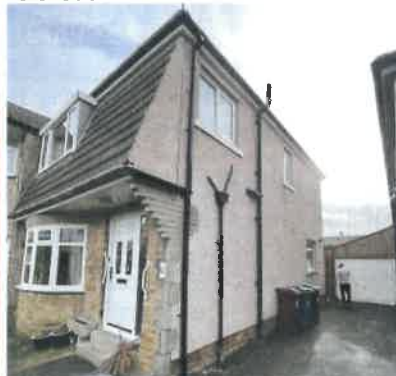
Side elevation of the house and front of Garage

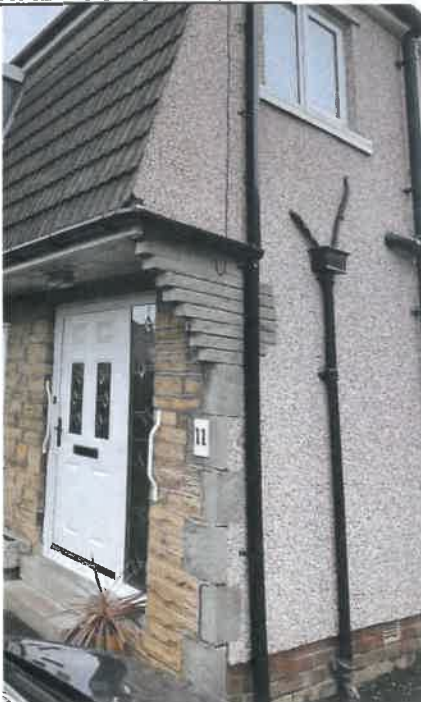
Front/side house walls

The walls are a combination of pebble dash render over brickwork, natural stone to the front elevation and a section of hung tile to the front at first floor level. The garage walls are pebble dash over brick as before.

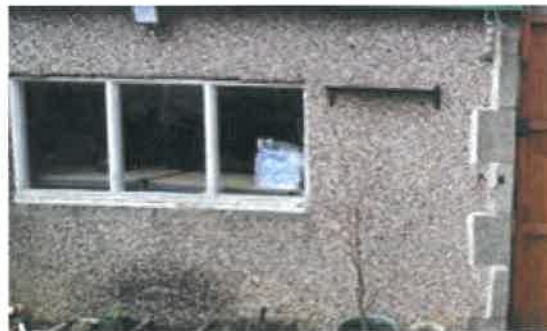
Garage side wall.

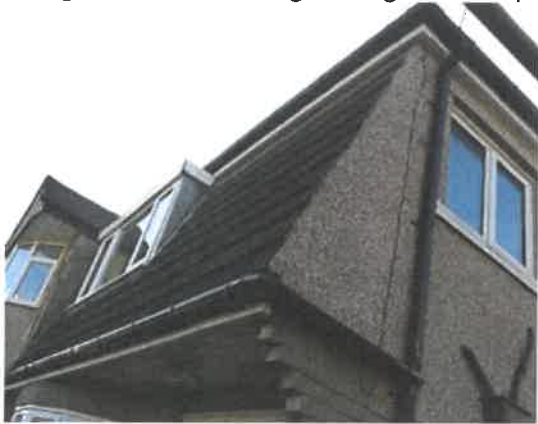
The walls are in good condition, render is in perfect condition with no cracks or crevices. The hung tile is in good condition all tight fitting does not provide any crevices.

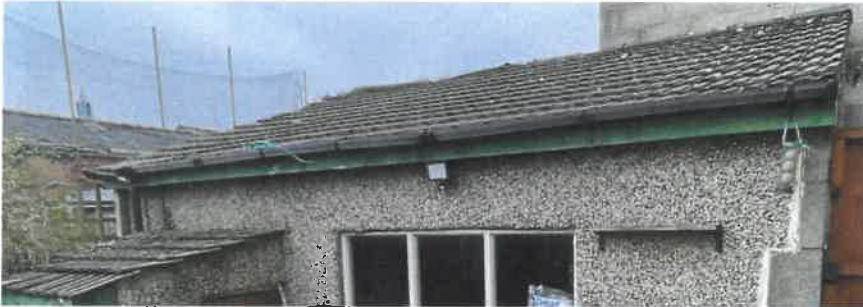
The garage roof is now a mono pitch after half has been demolished. There is a slight over hang with a timber fascia fixed to the rafter ends. The finish is profile tiles. The small adjacent lean to has a flat tile finish.

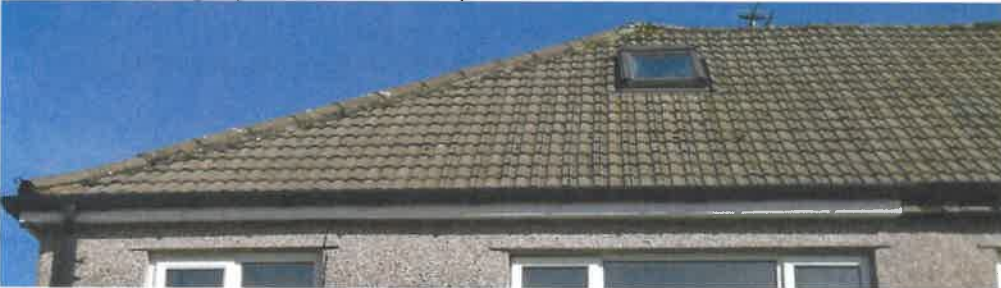
The main roof is hipped with upvc fascias and soffits. The finish is profile tile with hip and ridge tiles. There is a roof light present in the rear pitch.

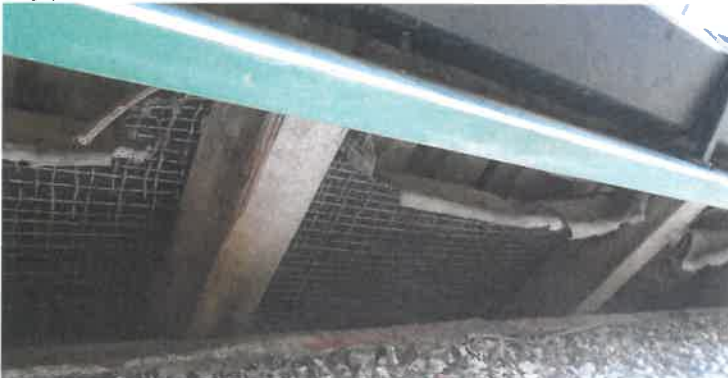
There is direct access into the garage via gaps between the rafters at the eaves. The tiles are tight fitting and do not provide any gaps or crevices, the verges are well pointed. The roof does not provide any potential roost habitat for bats.

grease marks or feeding remains particularly the garage eaves which are accessible. The result was negative, no evidence was found.

The lack of evidence and lack of potential access points or crevices at this property indicates that the disruption to the roof and demolition of the garage will not impact adversely on any local bat population nor is it likely that any bats will be uncovered or disturbed during the tile removal. It is not considered necessary to carry out an emergence survey nor is there a requirement for a mitigation scheme.
