# Dusk Survey Results Inclusive of a Preliminary Roost Assessment

September 2023

**The Manor Care Home**  
Chatburn  
Clitheroe  
BB7 4AW

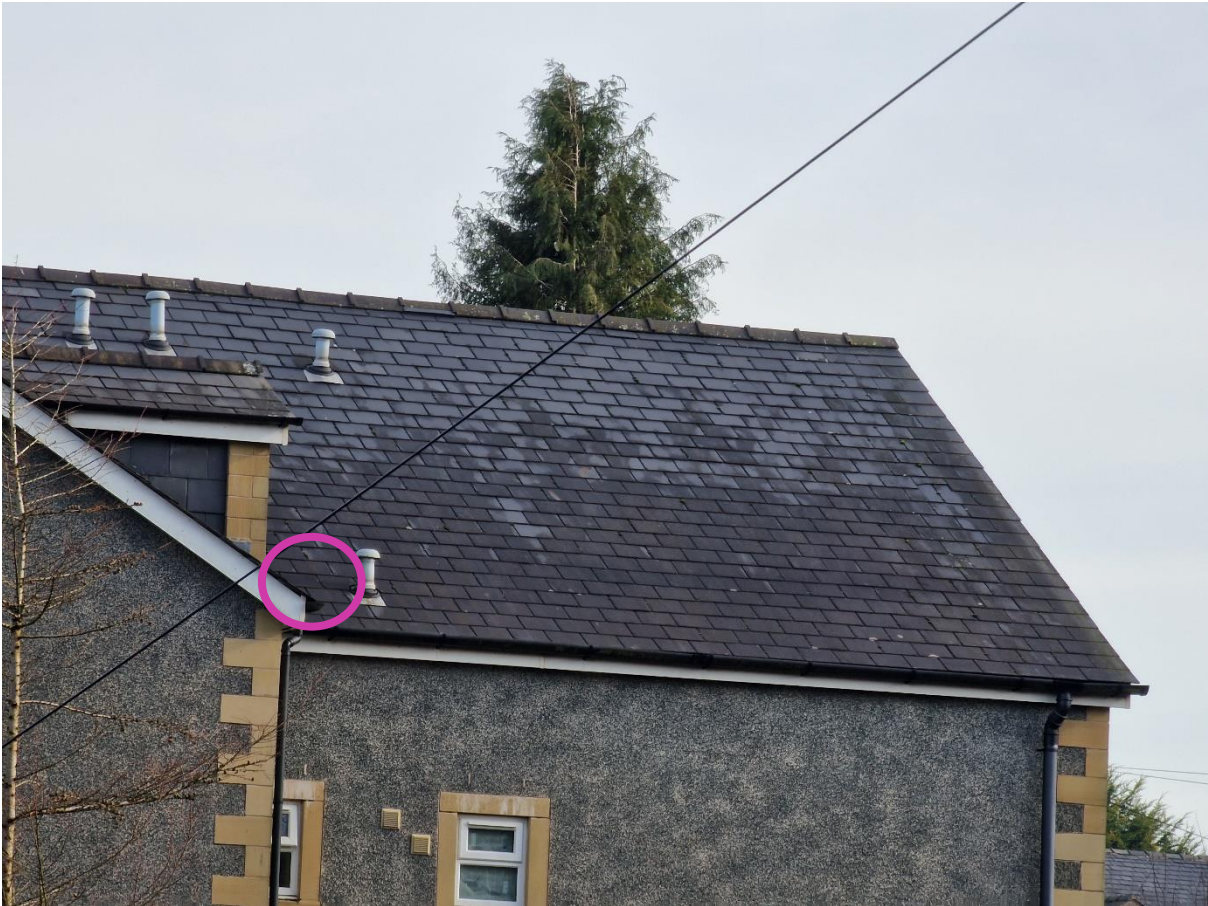
Figure 5.4 – Emergence Point 1 identified on the southwest elevation of the Manor Care Home

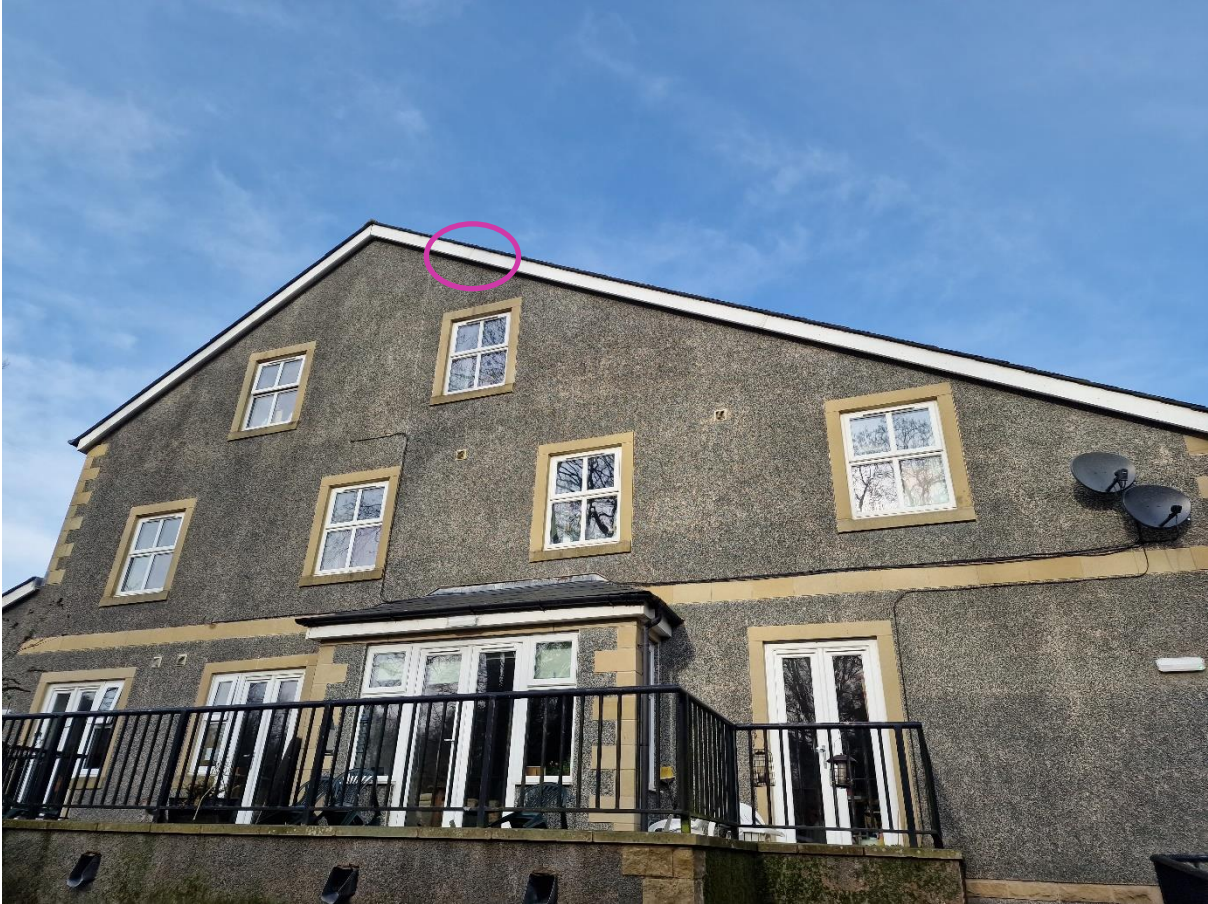
**Figure 5.5** – Emergence Point 2 identified on the southern elevation of the Manor Care Home

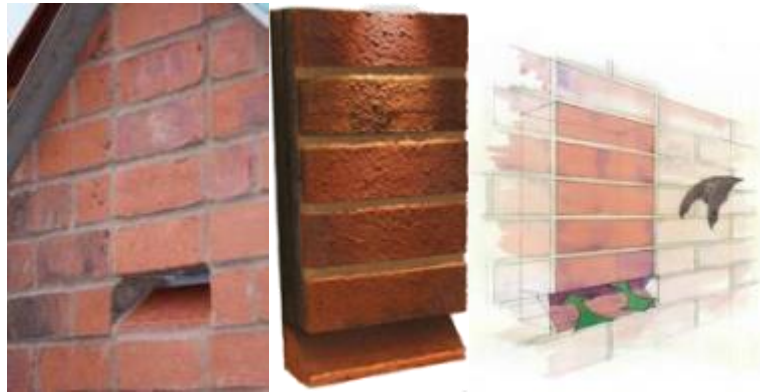
The Habibat Bat Box is a solid box made of insulating concrete with internal roosting space. The box blends seamlessly into brick-built properties and may be incorporated into the fabric of buildings, being best placed on gable elevations.

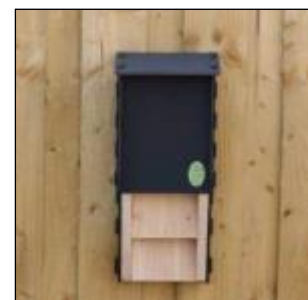
A large number of externally fitted box models for bats exist for buildings and trees. Suitable models for both buildings and trees may include the Eco Kent Bat Box, with more examples present online.

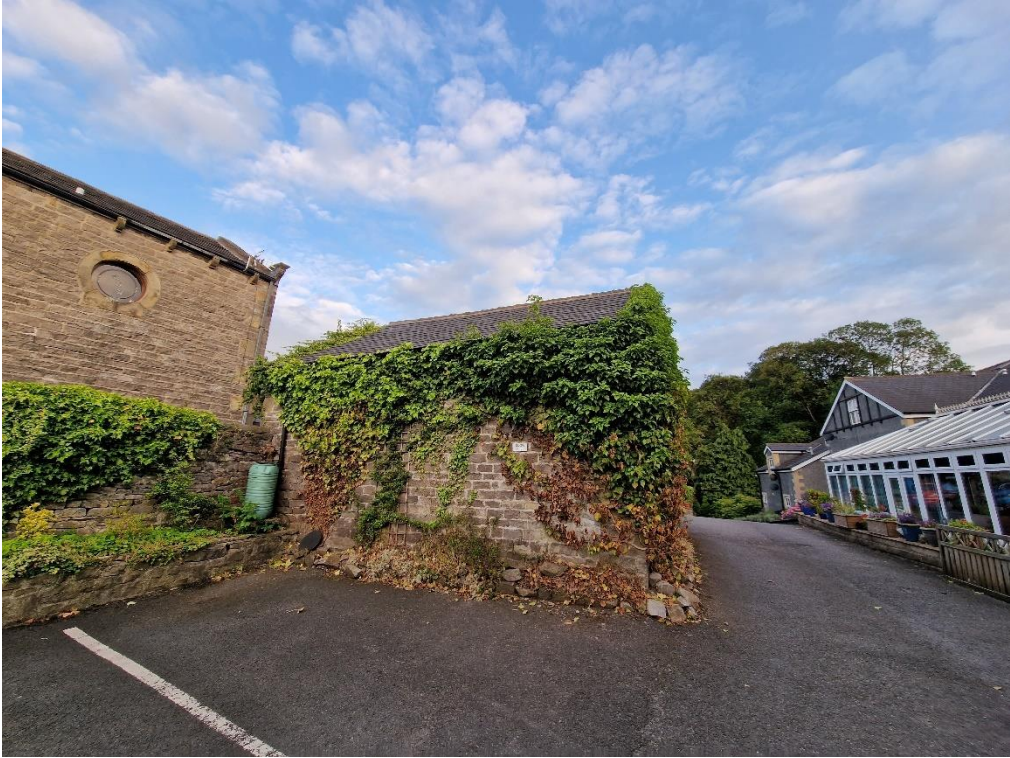
- 5.5 Externally, the building was found to be absent of any significant potential roost features (PRF's) that could provide ingress opportunities to bat species, with the roof appearing to be tight fitting, the wall being well-pointed and no significant gaps within the lintels or wooden barge boards; furthermore, an external security light was found to be present on the southern elevation. That being said, the western and northern aspects were noted as considerably ivy-clad, which may be obscuring PRFs. Therefore, solely on a precautionary basis the single story storage building has been duly categorised as pertaining to 'Low' bat roost potential in line with BCT Guidelines. Refer to **Appendix I** for photographs.

Photograph 1 – *The northern aspect of B2*

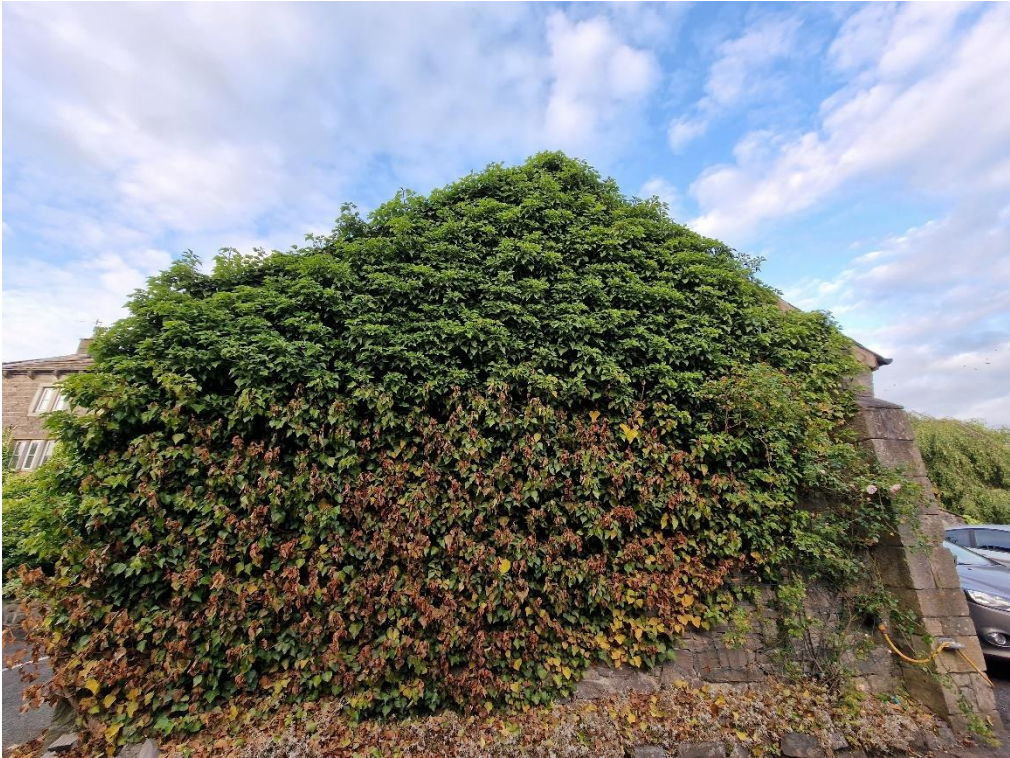
Photograph 2 – *The western aspect of B2*

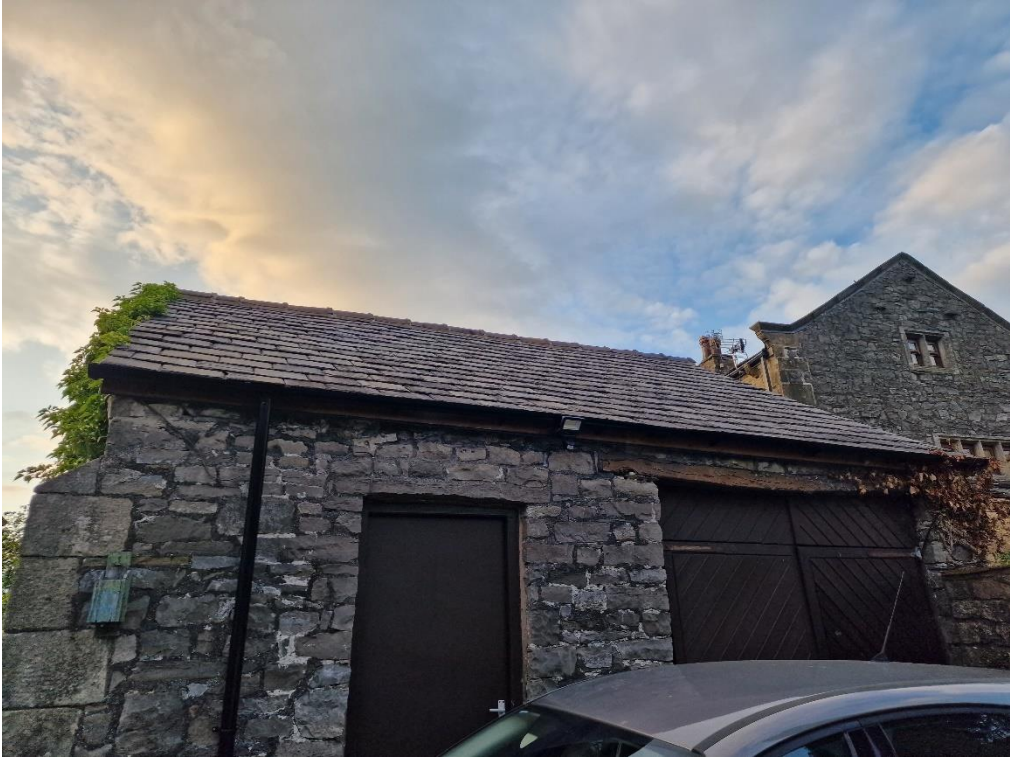
Photograph 3 – *The southern aspect of B2*

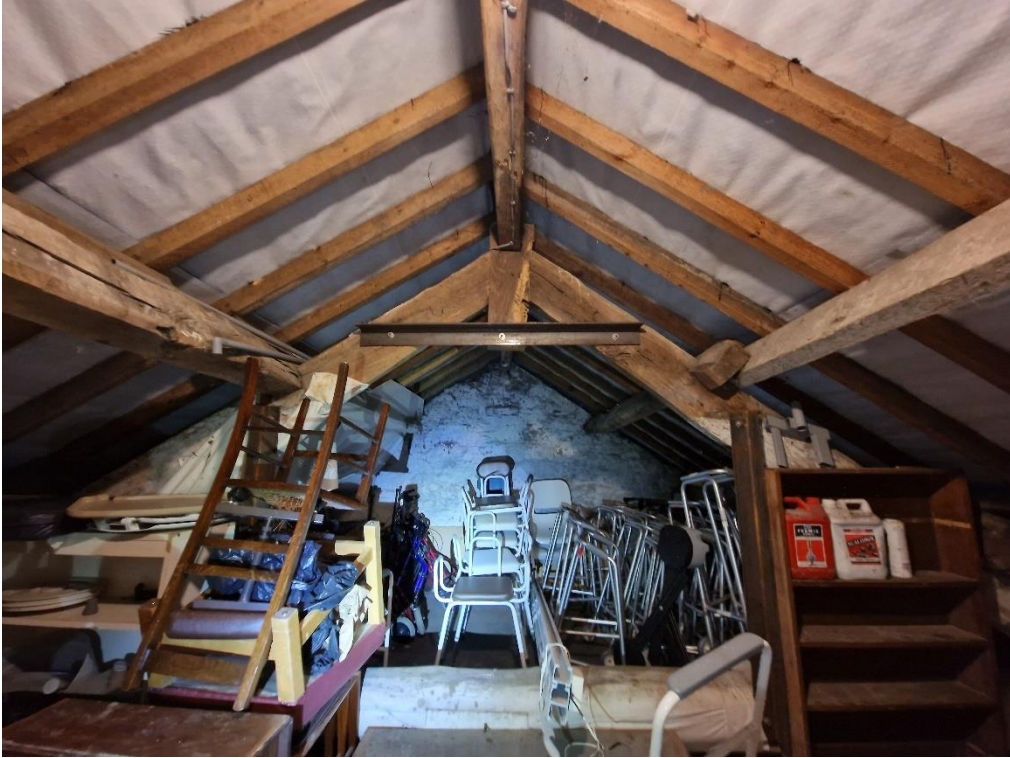
- 5.3 Internally the building comprised of a single storey layout with a ground and upper floor; the upper floor is open to the ridge and of a trussed construction with no loft void present. Breathable Roof Membrane is present beneath the slates and spans the extent of the roof. The upper floor, similar to that of the ground floor, is used for storage and as such is considered to be cluttered with paraphernalia. The internal conditions of the building were considered to be cool, draughty and dark, with cobwebbing present towards the apex of the ridge; a light is present and is not considered to be turned on at all times, but due to the buildings use for storage it is perceived that the light is utilised somewhat frequently.

Photograph 4 – *The internal character of B2*
