## **PRELIMINARY BAT ROOST ASSESSMENT**

**23 Rogersfield  
Langho  
Blackburn  
Lancashire**

November 2022

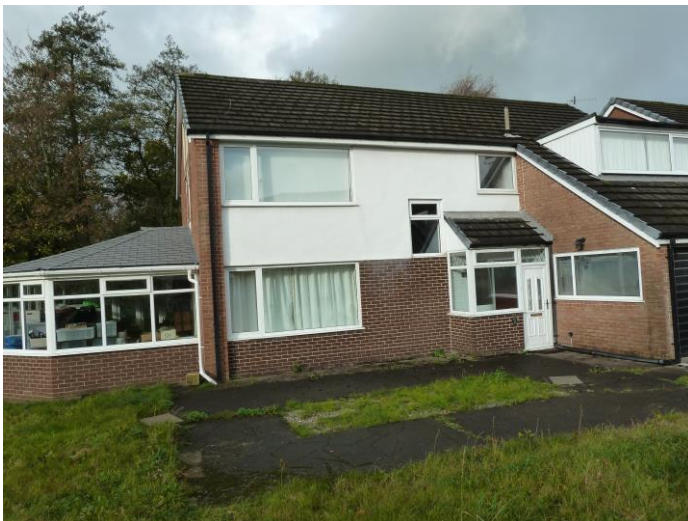
**Photograph 1: Front (east) elevation.**

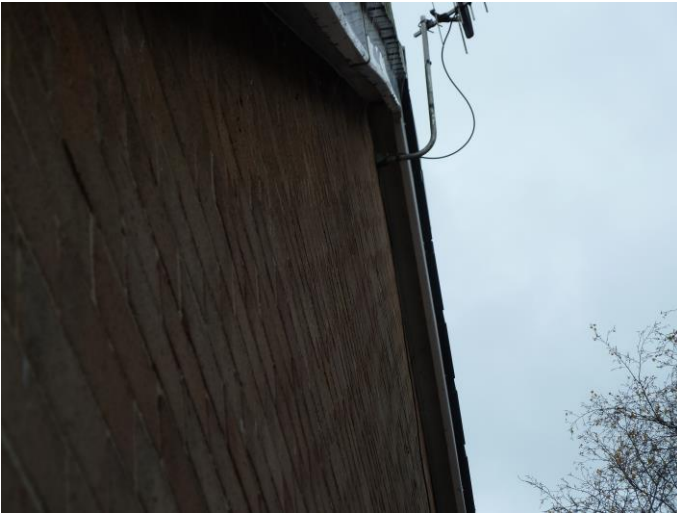
There are UPVC soffits throughout the property that fit tight to the wall with no gaps to allow bat ingress.

The roof verges have a dry verge system that also prevents bat ingress at the verge.

**Photograph 2: Typical view of the tight-fitting UPVC soffits on the north gable. Dry verge visible.**

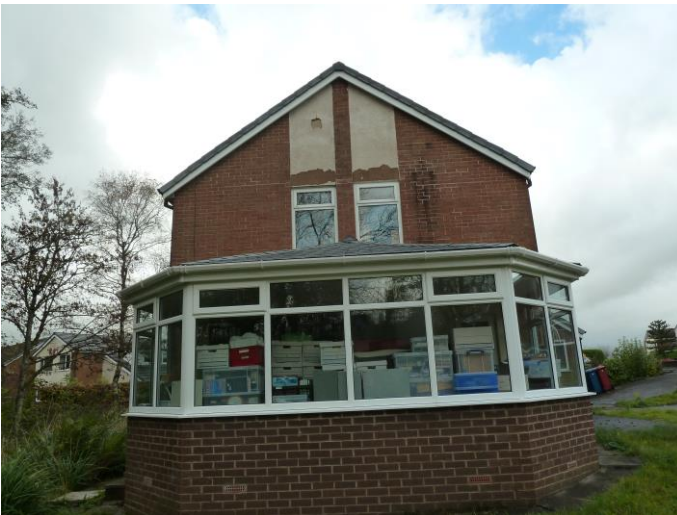
A conservatory extends off the south elevation which has a composite slate roof with matching ridge. The roof is in good condition with no gaps where bats might gain access.

A small area of decorative rendering on the south elevation has 'blown', creating a small gap where the thin outer layer of render has lifted from the base coat. However, the raised skin of blown render is cracked and fragile and is of no significance to roosting bats.

**Photograph 3: South elevation – conservatory with composite slate roof. Blown render visible above.**

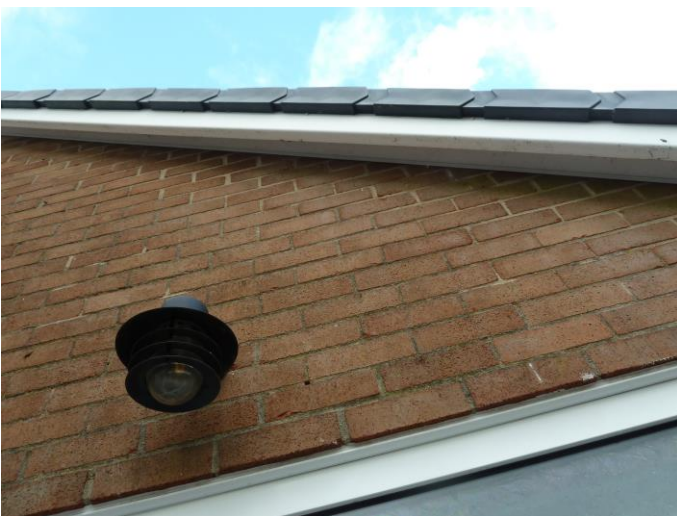
**Photograph 4: General view of the dry verge and UPVC soffits with no means of bat ingress.**

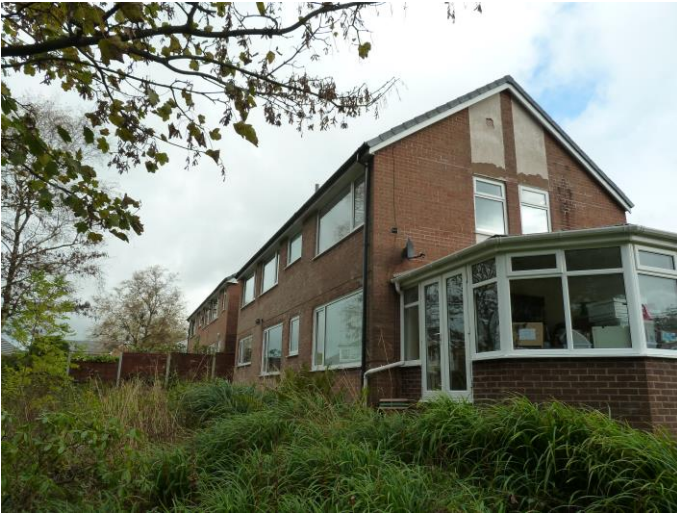
**Photograph 5: Typical view of the rear (west) and south gable elevations.**

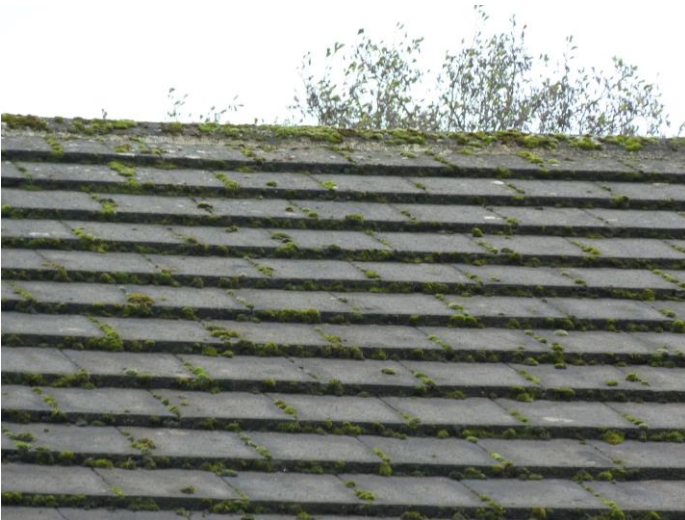
The roof of the house is in good condition with no missing or slipped tiles and the ridge tiles are mortared into place and neatly pointed. There are no gaps that might potentially allow bat ingress into the roof space.

**Photograph 6: Typical view of the roof which is in good condition with no gaps.**
