Your Ref:  
Our Ref: 8336

**RE: SCOPING BAT SURVEY**  
**LOCATION: SMITHIES BRIDGE FARM, CLITHEROE**  
**PROPOSAL: REMOVAL OF EXISTING LIVESTOCK SHELTER STRUCTURE TO BE REPLACED BY NEW AGRICULTURAL BUILDING**

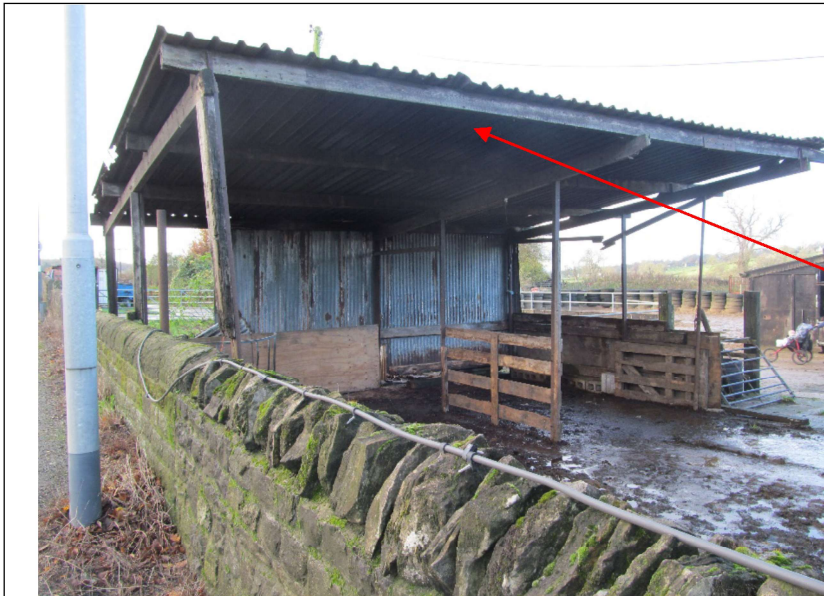
The structure is made from sheet metal panels over a steel frame with timber joists

The structure is made from single skin sheet metal panels with some timber boards at ground level. The frame is made from steel with timber joists to support the roof panels. The roof panels are loose fitting and three of the sides to the structure are missing. There were no enclosed voids, cavities or crevices in the entire structure that could provide safe or suitable roosting potential for bats.

Overall the structure has no potential for roosting bats. No evidence of bats has been found at the site.

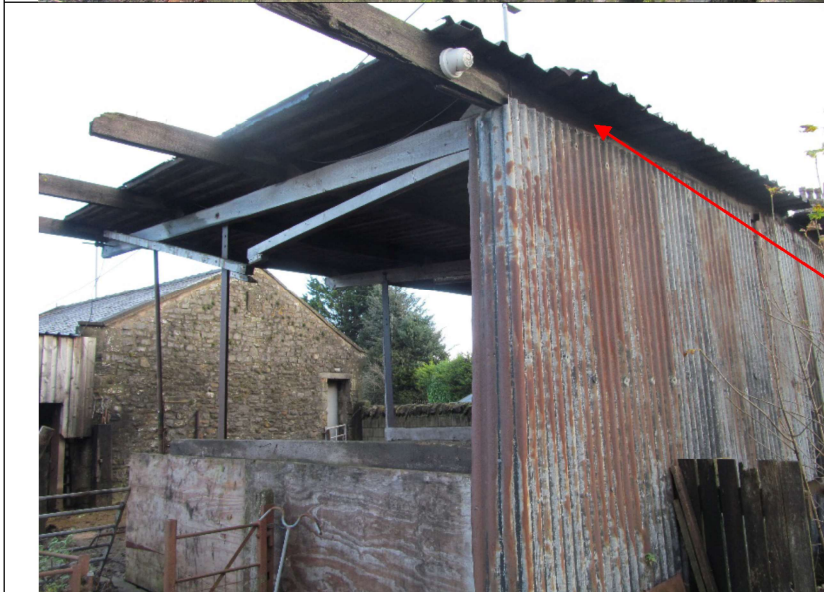
There were no enclosed voids, crevices or cracks in any part of the structure

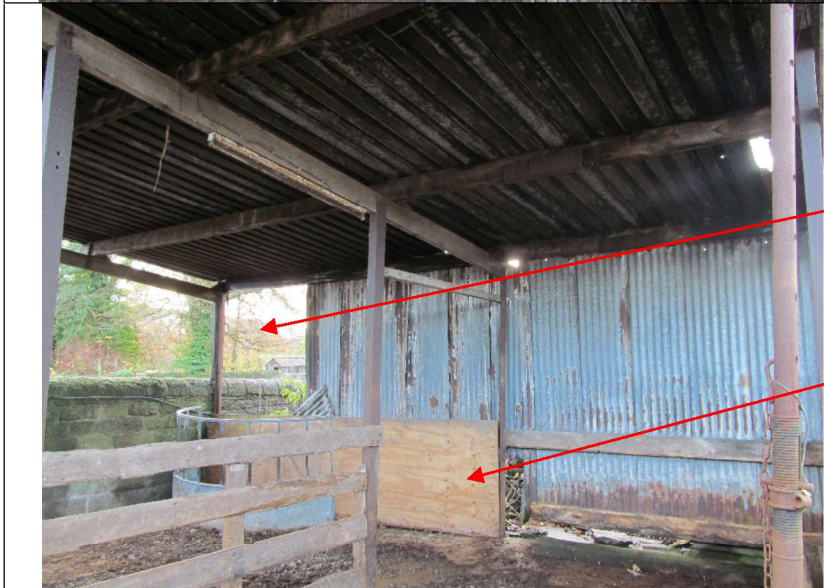
The internal space is extremely light, draughty and exposed due to the missing three sides and poor fitting roof

There were no bats present and no past evidence on any surfaces on or inside the structure

The internal space is naturally extremely light and draughty from the open sides and poor fitting roof.

There were no bats present and no past evidence on any of the surfaces inside or on the structure such as droppings, urine staining or prey items.

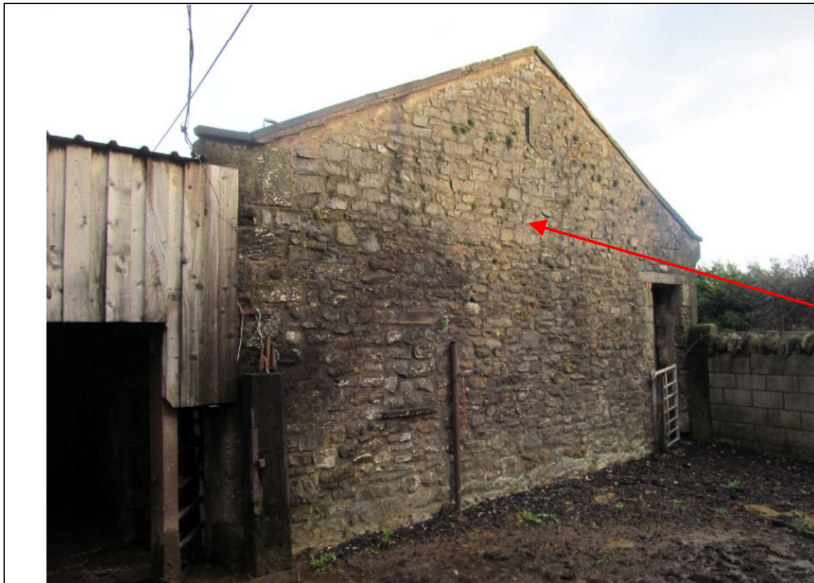
The adjacent building that the proposed structure will adjoin is fully pointed across the entire gable elevation

The gable end of the adjacent barn that the proposed new structure will adjoin was found to be fully pointed across the entire elevation. The proposed new building will stand alone and be structurally independent of this.
