Schedule of Photographs Brennands Endowed Primary School

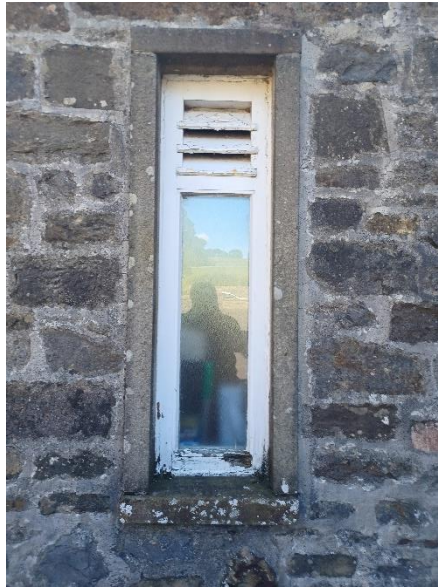
Window TW 01

Timber frame is Wrotten at the bottom and part timber stiles

Complete timber window to be removed and replaced with PVCu Casement Frame window with a Vent Axia extractor.

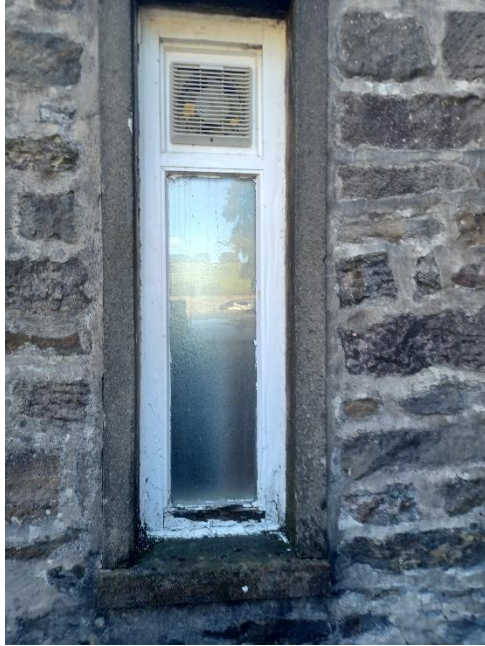
Window TW 02

Timber frame is Wrotten at the bottom and part timber stiles

Complete timber window to be removed and replaced with PVCu Casement Frame window with a Vent Axia extractor.

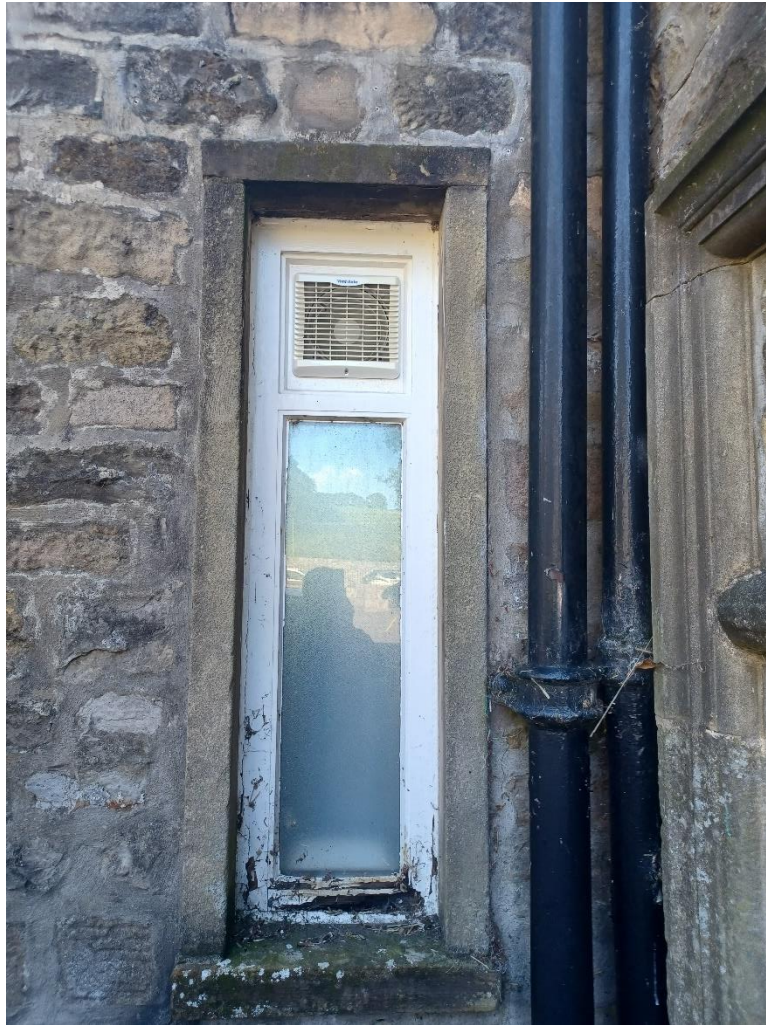
Window TW 03

Timber frame is Wrotten at the bottom and part timber stiles

Complete timber window to be removed and replaced with PVCu Casement Frame window with a Vent Axia extractor.

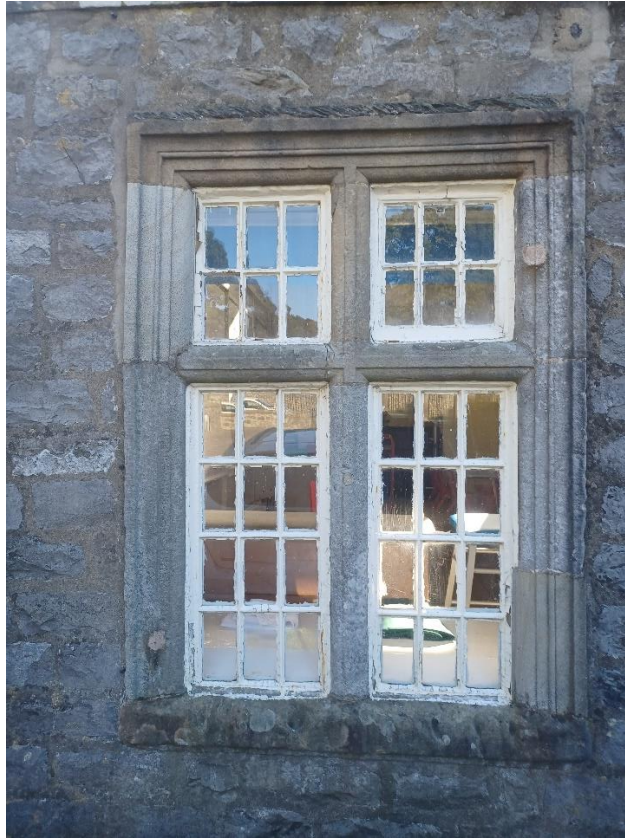
GF 01

Existing Period Metal Frame window Single Glazing

- Carefully remove the existing glazing;
- Metal framework to be rubbed down and new metal paint applied to prevent further rust appearing and make any necessary repairs to the framework;
- Clean all the paint off the existing glazing;
- Refurbish the existing opening light to enable the top light to open to allow fresh air to enter the hall;
- Replace any damaged glazing with suitable restoration glass. Also include for the replacement of 17Nr Obscure glazing panes (Allow 10%);
- Coat the existing framework with new Metal paint to prolong the life of the windows, colour to be an Off White;
- Reglaze the window with new Linseed Oil Putty
- Seal the existing window with approved Mastic Sealant.

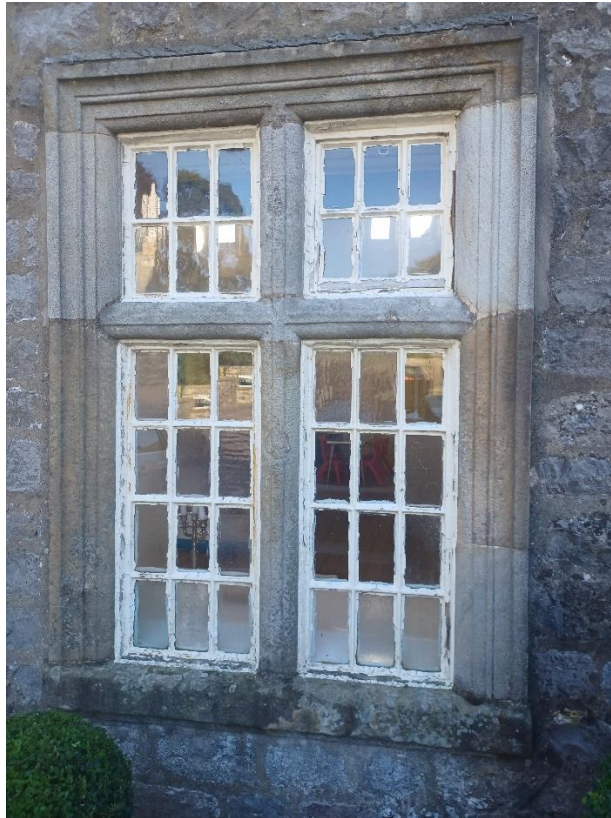
GF 02

Existing Period Metal Frame window Single Glazing
Single glazed timber Top Opening Light

- Carefully remove the existing glazing;
- Metal framework to be rubbed down and new metal paint applied to prevent further rust appearing and make any necessary repairs to the framework;
- Clean all the paint off the existing glazing;
- Repair & refurbish the existing Timber opening light to enable the top light to open to allow fresh air to enter the hall;
- Replace any damaged glazing with suitable restoration glass. Also include for the replacement of 10Nr Obscure glazing panes (Allow 10%);
- Coat the existing framework with new Metal paint to prolong the life of the windows, colour to be an Off White;
- Reglaze the window with new Linseed Oil Putty
- Seal the existing window with approved Mastic Sealant;

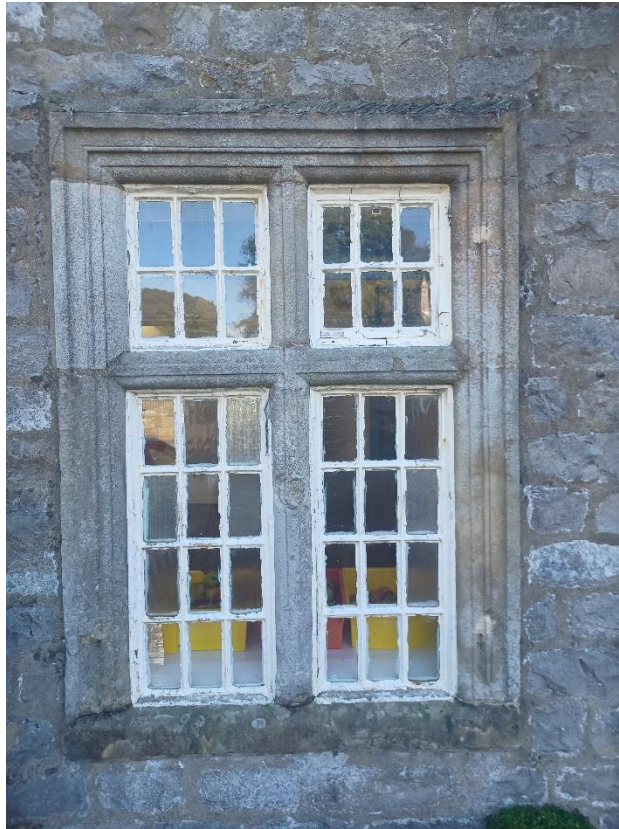
GF 03

Existing Period Metal Frame window Single Glazing
Single glazed timber Top Opening Light

- Carefully remove the existing glazing;
- Metal framework to be rubbed down and new metal paint applied to prevent further rust appearing and make any necessary repairs to the framework;
- Clean all the paint off the existing glazing;
- Repair & refurbish the existing Timber opening light to enable the top light to open to allow fresh air to enter the hall;
- Replace any damaged glazing with suitable restoration glass. Also include for the replacement of 6Nr Obscure glazing panes (Allow 10%);
- Coat the existing framework with new Metal paint to prolong the life of the windows, colour to be an Off White;
- Reglaze the window with new Linseed Oil Putty
- Seal the existing window with approved Mastic Sealant;

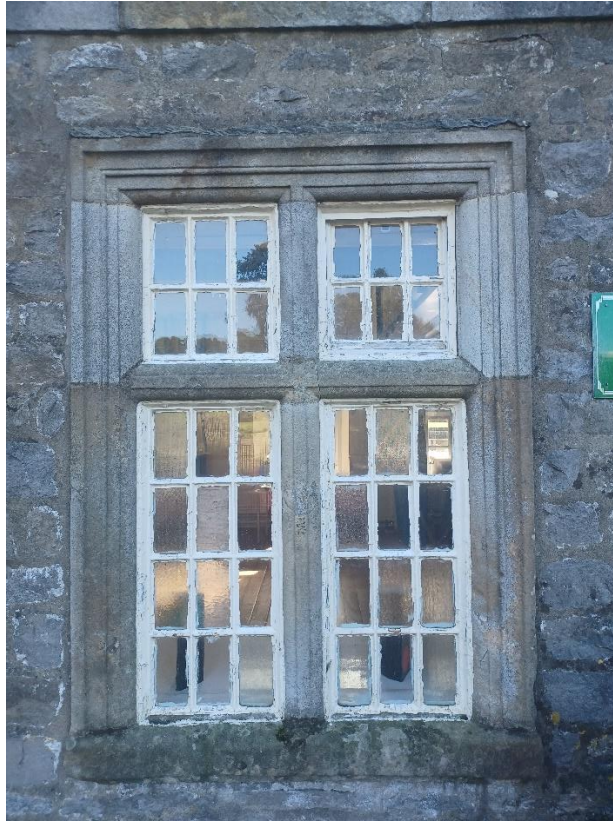
GF 04

Existing Period Metal Frame window Single Glazing
Single glazed timber Top Opening Light

- Carefully remove the existing glazing;
- Metal framework to be rubbed down and new metal paint applied to prevent further rust appearing and make any necessary repairs to the framework;
- Clean all the paint off the existing glazing;
- Repair & refurbish the existing Timber opening light to enable the top light to open to allow fresh air to enter the hall;
- Replace any damaged glazing with suitable restoration glass. Also include for the replacement of 12Nr Obscure glazing panes (Allow 10%);
- Coat the existing framework with new Metal paint to prolong the life of the windows, colour to be an Off White;
- Reglaze the window with new Linseed Oil Putty
- Seal the existing window with approved Mastic Sealant;

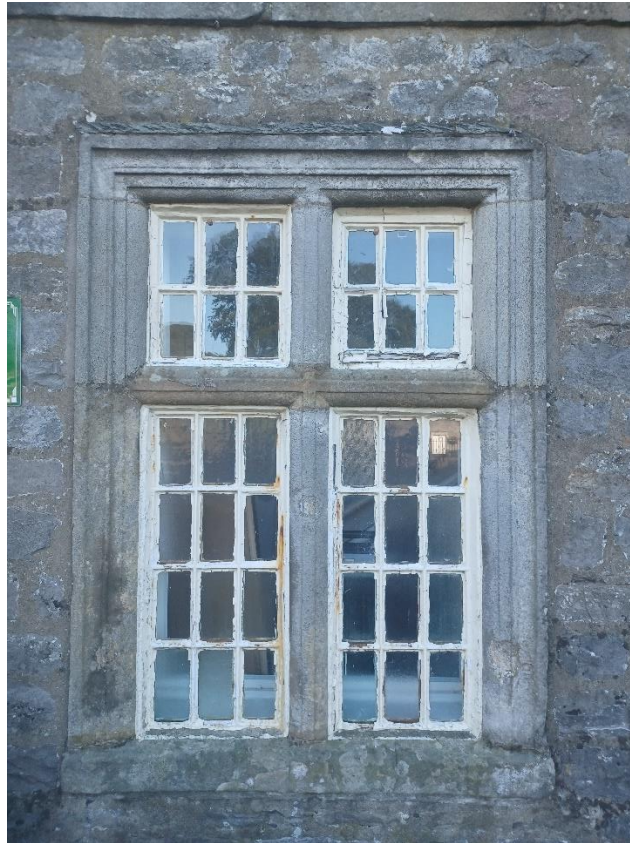
GF 05

Existing Period Metal Frame window Single Glazing
Single glazed timber Top Opening Light

- Carefully remove the existing glazing;
- Metal framework to be rubbed down and new metal paint applied to prevent further rust appearing and make any necessary repairs to the framework;
- Clean all the paint off the existing glazing;
- Repair & refurbish the existing Timber opening light to enable the top light to open to allow fresh air to enter the hall;
- Replace any damaged glazing with suitable restoration glass. Also include for the replacement of 8Nr Obscure glazing panes (Allow 10%);
- Coat the existing framework with new Metal paint to prolong the life of the windows, colour to be an Off White;
- Reglaze the window with new Linseed Oil Putty
- Seal the existing window with approved Mastic Sealant;

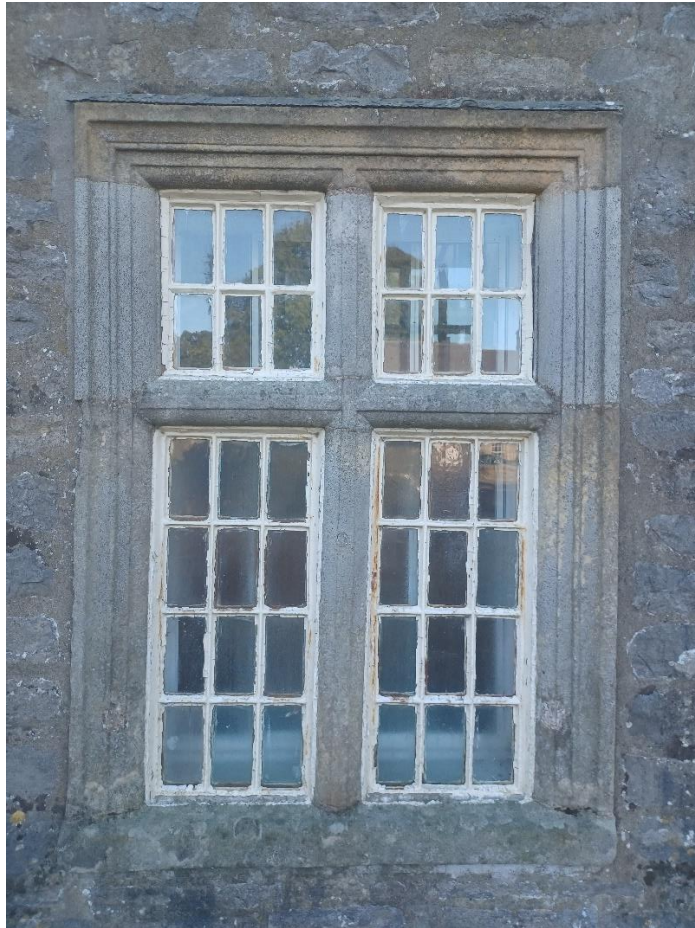
GF 06

Existing Period Metal Frame window Single Glazing

- Carefully remove the existing glazing;
- Metal framework to be rubbed down and new metal paint applied to prevent further rust appearing and make any necessary repairs to the framework;
- Clean all the paint off the existing glazing;
- Replace any damaged glazing with suitable restoration glass. Also include for the replacement of 20Nr Obscure glazing panes (Allow 10%);
- Coat the existing framework with new Metal paint to prolong the life of the windows, colour to be an Off White;
- Reglaze the window with new Linseed Oil Putty
- Seal the existing window with approved Mastic Sealant;

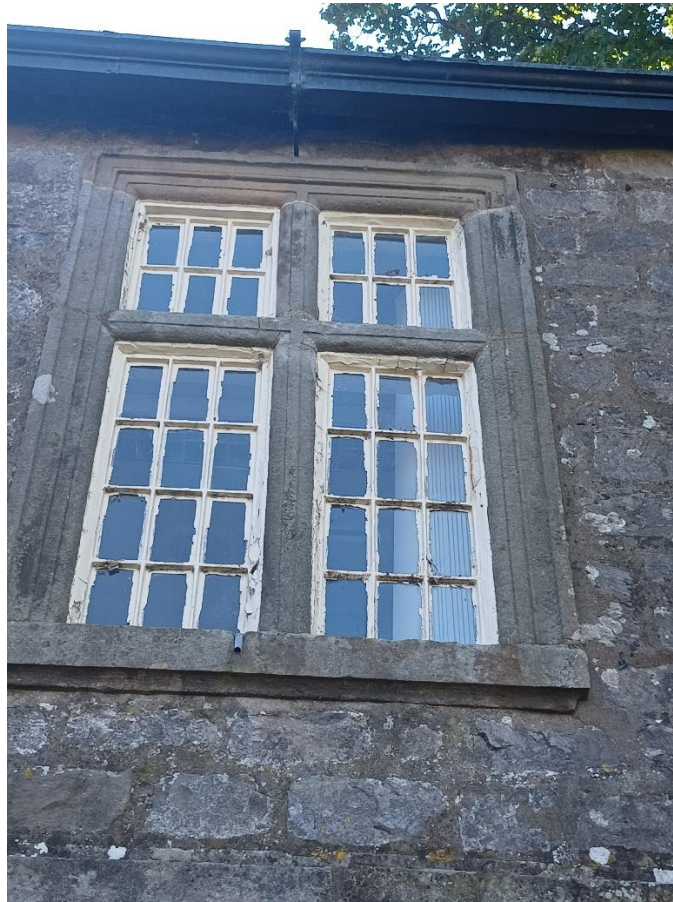
FF 01

Existing Period Metal Frame window Single Glazing

- Carefully remove the existing glazing;
- Metal framework to be rubbed down and new metal paint applied to prevent further rust appearing and make any necessary repairs to the framework;
- Clean all the paint off the existing glazing;
- Replace any damaged glazing with suitable restoration glass. (Allow 10%);
- Coat the existing framework with new Metal paint to prolong the life of the windows, colour to be an Off White;
- Reglaze the window with new Linseed Oil Putty
- Seal the existing window with approved Mastic Sealant;

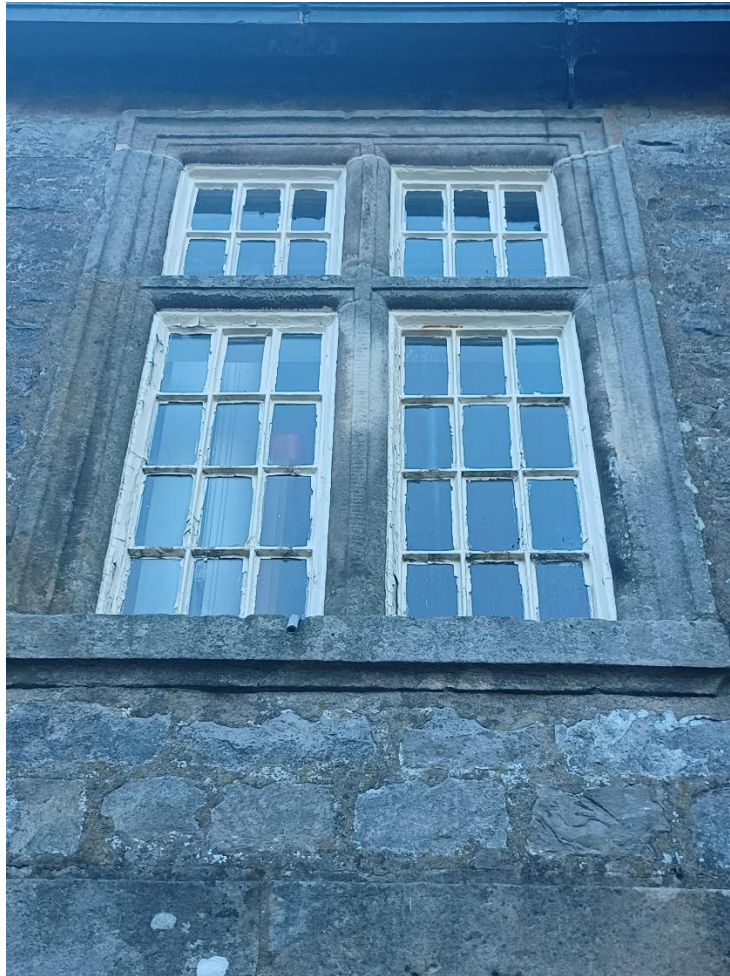
FF 02

Existing Period Metal Frame window Single Glazing

- Carefully remove the existing glazing;
- Metal framework to be rubbed down and new metal paint applied to prevent further rust appearing and make any necessary repairs to the framework;
- Clean all the paint off the existing glazing;
- Replace any damaged glazing with suitable restoration glass. (Allow 10%);
- Coat the existing framework with new Metal paint to prolong the life of the windows, colour to be an Off White;
- Reglaze the window with new Linseed Oil Putty
- Seal the existing window with approved Mastic Sealant;

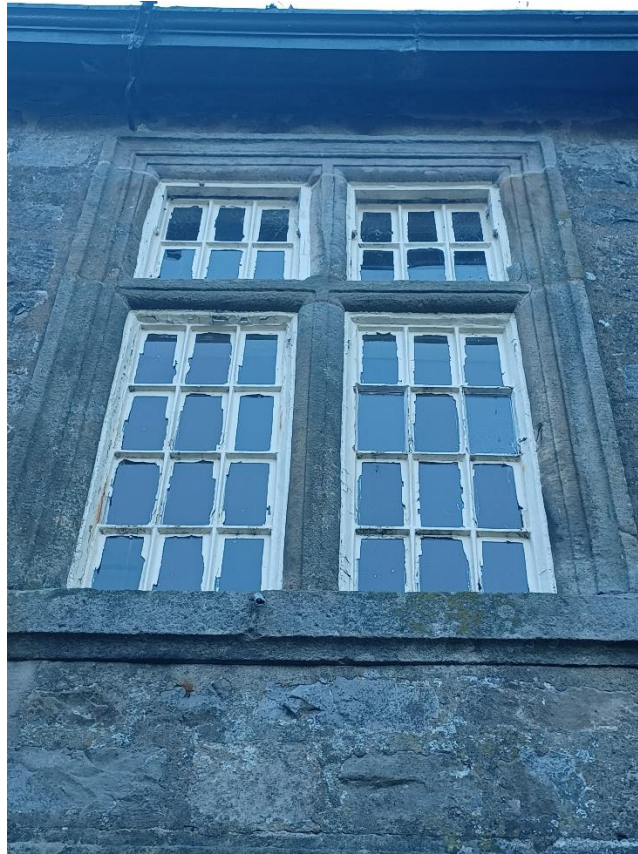
FF 03

Existing Period Metal Frame window Single Glazing
2Nr Single glazed Top Opening Light

- Carefully remove the existing glazing;
- Metal framework to be rubbed down and new metal paint applied to prevent further rust appearing and make any necessary repairs to the framework;
- Clean all the paint off the existing glazing;
- Repair & refurbish the existing Metal opening light to enable the top lights to open to allow fresh air to enter the hall;
- Replace any damaged glazing with suitable restoration glass. (Allow 10%);
- Coat the existing framework with new Metal paint to prolong the life of the windows, colour to be an Off White;
- Reglaze the window with new Linseed Oil Putty
- Seal the existing window with approved Mastic Sealant;

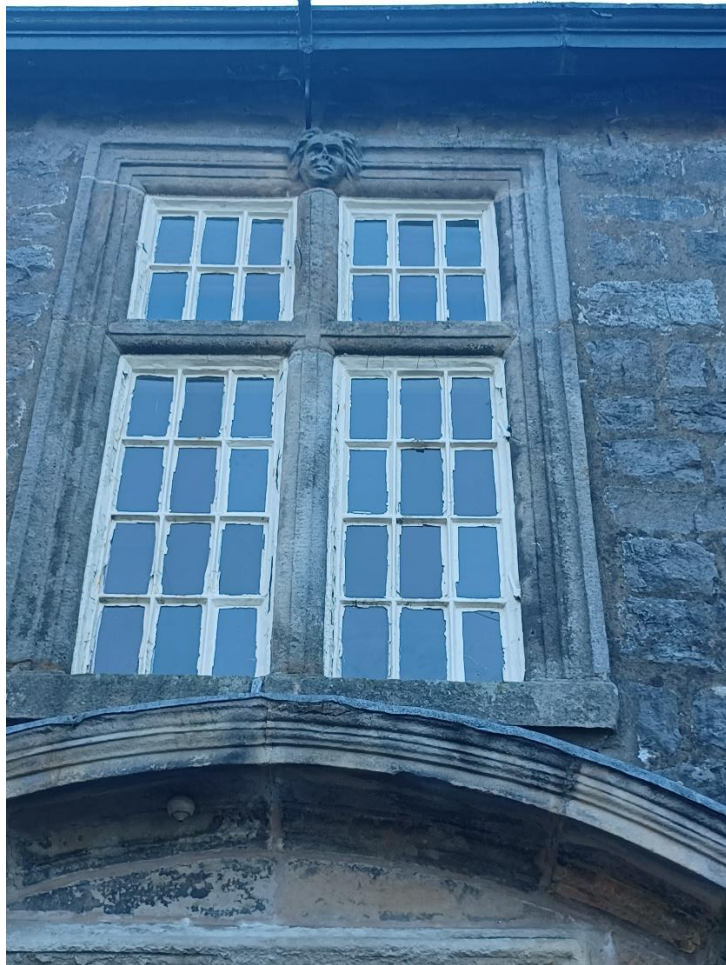
FF 04

Existing Period Metal Frame window Single Glazing

- Carefully remove the existing glazing;
- Metal framework to be rubbed down and new metal paint applied to prevent further rust appearing and make any necessary repairs to the framework;
- Clean all the paint off the existing glazing;
- Replace any damaged glazing with suitable restoration glass. (Allow 10%);
- Coat the existing framework with new Metal paint to prolong the life of the windows, colour to be an Off White;
- Reglaze the window with new Linseed Oil Putty
- Seal the existing window with approved Mastic Sealant;

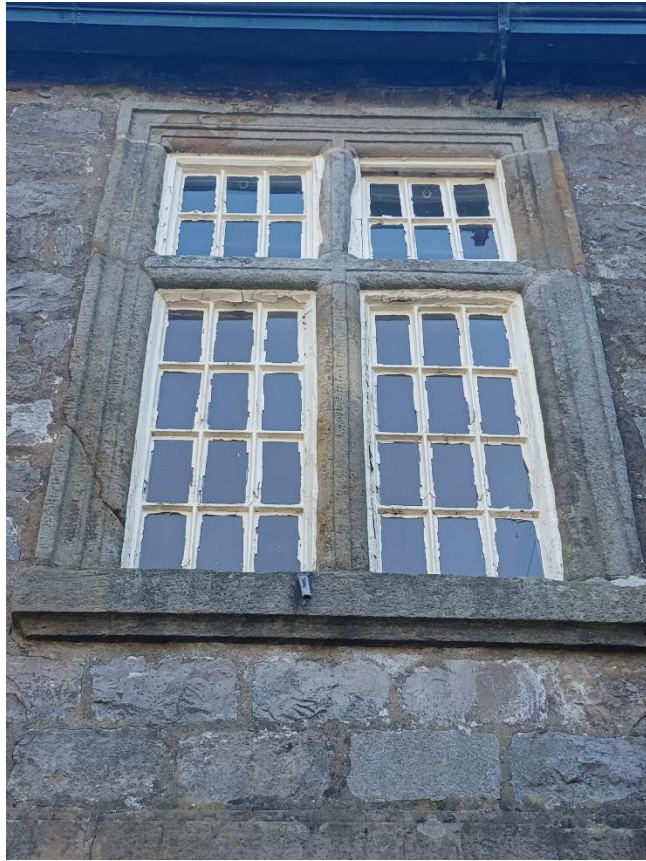
FF 05

Existing Period Metal Frame window Single Glazing
2Nr Single glazed Top Opening Light

- Carefully remove the existing glazing;
- Metal framework to be rubbed down and new metal paint applied to prevent further rust appearing and make any necessary repairs to the framework;
- Clean all the paint off the existing glazing;
- Repair & refurbish the existing Metal opening light to enable the top lights to open to allow fresh air to enter the hall;
- Replace any damaged glazing with suitable restoration glass. (Allow 10%);
- Coat the existing framework with new Metal paint to prolong the life of the windows, colour to be an Off White;
- Reglaze the window with new Linseed Oil Putty
- Seal the existing window with approved Mastic Sealant;

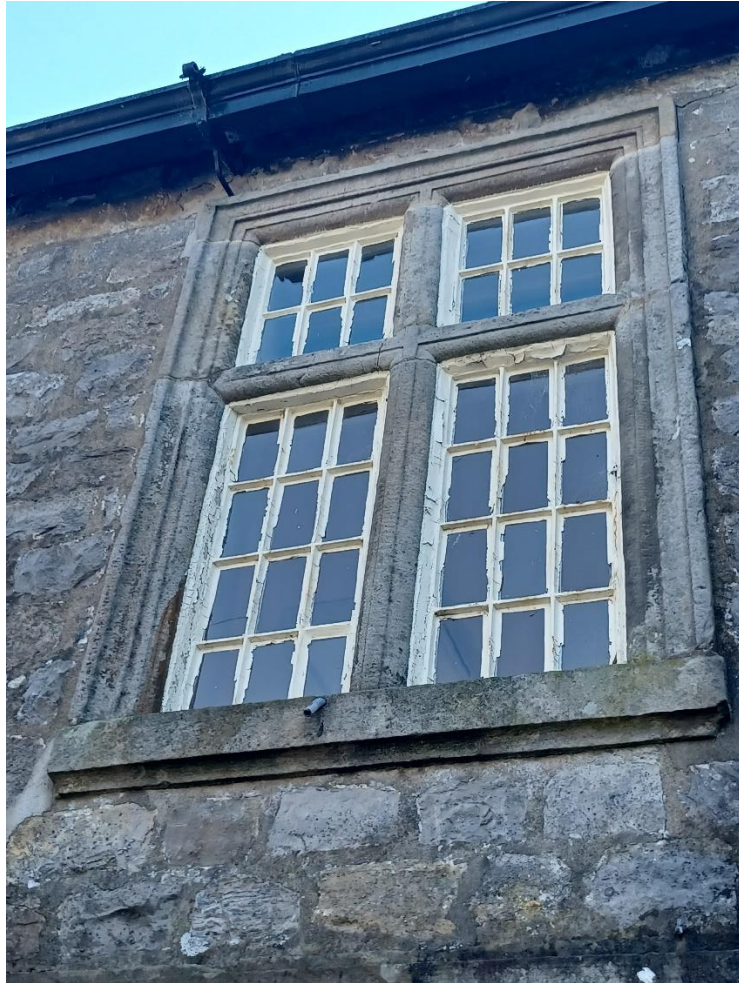
FF 06

Existing Period Metal Frame window Single Glazing

- Carefully remove the existing glazing;
- Metal framework to be rubbed down and new metal paint applied to prevent further rust appearing and make any necessary repairs to the framework;
- Clean all the paint off the existing glazing;
- Replace any damaged glazing with suitable restoration glass. (Allow 10%);
- Coat the existing framework with new Metal paint to prolong the life of the windows, colour to be an Off White;
- Reglaze the window with new Linseed Oil Putty
- Seal the existing window with approved Mastic Sealant;

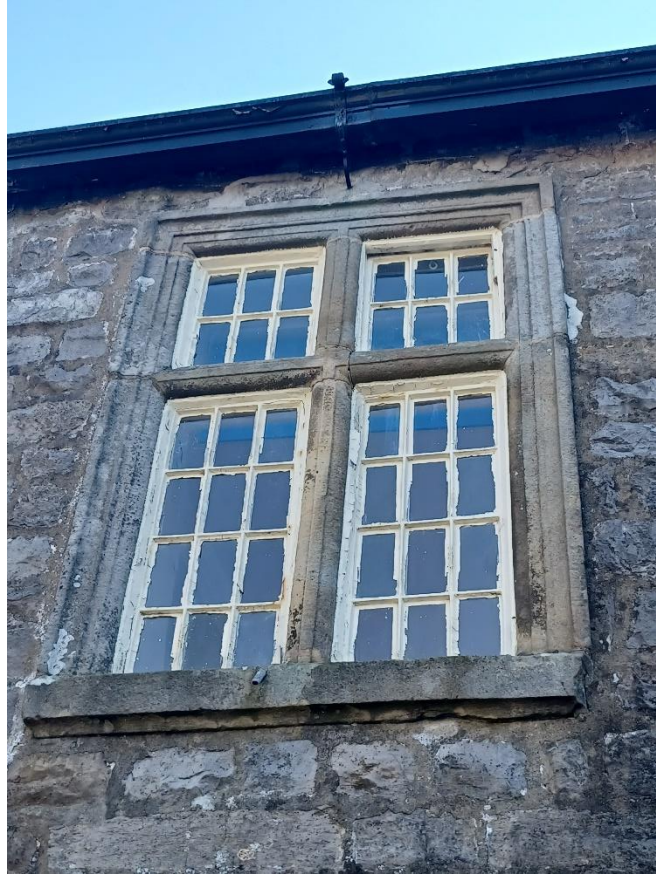
FF 07

Existing Period Metal Frame window Single Glazing
1Nr Single glazed Top Opening Light

- Carefully remove the existing glazing;
- Metal framework to be rubbed down and new metal paint applied to prevent further rust appearing and make any necessary repairs to the framework;
- Clean all the paint off the existing glazing;
- Repair & refurbish the existing Metal opening light to enable the top lights to open to allow fresh air to enter the hall;
- Replace any damaged glazing with suitable restoration glass. (Allow 10%);
- Coat the existing framework with new Metal paint to prolong the life of the windows, colour to be an Off White;
- Reglaze the window with new Linseed Oil Putty
- Seal the existing window with approved Mastic Sealant;

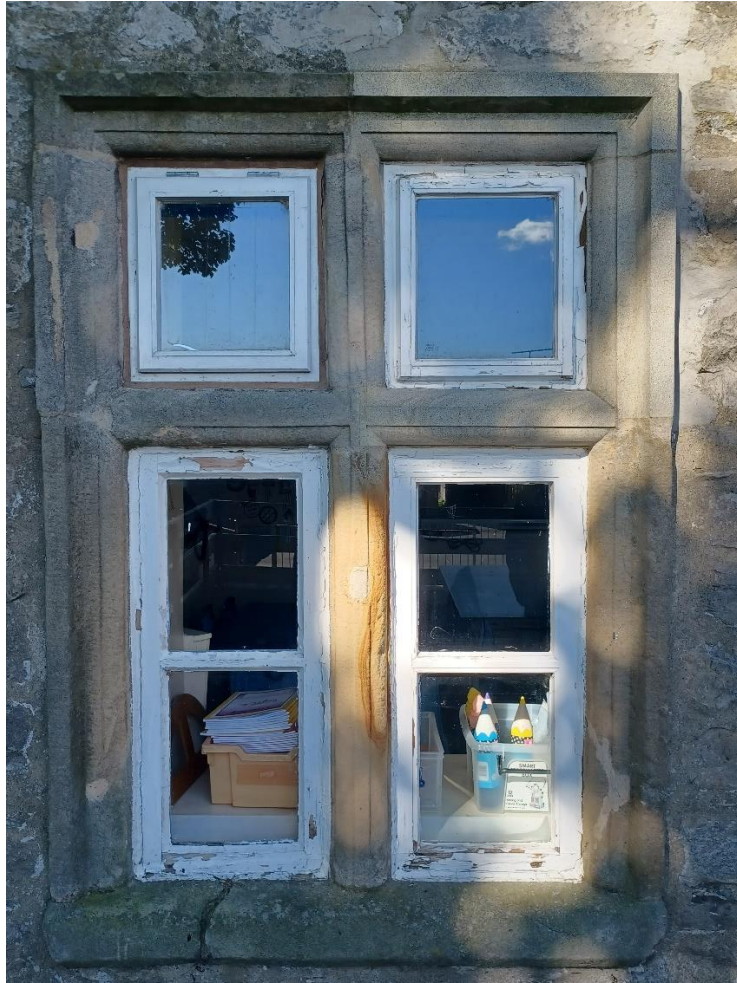
GFR 01

Existing Timber Frame window Single Glazing
2Nr Single glazed Top Opening Light

- Replace the existing Timber framed windows with new Double glazed windows with Side Opening Casements and Top Lights
- The new windows to be coated in an External grade Timber paint, colour to be an Off White;
- Glazing to be bedded in Linseed Oil Putty
- Seal the existing window with approved Mastic Sealant;

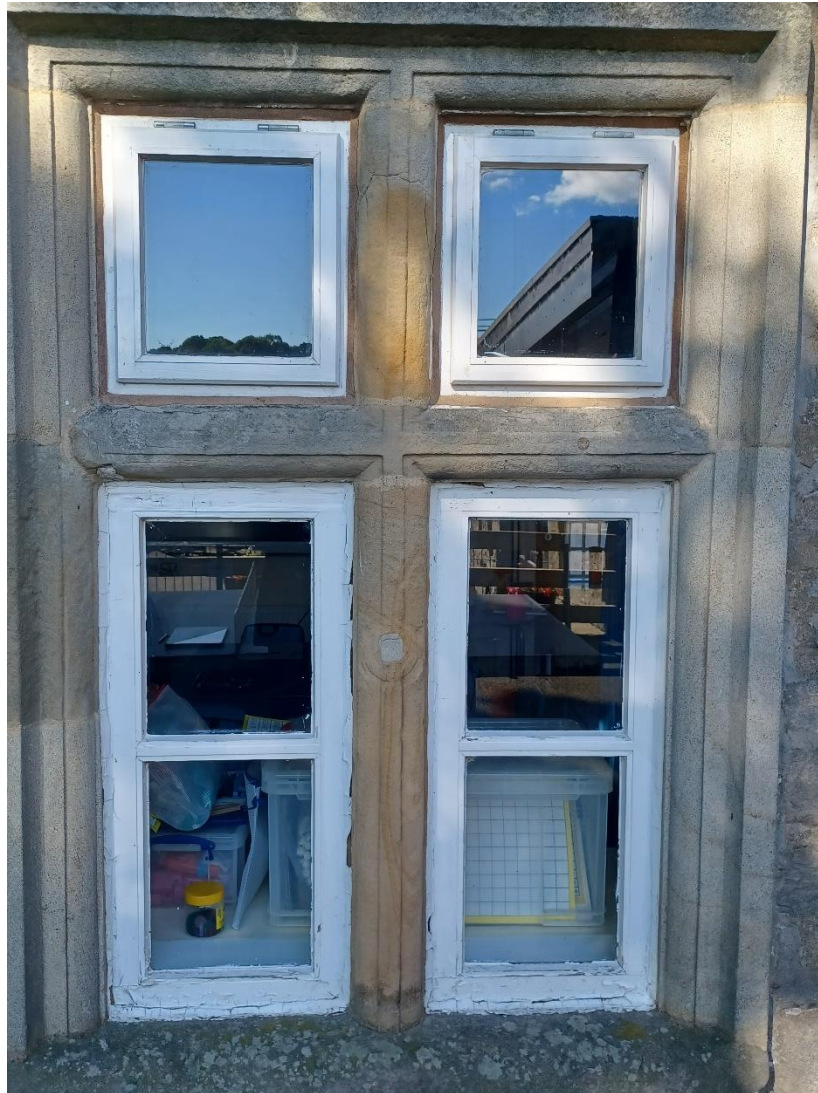
GFR 02

Existing Timber Frame window Single Glazing
2Nr Single glazed Top Opening Light

- Replace the existing Timber framed windows with new Double glazed windows with Side Opening Casements and Top Lights
- The new windows to be coated in an External grade Timber paint, colour to be an Off White;
- Glazing to be bedded in Linseed Oil Putty
- Seal the existing window with approved Mastic Sealant;

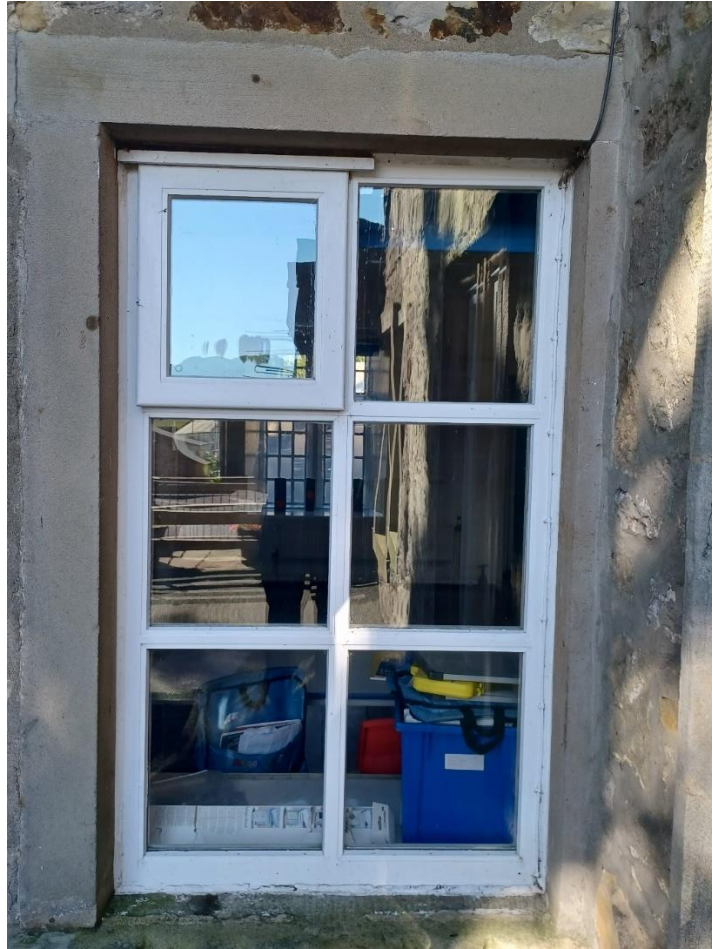
GFR 03

Existing Timber Frame window Single Glazing
1Nr Single glazed Top Opening Light

- Replace the existing Timber framed windows with new Double glazed windows with Side Opening Casements and Top Lights
- Due to the Stone surround missing a Mullion & Transom the window will be slightly different design;
- The new windows to be coated in an External grade Timber paint, colour to be an Off White;
- Glazing to be bedded in Linseed Oil Putty
- Seal the existing window with approved Mastic Sealant;

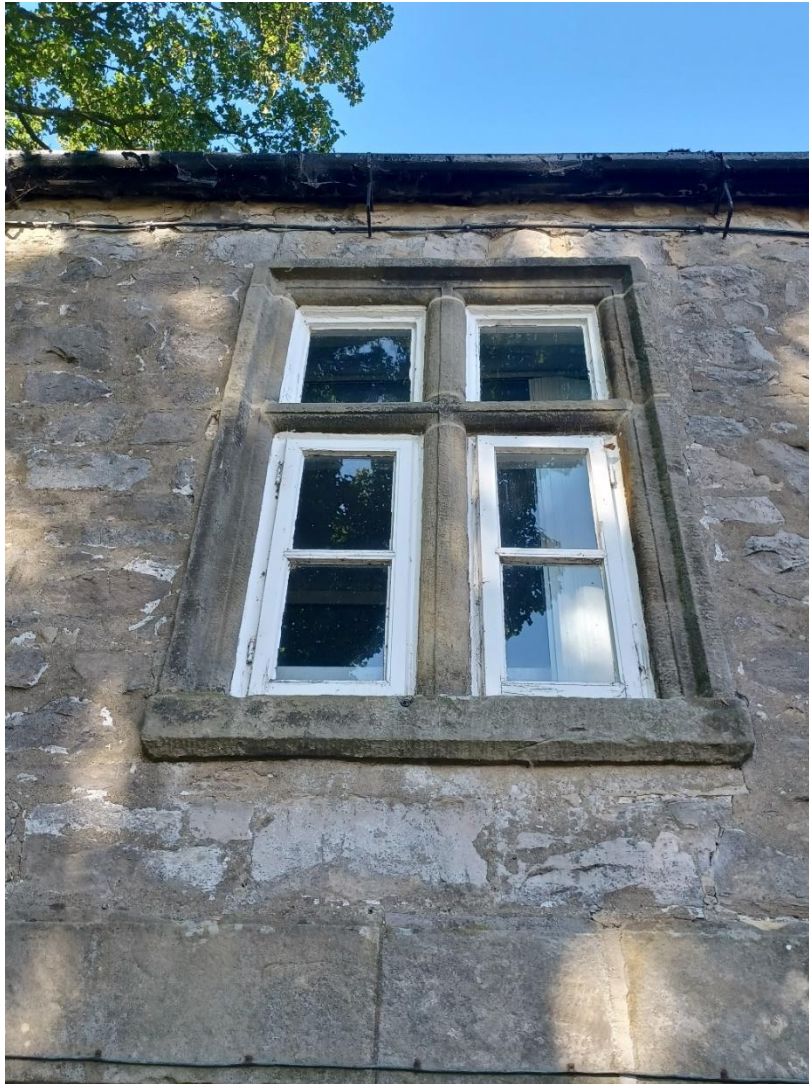
FFR 01

Existing Timber Frame window Single Glazing
2Nr Single glazed Side Opening Light

- Replace the existing Timber framed windows with new Double glazed windows with Side Opening Casements and Top Lights
- The new windows to be coated in an External grade Timber paint, colour to be an Off White;
- Glazing to be bedded in Linseed Oil Putty
- Seal the existing window with approved Mastic Sealant;

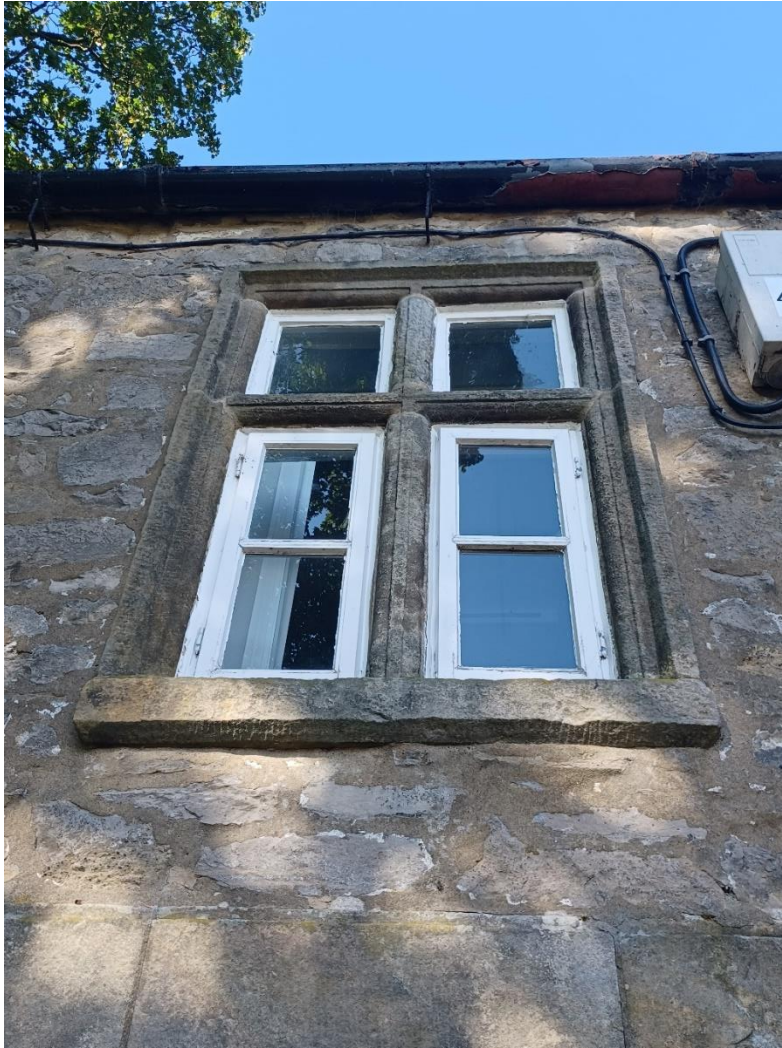
FFR 02

Existing Timber Frame window Single Glazing
2Nr Single glazed Side Opening Light

- Replace the existing Timber framed windows with new Double glazed windows with Side Opening Casements and Top Lights
- The new windows to be coated in an External grade Timber paint, colour to be an Off White;
- Glazing to be bedded in Linseed Oil Putty
- Seal the existing window with approved Mastic Sealant;

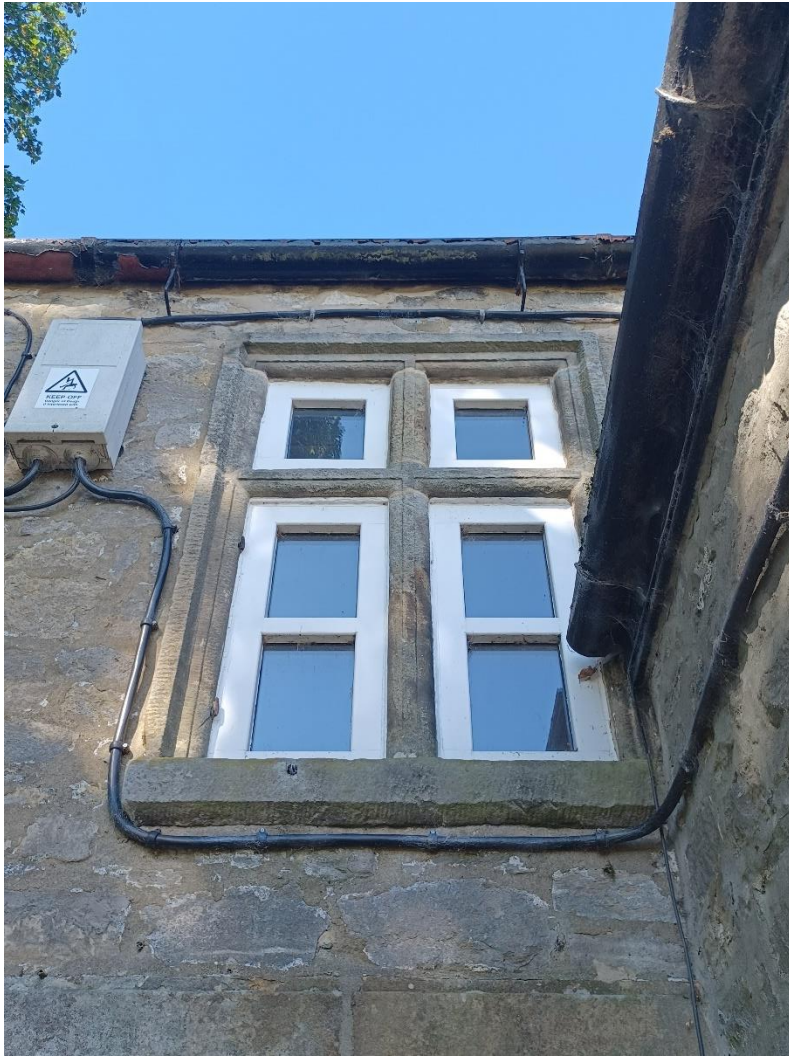
FFR 03

Existing Timber Frame window Single Glazing
Completely Inappropriate window design

- Replace the existing Timber framed windows with new Double glazed windows with Side Opening Casements and Top Lights
- The new windows to be coated in an External grade Timber paint, colour to be an Off White;
- Glazing to be bedded in Linseed Oil Putty
- Seal the existing window with approved Mastic Sealant;

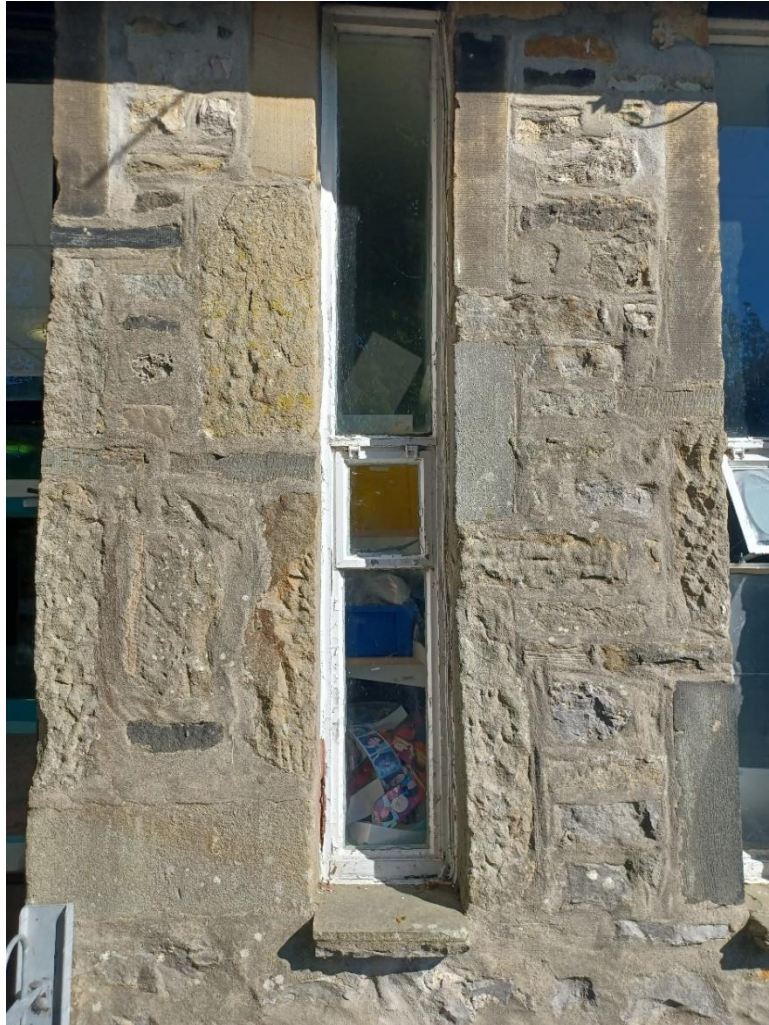
SG 01 & SG02

Existing Timber Outer Frame with Metal Frame window Single Glazing
1Nr Single glazed Top Opening Light

- Replace the existing with new Double Glazed Timber Casement Window with a Single double glazed Opening
- The new windows to be coated in an External grade Timber paint, colour to be an Off White;
- Glazing to be bedded in Linseed Oil Putty
- Seal the existing window with approved Mastic Sealant;

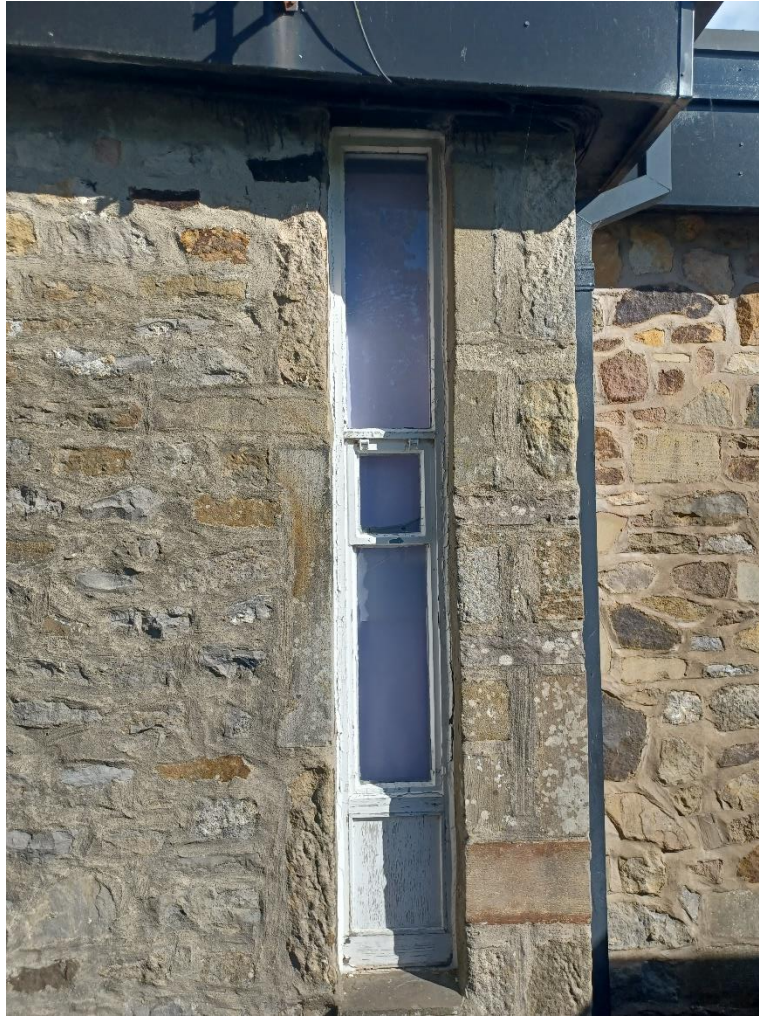
SG 01 & SG02

Existing Timber Outer Frame with Metal Frame window Single Glazing
1Nr Single glazed Top Opening Light

Plywood panel located at the bottom due to greater opening

- Replace the existing with new Double Glazed Timber Casement Window with a Single double glazed Opening and WBP Plywood panel at the bottom;
- The new windows to be coated in an External grade Timber paint, colour to be an Off White;
- Glazing to be bedded in Linseed Oil Putty
- Seal the existing window with approved Mastic Sealant;
