RE: SCOPING BAT SURVEY
LOCATION: GREEN LANE FARM, CLITHEROE
PROPOSAL: REMOVAL OF EXISTING LIVESTOCK SHELTER STRUCTURE TO BE REPLACED BY NEW AGRICULTURAL BUILDING

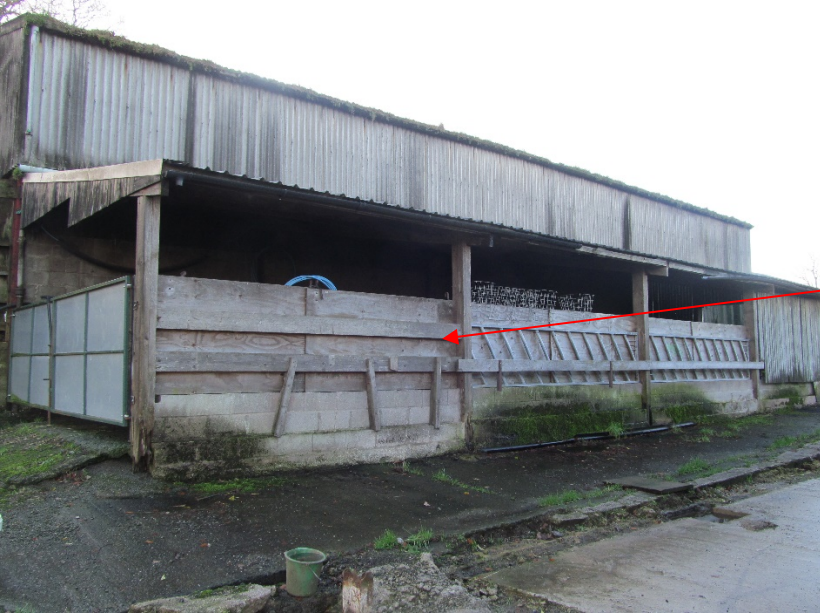
The structure is made from sheet metal roof panels over a timber frame. There are timber wall panels and Yorkshire boarding for the elevations.

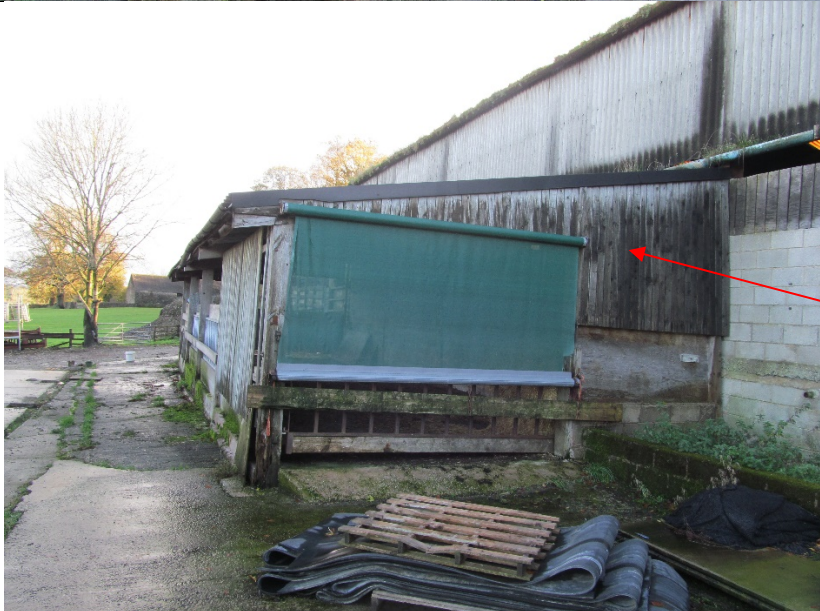
There were no enclosed voids, crevices or cracks in any part of the structure

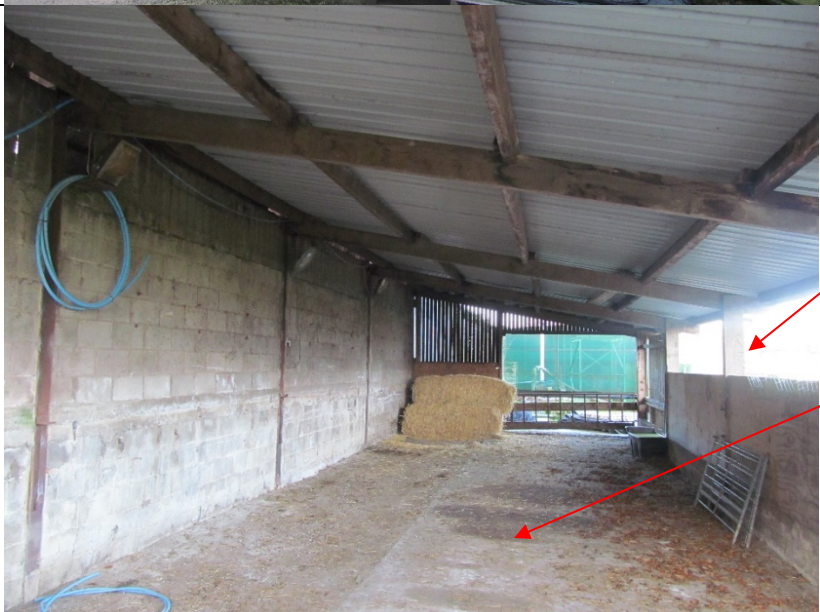
The internal space is naturally extremely light, draughty and exposed due to the open sides

There were no bats present and no past evidence on any surfaces on or inside the structure

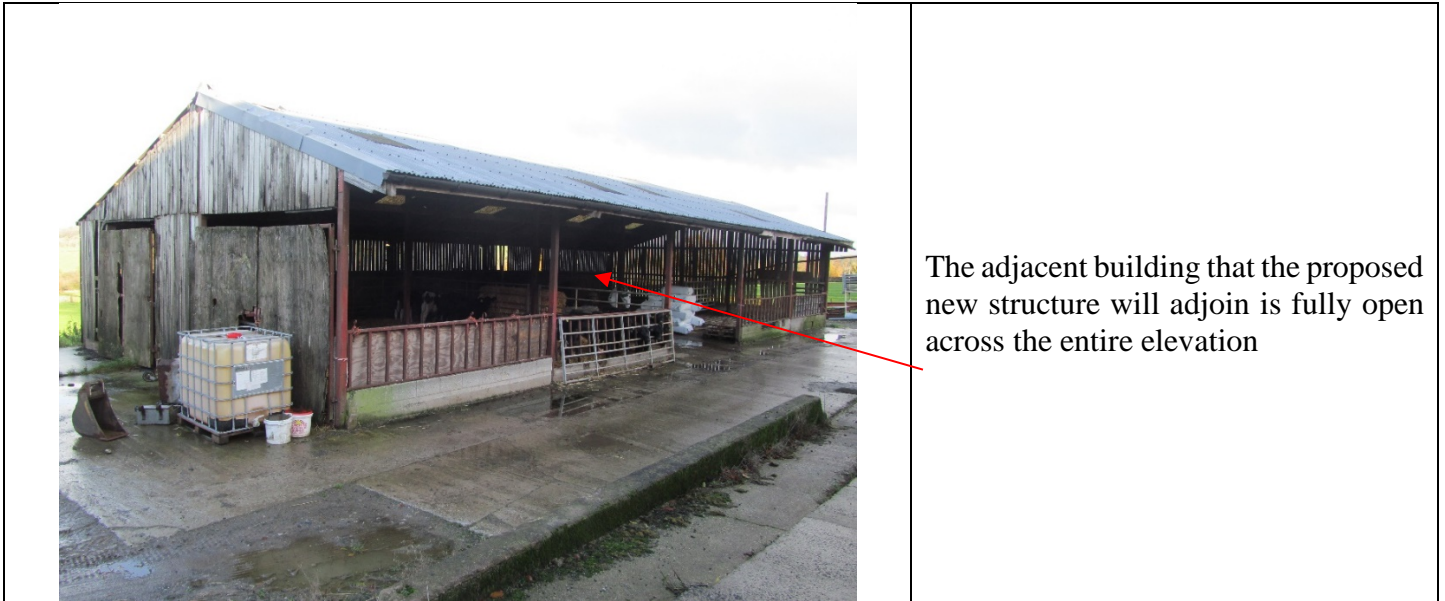
The adjacent building that the proposed new structure will adjoin is fully open across the entire elevation

The elevation of the adjacent barn that the proposed new structure will adjoin was found to be fully open across the entire elevation and is used to house livestock. The proposed new building will be structurally independent of this.
