BAT SURVEY AT -
No 3 THE BARN
CLERK HILL ROAD
SABDEN

DATE AND TIME OF VISIT
3rd Dec 2022 1pm

REFERENCE. [REDACTED]

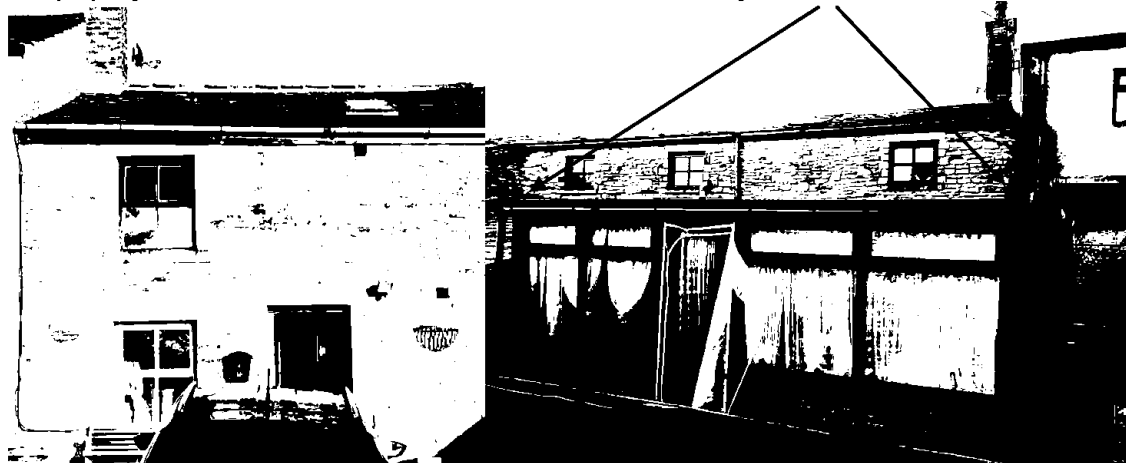
The property is a mid terrace conversion of a barn with a conservatory extension to the rear.

Front elevation

Rear elevation

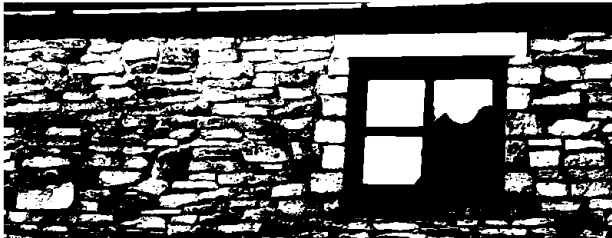
The walls are random stone to the house and the base wall of the conservatory.

The walls are in good condition and well pointed with no cracks or crevices suitable for bat ingress.

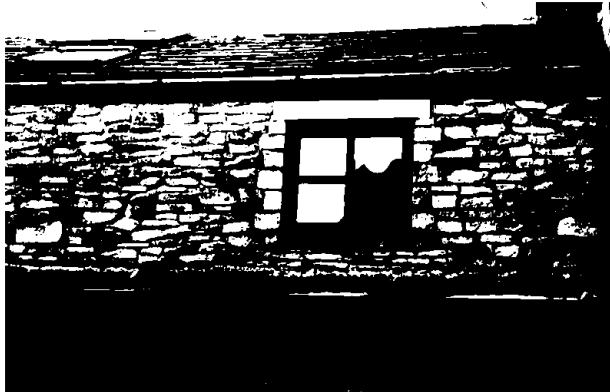
The house pitched roof has a slate finish with timber barge boards flush fixed to the wall.

The conservatory roof is a lean to construction, upvc frame with polycarbonate sheets.
