**51 Downham Road, Chatburn
Clitheroe, Lancashire**

**Preliminary Bat Roost
Assessment**

October 2022

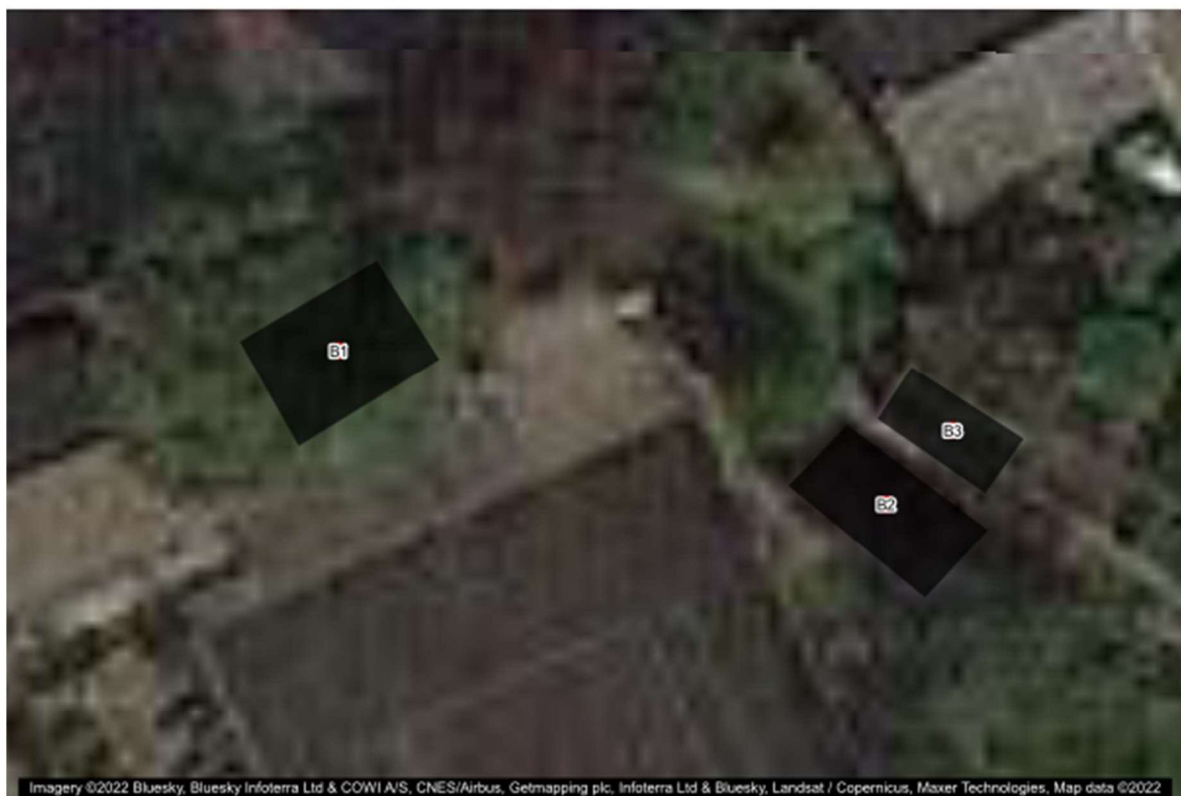
Figure 2. Buildings surveyed

- 3.2.5 The Site (ref. **PLATE 1** to **PLATE 24**) consists of two small outhouses and a small green house within a residential garden setting on the south side of Downham Road (ref **PLATE 1** and **PLATE 2**).

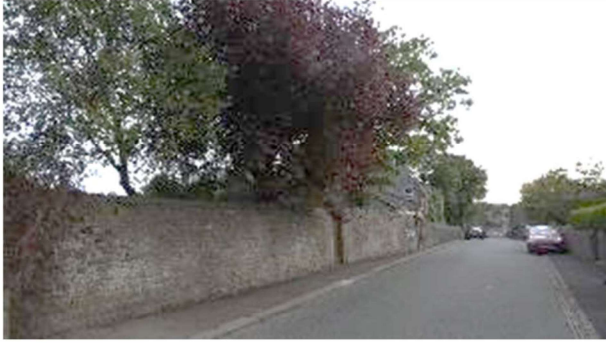
PLATE 1: Looking south-west along Downham Road from the with the Site boundary on the southern side of the road (left side).

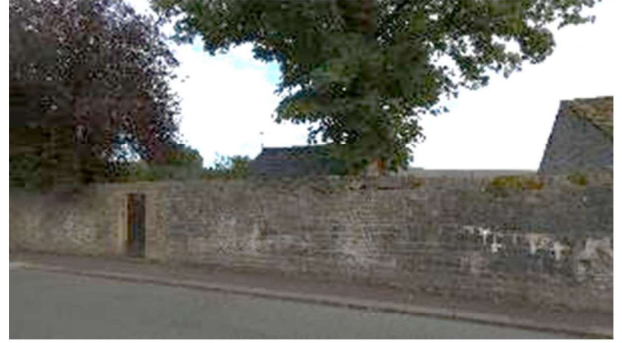
PLATE 2: Looking south across Downham Road towards the Site boundary, towards the stone shed (B1)

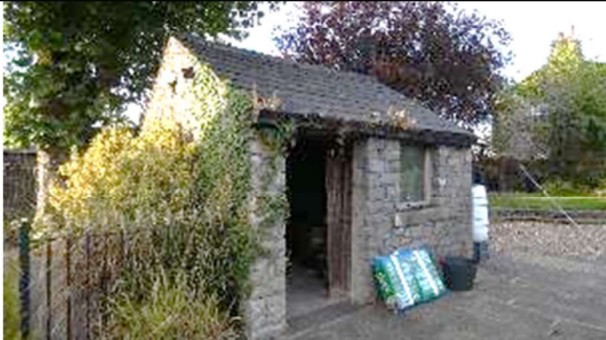
PLATE 3: South facing aspect of the shed (B1), looking from south-western corner.

- 3.2.6 Building 1 (B1) is a single story shed [NGR: SD 77258 44228], of stone construction with gable ends and a pitched slate roof (ref. **PLATE 3**), overall the building is well pointed with limited features for roosting bats. Externally the roof slates are in good condition, with no gaps on either south (ref. **PLATE 3**) or northern aspect (ref. **PLATE 4**). The buildings gable ends face east (ref. **PLATE 5**) and west (ref. **PLATE 6**). The dry verge is intact at both ends providing limited access points for cavity dwelling bat species. A potential access point is present at the west facing end of the concrete ridge tile at the gable end (ref. **PLATE 7**), providing potential access under the tiles for crevice dwelling bats. The western gable end also features a solar powered motion sensitive security light with a terracotta ducting pipe installed for wiring, this has potential to provide access for roosting bats. It is full of wiring (ref. **PLATE 8**) and there are no signs to suggest it has been used by bats for roosting or access, no indication of use was noted internally. On the south facing aspect, a box shaped section of metal guttering runs under the eaves. It has an approximate gap of 15mm wide and 80mm deep between the guttering and the wall (ref. **PLATE 9**), where debris and cobwebs is evident within the gap. No evidence of bat use is present, and feature is viewed as having low potential for roosting bats. Most of the north side of B1 is void of features with roost potential, the walls are well pointed, no gaps are present under the eaves,

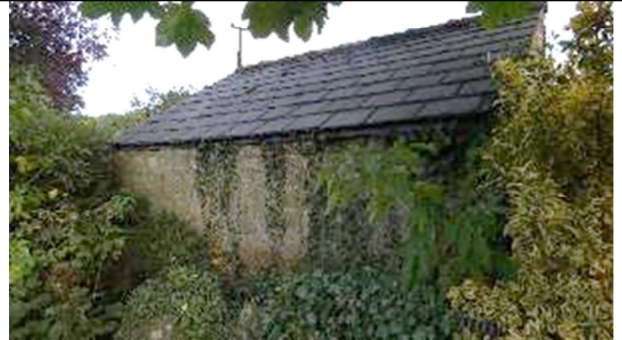
PLATE 4: North facing aspect by Downham Road. Tight fitting eaves few at base of pitched roof, minor ivy cover on wall. Ridge tile at western end with small gap ()

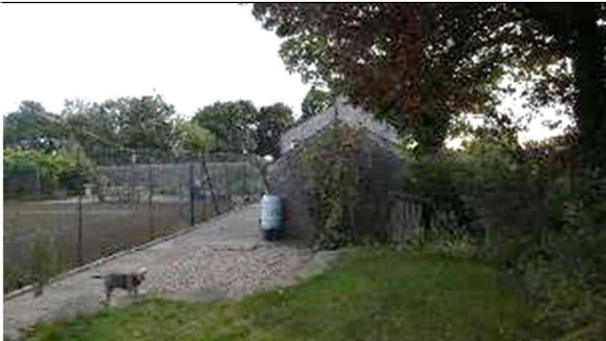
PLATE 5: B1 gable end at east side of building. Some shrub coverage along gable end.

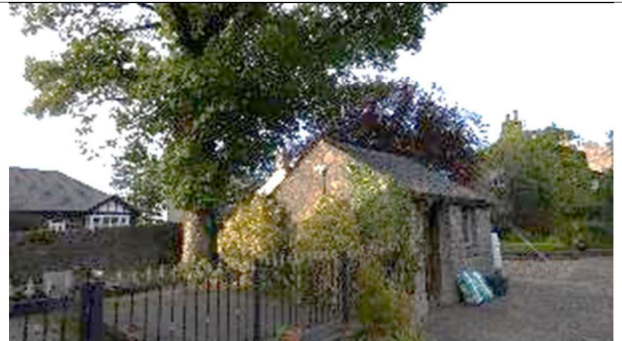
PLATE 6: Building B1 west facing aspect of gable end. Minor amounts of ivy cladding in southern corner, shrub covering stonework.

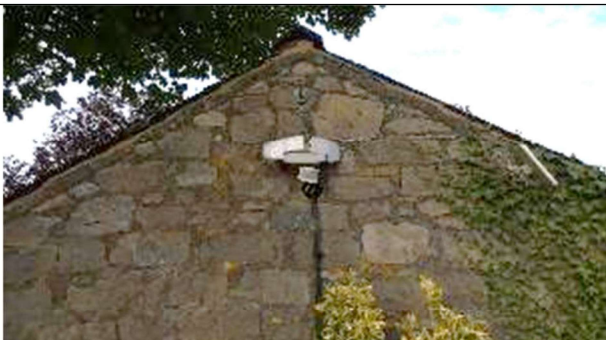
PLATE 7: West facing gable end. Ridge tile with missing dry verge pointing. Cable ducting pipe under a solar powered motion activated security light.

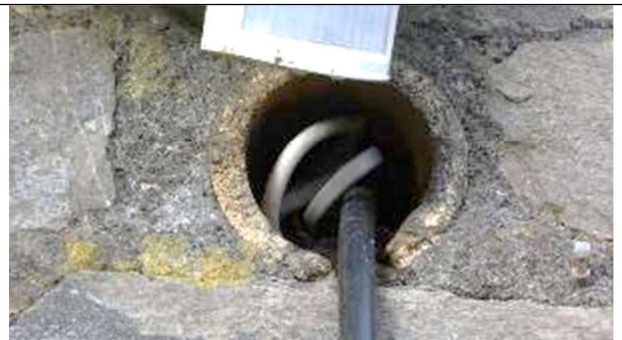
PLATE 8: Terracotta drainpipe ducting under the security light, filled with electrical cable.

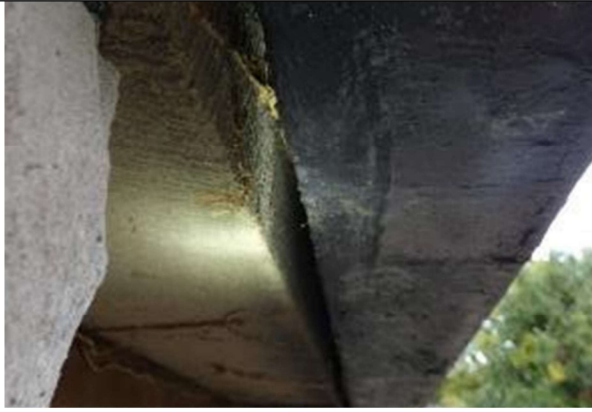
PLATE 9: Gap between wall and beam above the door along the south facing eaves. Gap is approx. 1.5cm wide and 10cm deep and filled with cobwebs.

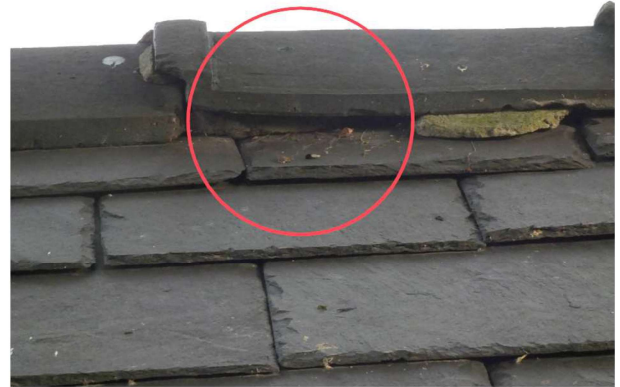
the slate tiles are well fitting. The one notable exception is the final ridge tile where missing pointing is evident (ref. **PLATE 10**). Entrance to the outbuilding is via a south facing timber sliding door (ref. **PLATE 3**), which has a narrow gap within the door frame (ref. **PLATE 11**). Internally the pitched roof is lined with timber board (ref. **PLATE 12** and **PLATE 13**) and the internal walls are painted, with no signs of bat use evident. A single glazed south facing window is timber frame is in good condition and is tight fitting. Internally the windowsill is headily covered in cobwebs and desiccated invertebrates (ref. **PLATE 14**). No signs are evident to indicate any use of the structure by bats. Overall, the building is viewed as being **Low potential** features for bats.

PLATE 10: North facing gap under concrete ridge tile at western end of roof with missing pointing, building B1. 1cm gap x 10cm.

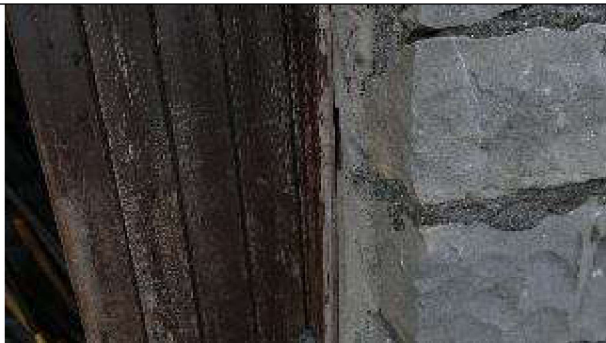
PLATE 11: Ca. <10mm gap, 1m above ground on right side of the south facing door.

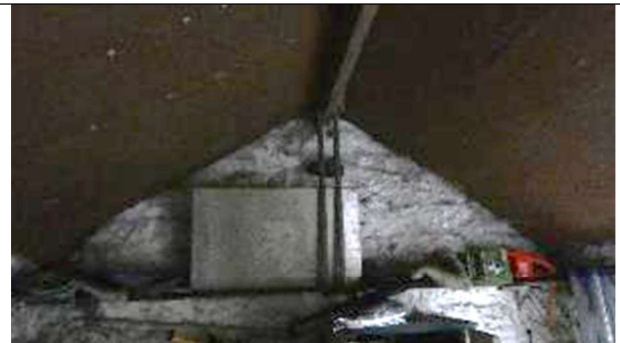
PLATE 12: B1 internal eastern gable end. Generally clean, with light covering of cobwebs. No signs to indicate use of building by bats.

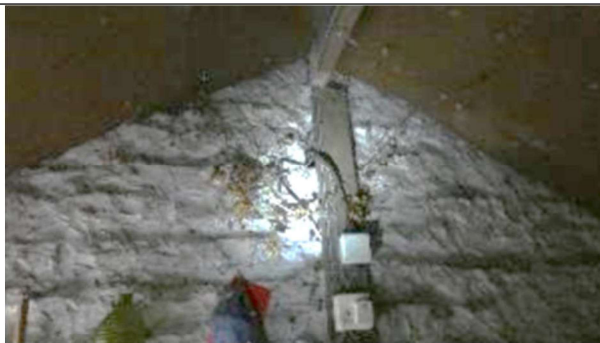
PLATE 13: B1 internal west facing gable end. Clean with light covering of cobwebs. No signs to indicate use by bats.

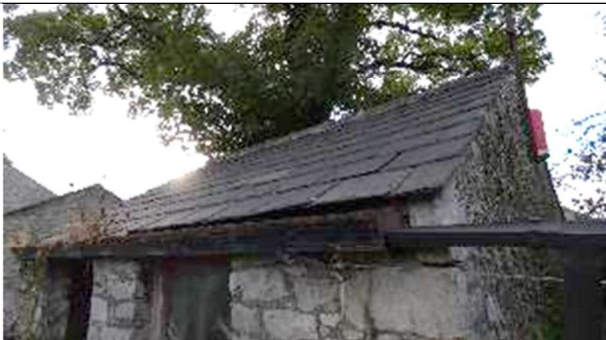
PLATE 15: South facing pitched roof from eastern end. Tiles tight fitting and gable end well pointed.

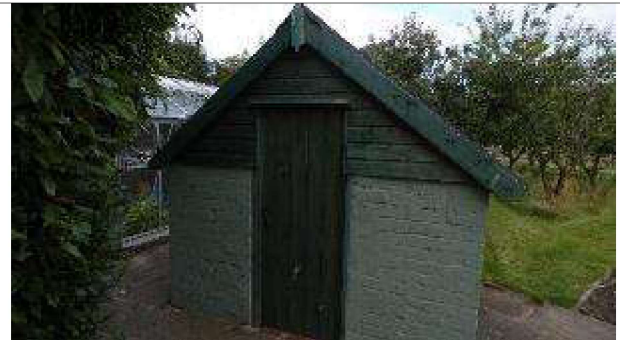
3.2.7 Building two (B2) [NGR: SD 77274 44223] is a single story shed with a single skin wall of brick with the upper a frame of the wall faced with a painted ship lap style timber skin on the north-west and south-east gable ends (ref. **PLATE 16** and **PLATE 19**). The building has been recently roofed with black bitumen corrugated roof sheet covered roof (ref. **PLATE 17** and **PLATE 18**), with matching ridge material and gable ends fitted with a tight-fitting timber fascia. The shed is approximately 8m long x 2.25m high. All materials were tight fitting with no visible gaps under surfaces. Internally, the unit is clean with all areas accessible (ref. **PLATE 20** to **PLATE 22**). The construction is flush and well-kept with no signs of suitable opportunities for crevice dwelling bats. Overall the building is viewed as being **negligible potential** features for roosting bats. No further consideration is required.

PLATE 16: North facing entrance to B2 of brick built shed. Cladding and gable end

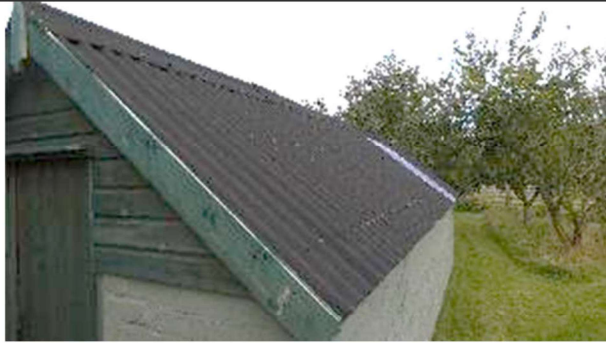
PLATE 17: B2, recently fitted, west facing black bitumen corrugated roof sheet covered roof, with matching ridge material. All materials were tight fitting.

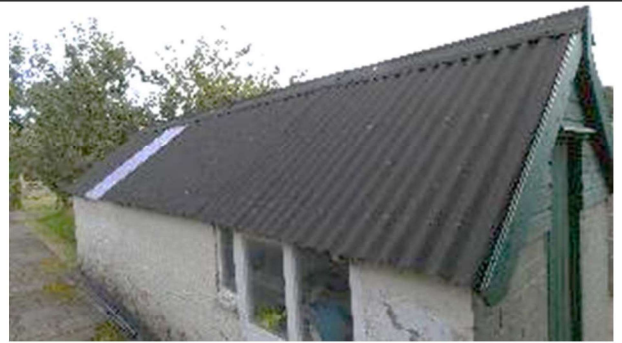
PLATE 18: B2, recently fitted, east facing black bitumen corrugated roof sheet covered roof, with matching ridge material.

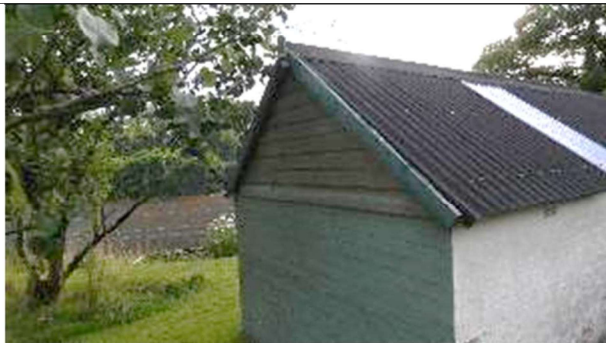
PLATE 19: South-eastern aspect of the gable end. Brick built gable end with tight fitting tongue & groove cladding

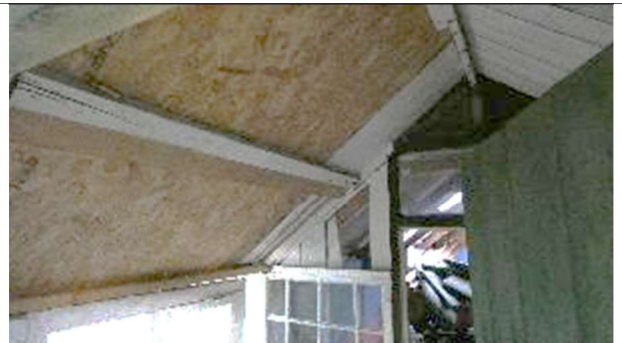
PLATE 20: Pitched roof and internal view entering the shed B2 from the north-west.

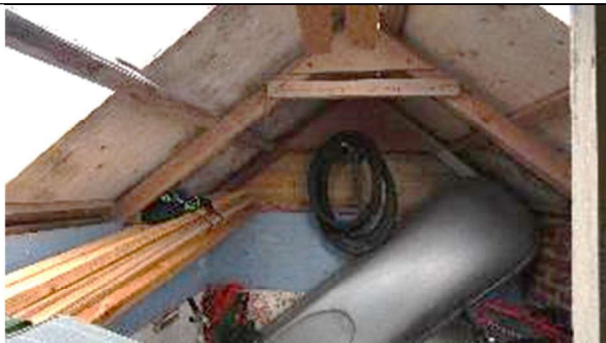
PLATE 21: South-east end of B2 gable end. No signs showing presence of bats were observed within the space.

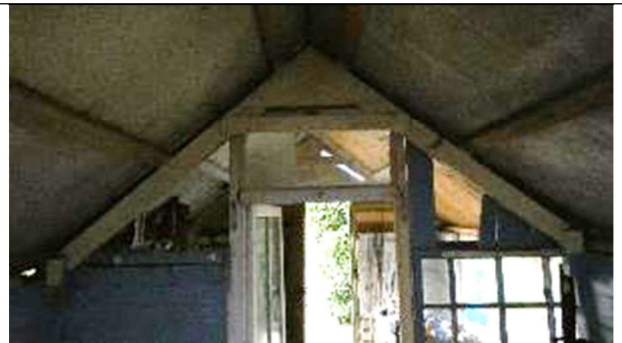
PLATE 22: Looking north-west along the ridgeline of the pitched roof shed. No signs of use were observed during the inspection.

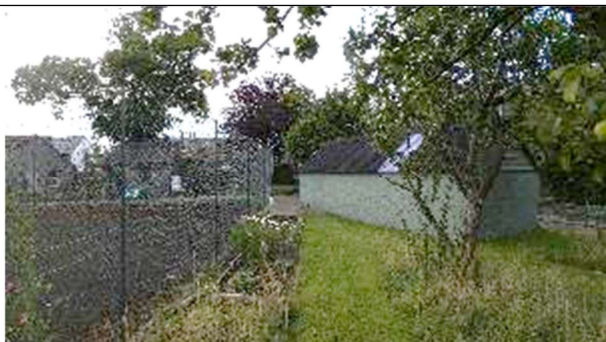
PLATE 23: The setting of B2 within the plot view north from the southern end of the Site.

4.1.3 No emergence/ re-entry was observed during the survey. Commuting noctule and pipistrelle bats were observed within the Site and common and soprano pipistrelles were observed foraging in areas of the existing garden of 51 Downham Road (ref **PLATES 23** and **PLATES 24**). It is the author's opinion that the development of the site should proceed as the survey information suggests there should be no significant concerns or constraints in relation to roosting bats in the proposals and there is no requirement for an EPSM licence in respect of bats.

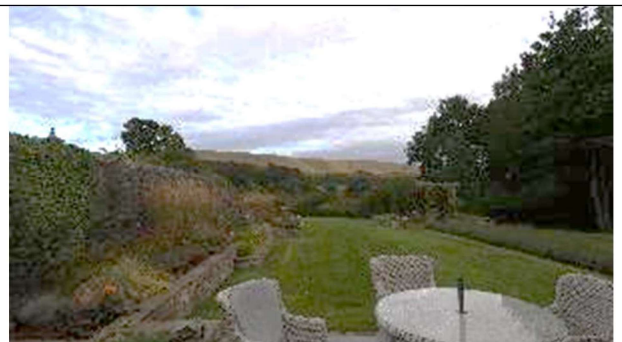
PLATE 24: The area of garden to the west of the Site within the curtilage to be retained. This area was noted as being used by bats for foraging.
