**BAT SURVEY AT -  
ABBAY HOUSE  
WORSTON**

REFERENCE NO. 6198

Demolition of garage prior to constructing new single storey extension

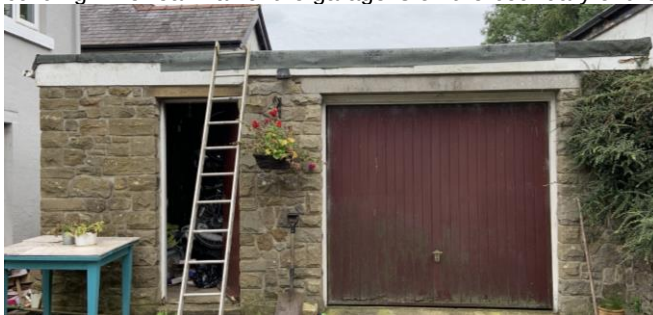
Front elevation

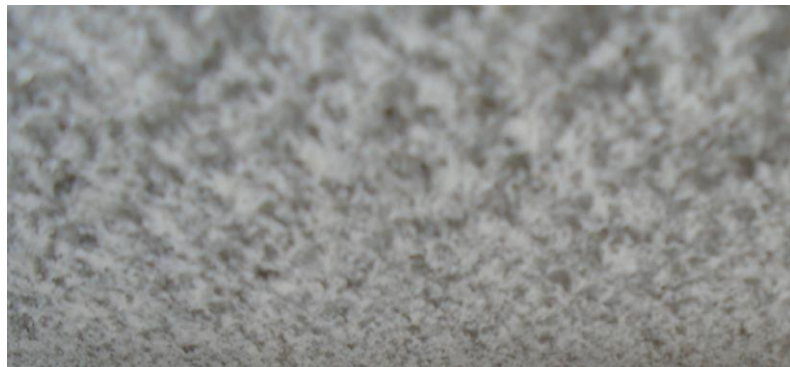
The garage is a relatively new structure in relation to the adjoining house. the walls are block work with a stone cladding to the front north east elevation. the north west side elevation has a smooth unpainted render finish. the south west and rear elevation has a rough cast painted render finish.

South west elevation

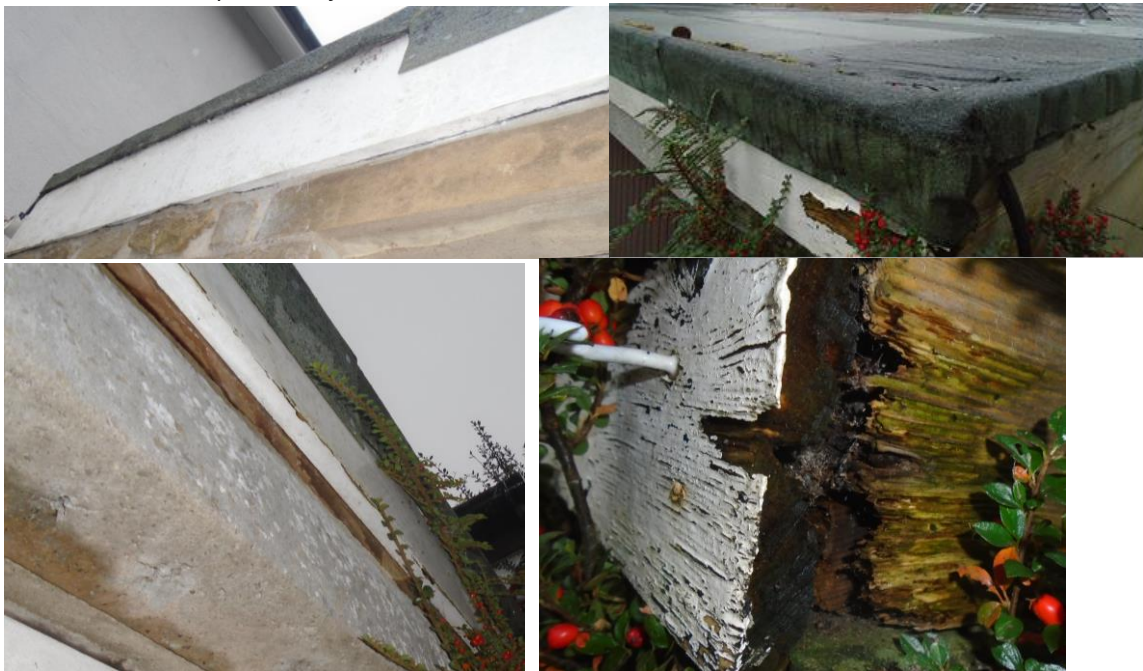
Although the roof appears to be in a poor condition, close inspection did not reveal any ingress points, tears or lifted sections at the verges with the potential to provide any roost opportunities for bats. The front, north west side and rear fascia's are flush to the walls and in reasonable condition and do not provide any crevices behind. However the north corner is rotten and does provide a gap which was possible to examine closely, the gap was shallow and did not provide any roost habitat.

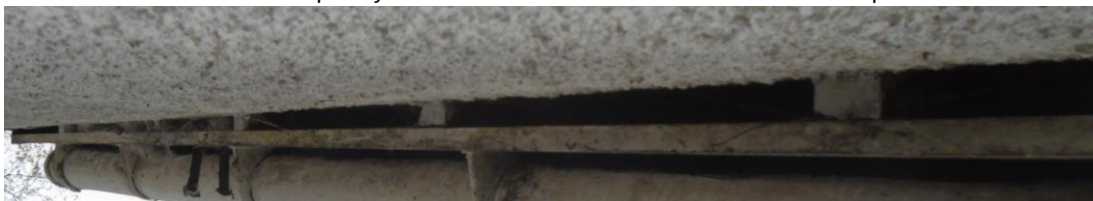
The south east elevation fascia has a small void behind but was easily examined, there was no access to the interior and the void was completely visible. No current or historic evidence of bat presence was found.

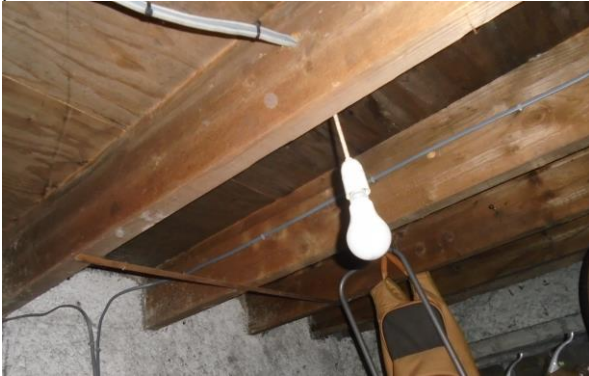
There was not an enclosed roof space in the garage the ply deck and joists were fully visible and closely inspected. The timbers were in good condition with no cracks or crevices the structure did not provide any roost potential for bats.

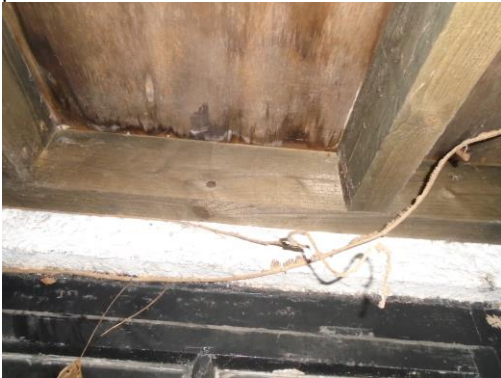
The Open store roof is timber rafters with ply fixed over, as before the structure did not provide any roost potential for bats.
