SUPPORTING INFORMATION

22 CHURCH STREET RIBCHESTER – REPLACEMENT WINDOWS TO FRONT AND REAR

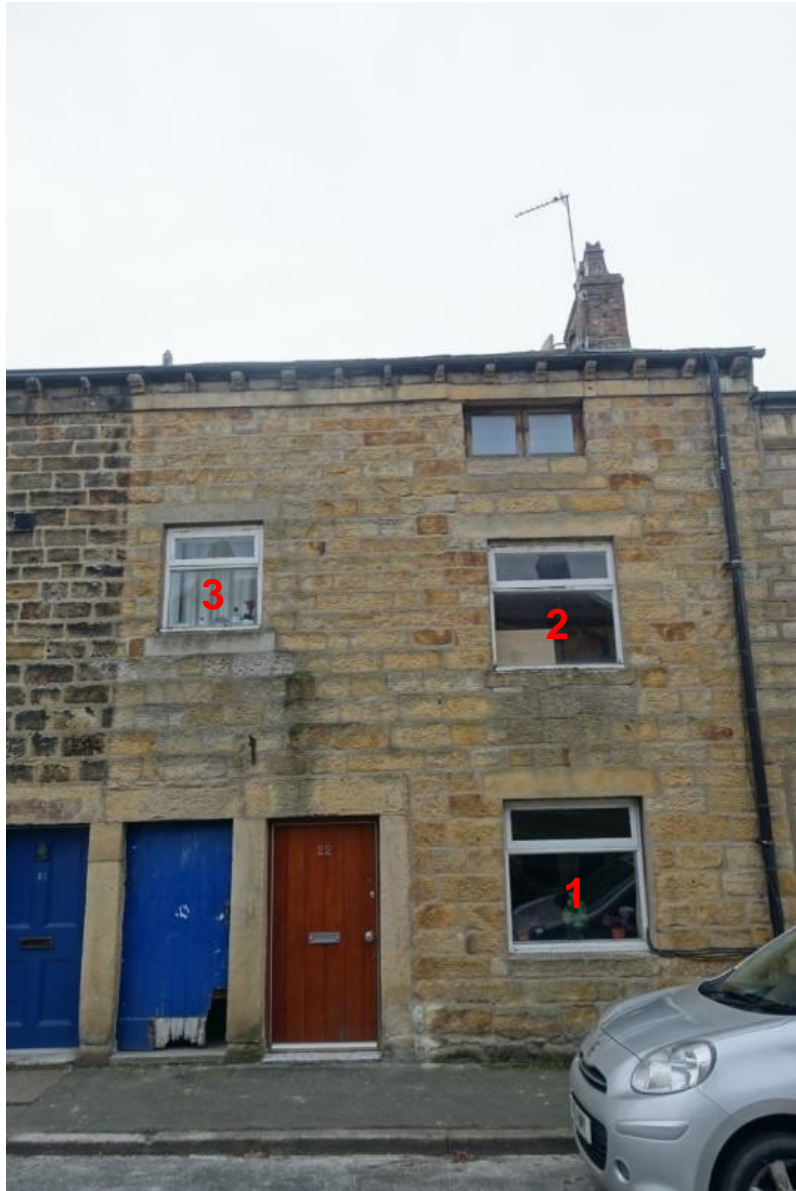
16. These replacement windows to the front and rear elevations are shown (and numbered for reference of this application) in the two images below, which show that no original windows remained in the property and that the replacements consisted of a mix of top-hung casement, top-hung faux sash, in a mixture of single and double glazed and finished in white paint and wood stain finishes. It is understood that none of these windows were appropriate for the significance of the property; in alignment with the Ribchester Conservation Area Appraisal, the top-opening casements with asymmetrically spaced lights are unsuitable for the building.

1.1 c.1995 Windows - Front Elevation – Adjoining Church Street

17. All the windows were in a poor state of repair and needed replacement as acknowledged in the Ribble Valley Borough Council 'Pre-Application Enquiry Response' (April 2019), that "the existing windows are in a poor state of repair and it is appropriate to replace them considering they are of no historical relevance to the property."

18. Further to this, these windows posed a serious health, safety and security risk to both the occupants and the public as:
 - a) The first-floor window openings had been sealed shut,

- b) The ground floor windowpanes were loose in their casements to the street,
 - c) The ground floor windows did not have locking openings and,
 - d) Some of the window frames had rotted through.

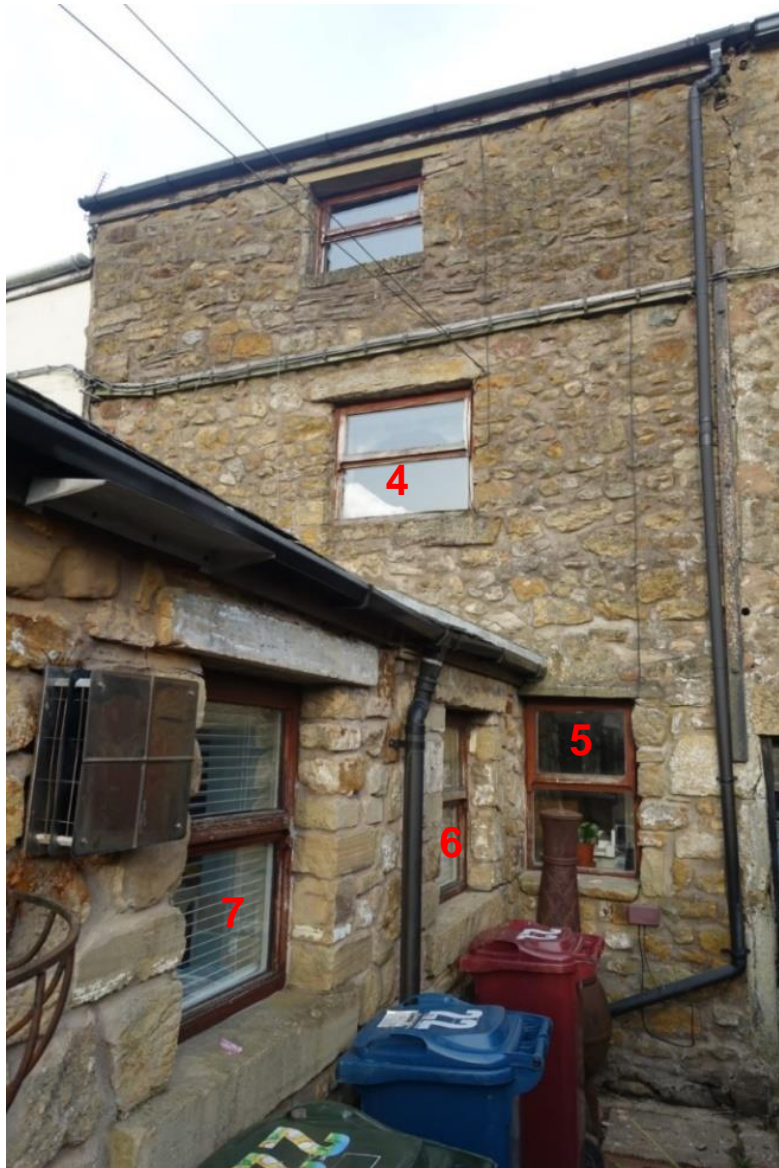
1.2 c.1995 Windows - Rear Elevation – Adjoining the Scheduled Monument

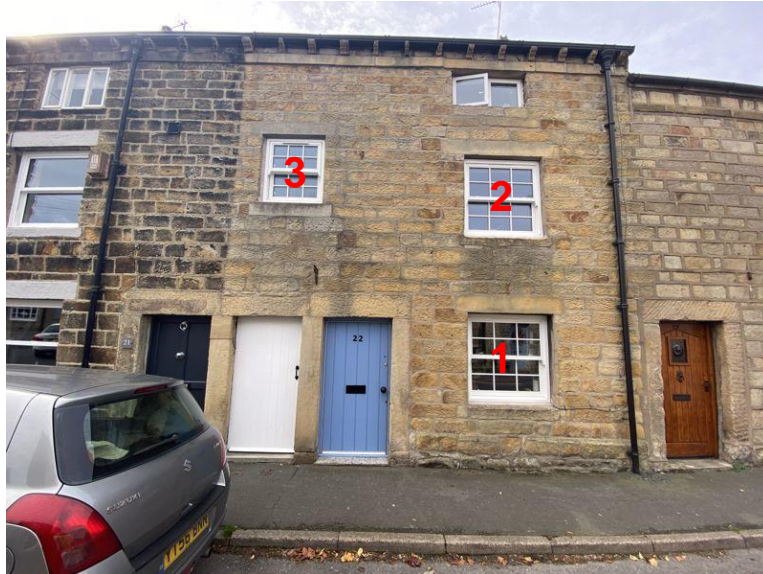
19. The current windows at the property consist of sliding sash to the front elevation and side hung casement to the rear. All in white finished solid wood with double glazing. These are shown in the two images below.

1.3 Current Windows - Front Elevation – Adjoining Church Street

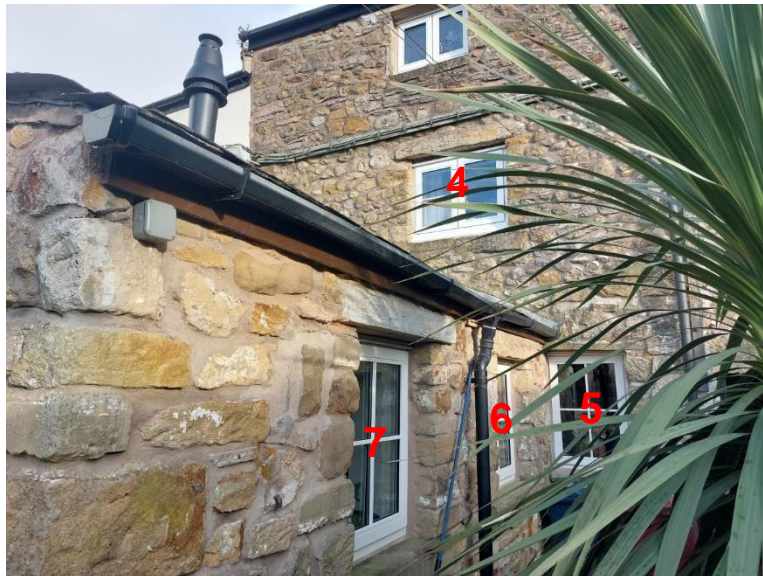
1.4 Current Windows - Rear Elevation – Adjoining the Scheduled Monument

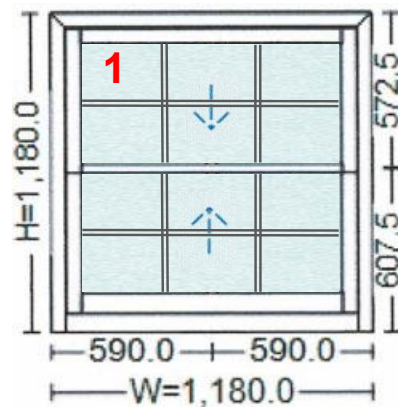
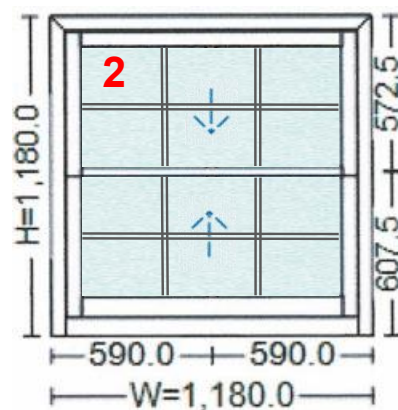
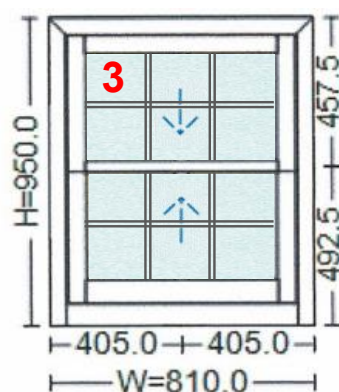
23. Front Elevation – Adjoining Church Street – All 6 over 6 sliding sash configurations, in order with the proportion of the window openings and to provide a consistent approach to the front elevation.

24. Front Elevation – Adjoining Church Street - Scaled window drawings and dimensions:

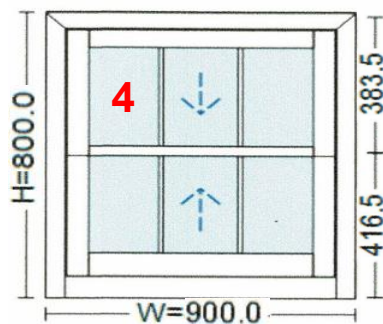
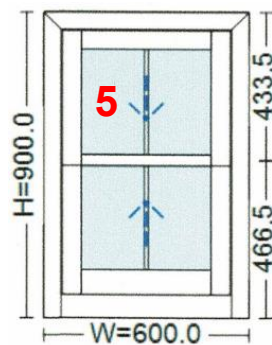
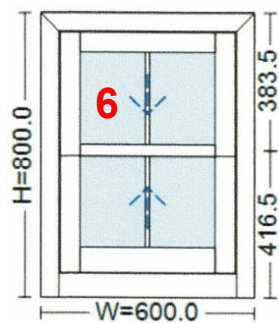
26. Rear Elevation – Adjoining Scheduled Monument – 3 over 3 sliding sash and 2 over 2 sliding sash configurations, in order with the proportion of the window openings (which are reduced in size as compared to the front elevation), the same configuration approach has been taken across all rear elevation windows to provide a consistent and harmonious approach (This also matches the rear elevation window configuration which was most recently approved at 26 Church Street).

- a) Please note this is a clarification of pane configuration from the original design statement for the rear elevation, which stated 6 over 6, due to reconsideration of the window proportions and more horizontal emphasis of the first-floor window (Window #4) as compared to the front elevation, as pointed out in further discussions with planning.

27. Rear Elevation – Adjoining Scheduled Monument – Scaled window drawings and dimensions:

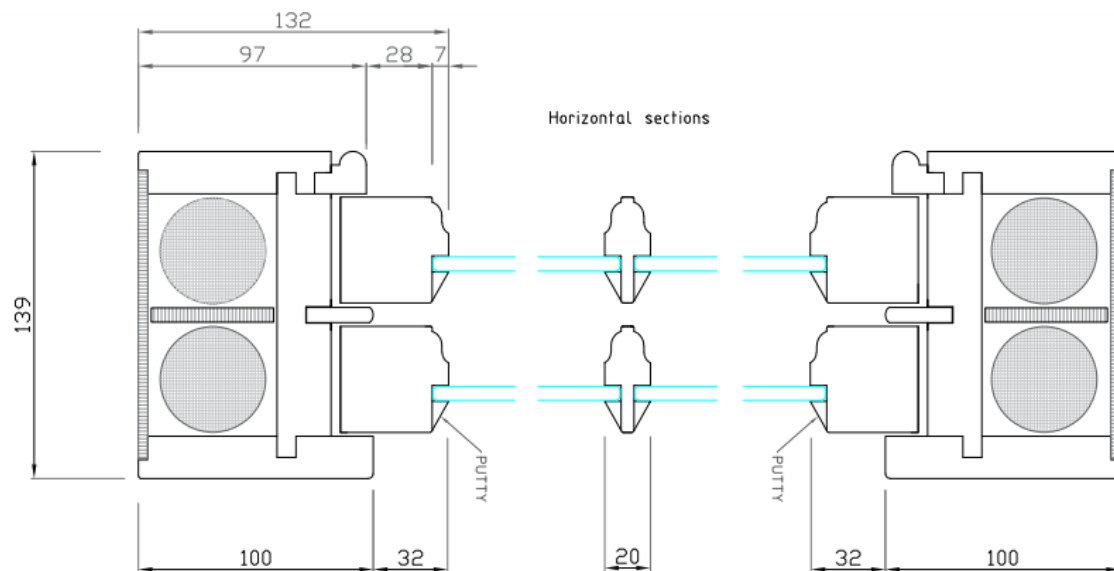
28. Vertical and horizontal scaled window sections included below as a direct reference for windows 1 to 7 above:

1.6 Horizontal Window Section

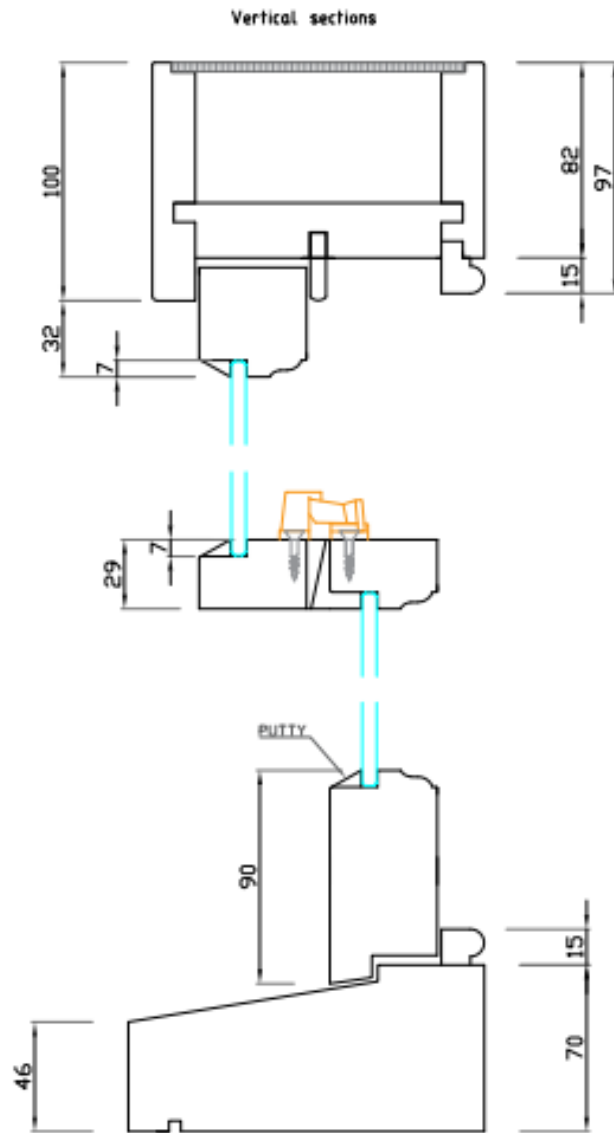
1.7 Vertical Window Section
