## **SITE INVESTIGATION & GROUND ASSESSMENT**

### **LAND TO SOUTH OF ACCRINGTON ROAD** **WHALLEY, CLITHEROE**

Report Ref BEK-19545-2 (Rev C)

### SITE INVESTIGATION & GROUND ASSESSMENT

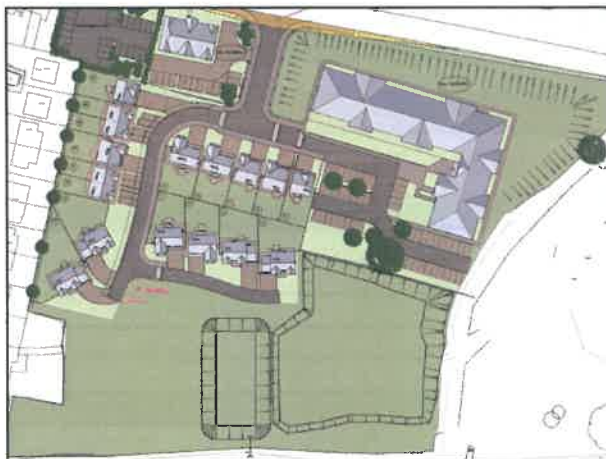
**Figure 1:** Development Layout

- 1.2.1 This report has been prepared to support a planning application for the construction of residential houses and apartments with associated gardens, access and infrastructure, see Figure 1 below:

- 1.2.2 The full development layout is presented on Drawing No 015/R-OAK/01 Revision G, titled 'Reduced Development Proposal', dated November 2022, a copy of which is presented in Appendix D.
-

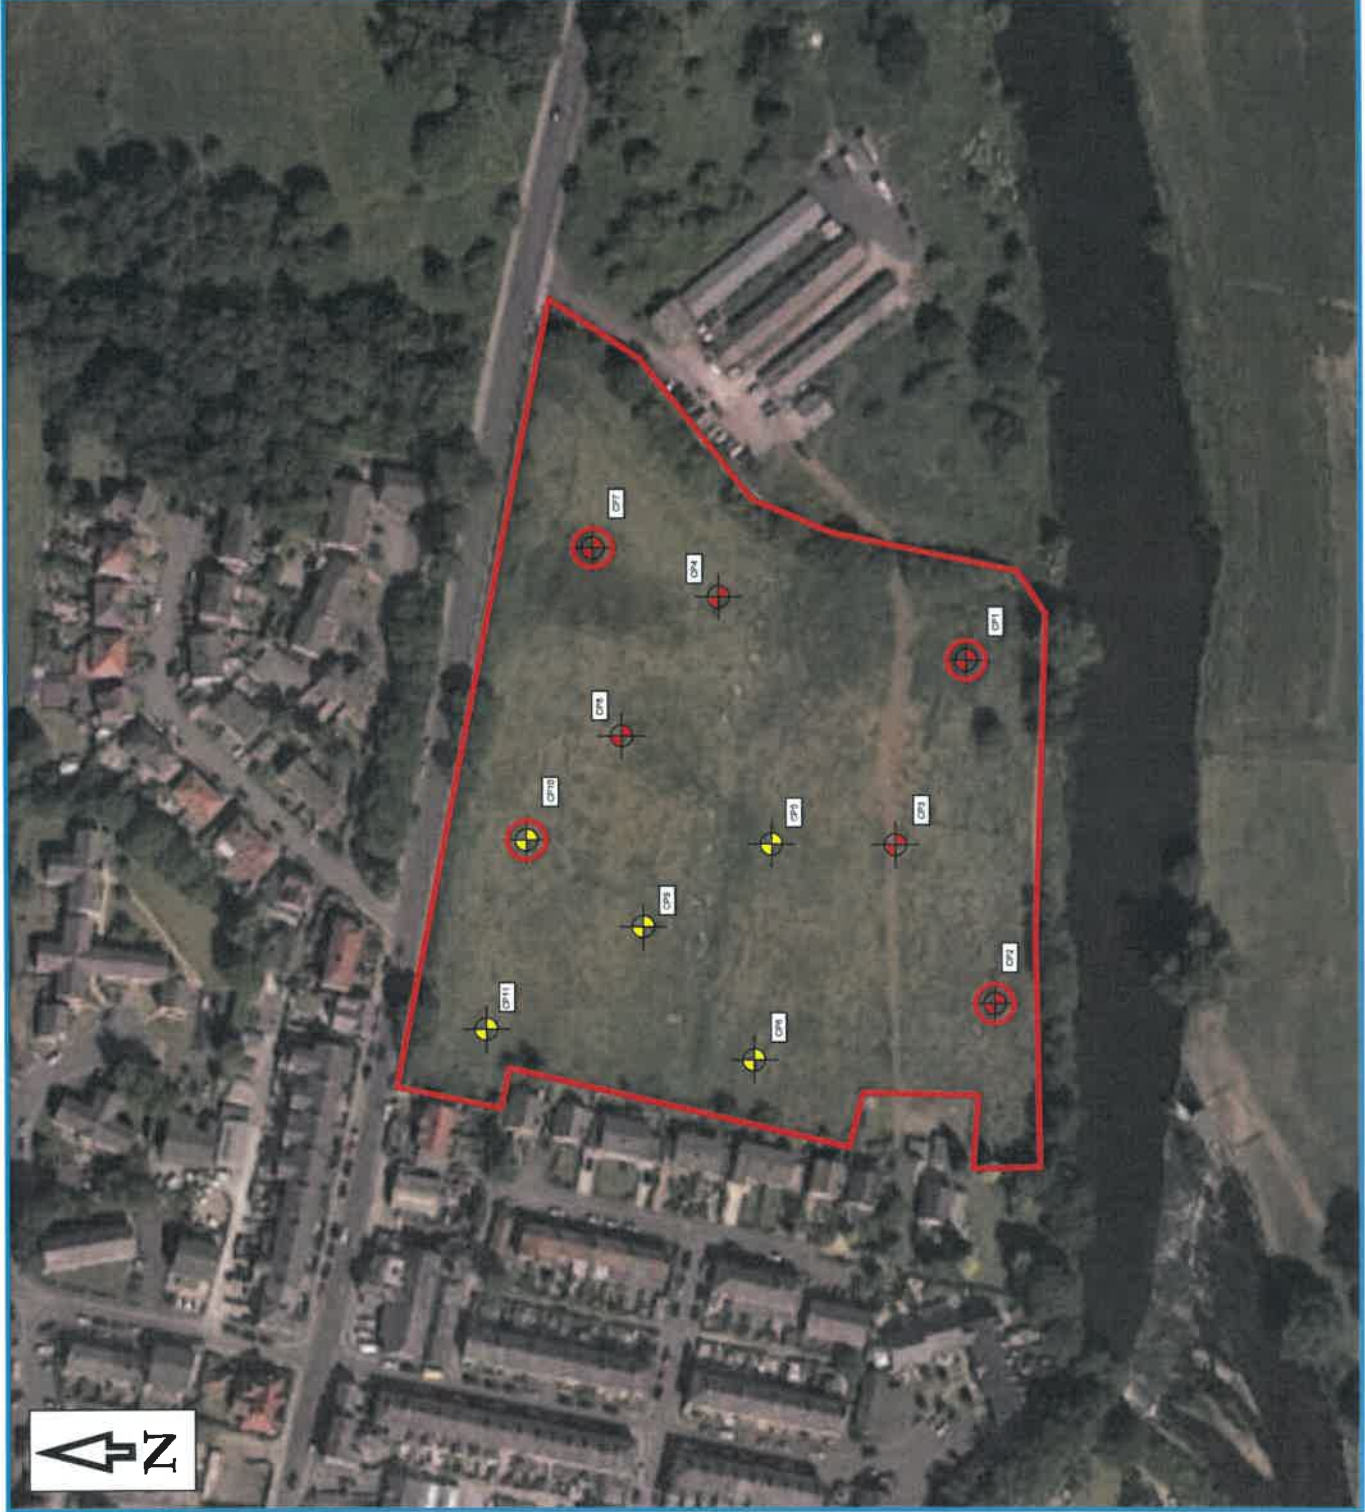
SCALE @ A3, NTS	DRAWN BY, D.E.	APPROVED BY, M.B.	DATE, 10/07/19
DRAWING No.	19545-3	REV.

- 3.2.1 Eleven cable percussion boreholes were drilled across the site with 6 boreholes being drilled to 25 m and 5 boreholes drilled to 10 m bgl.
- 3.2.2 In-situ testing (Standard Penetrations Tests (SPTs) were carried out as the drilling progressed. The ground conditions were recorded by an engineer from BEK and representative samples were recovered for chemical and geotechnical testing
- 3.2.3 Copies of the borehole records are presented in Appendix A and a borehole Location Plan is presented in Appendix D. The SPT results are presented on the borehole records.
- 3.2.4 All exploration locations were set out by the site engineer and the exploratory locations are illustrated on BEK Drawing No 19545-3 presented in Appendix D.

CABLE PERCUSSIVE  
BOREHOLE LOCATION PLAN

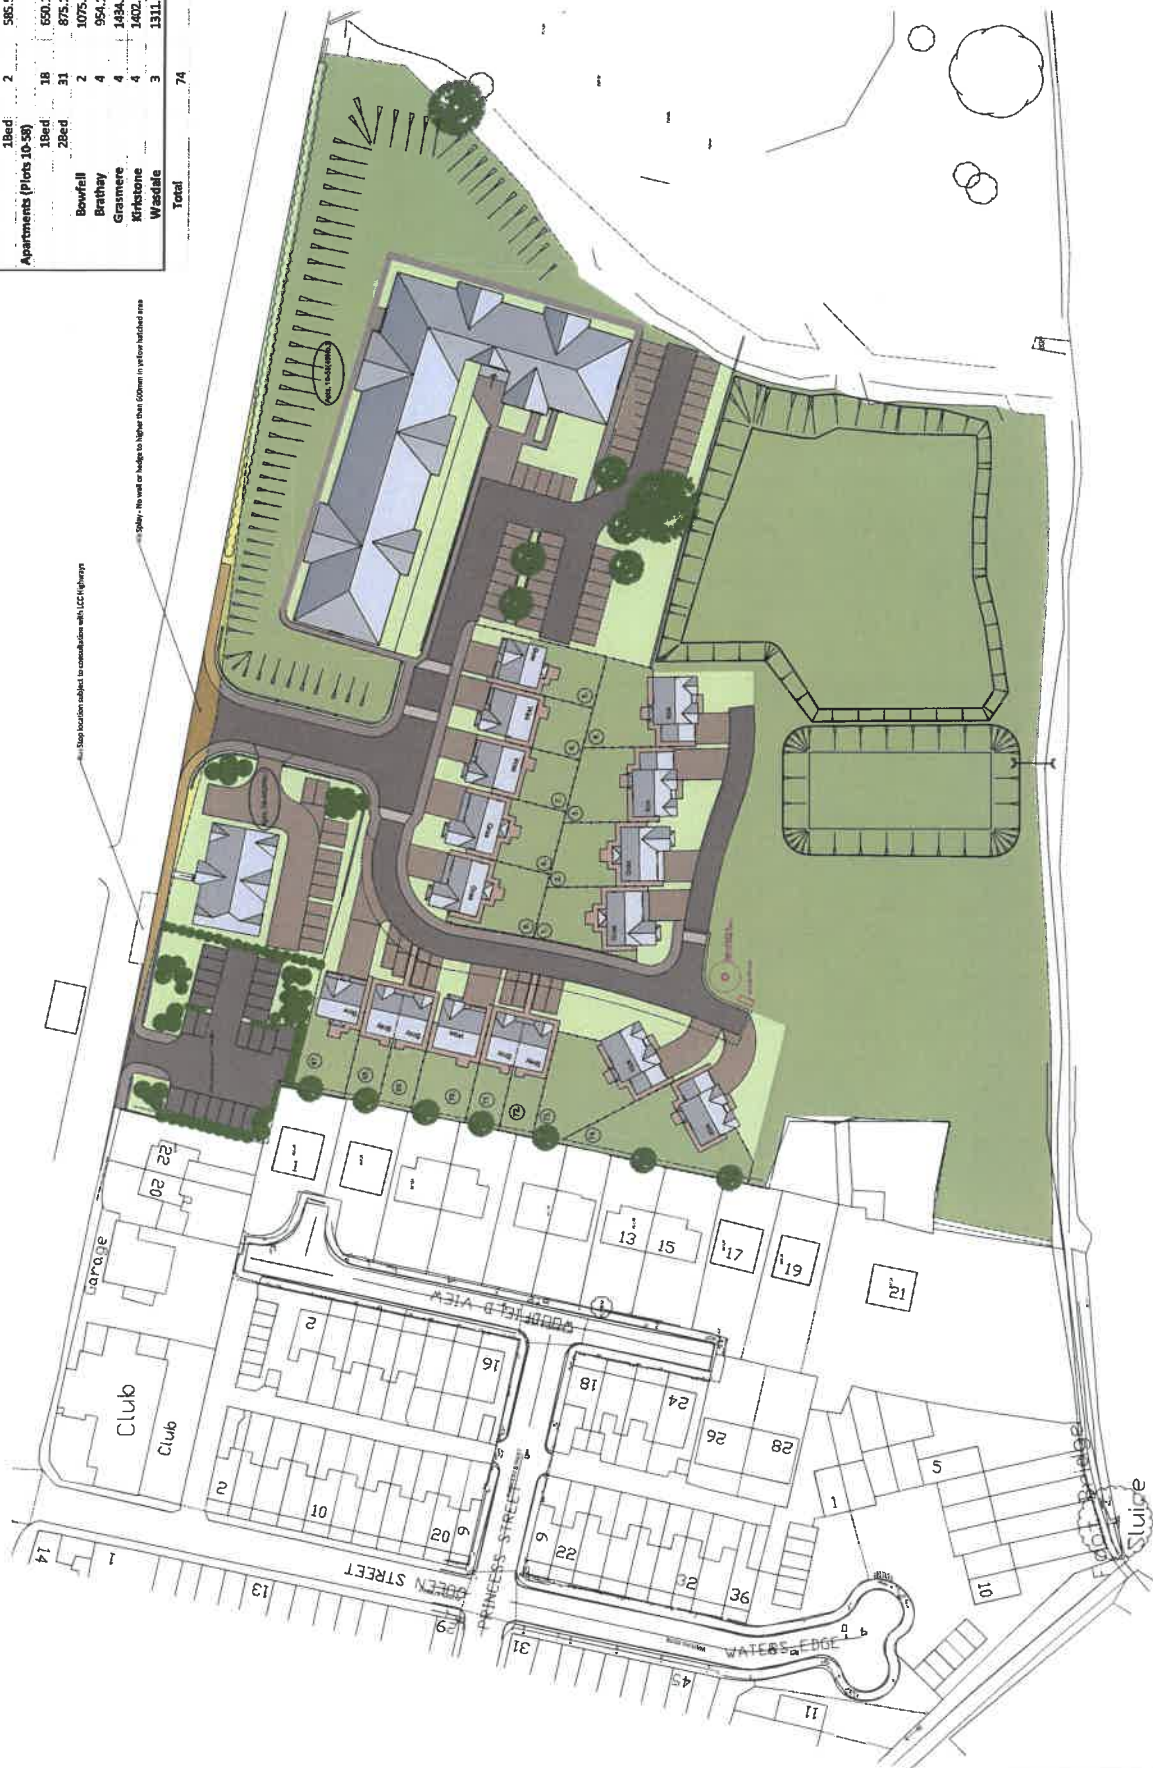
Project Title  
Apartment Block  
Drawing Title  
Residential Development Proposal  
Drawing Number  
61810-0001  
Date  
06/05/20  
Scale  
1:500 (B1)

Site location subject to consultation with LCC Highways

Spiky - No wall or hedge to higher than 600mm in yellow hatched area
