**Bat Survey Report and Method Statement
European Protected Species (Bats)**

Reasonable Avoidance and Mitigation Measures

**Lower Reaps Farm,
Whinney Lane,
Mellor,
BB2 7EL**

19.09.2022

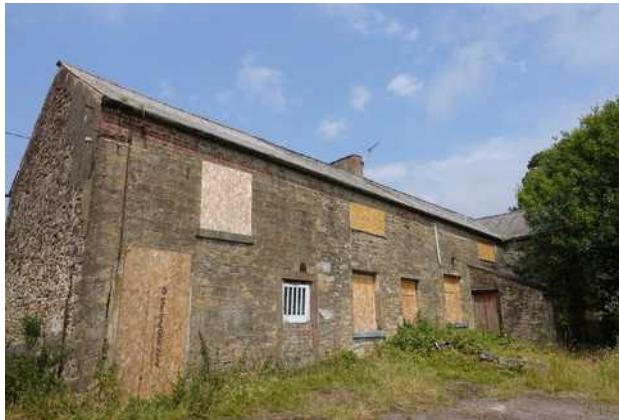
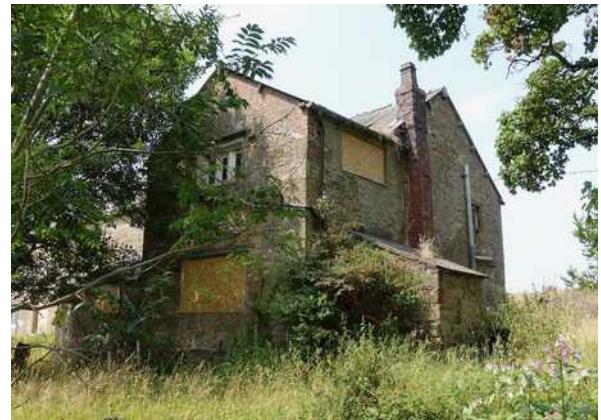
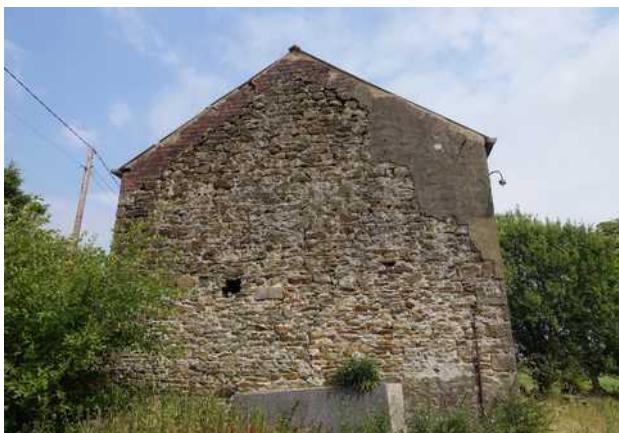
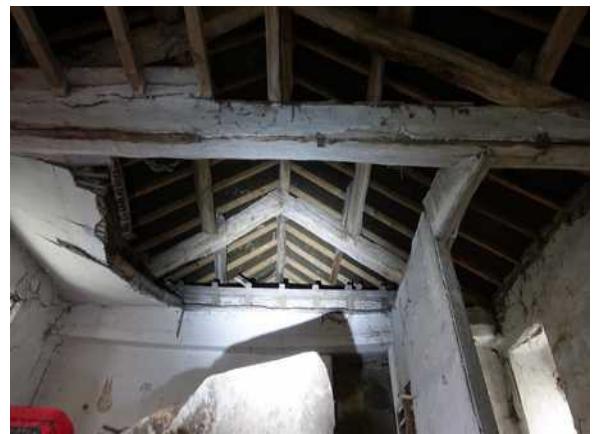
The property consists of a detached two storey stone built farmhouse with double pitched corrugated fibreboard roof and adjoining barn.

The main farmhouse has generally well pointed external walls, however gaps and crevices are present below the eaves and on gable ends. Roof panels were mainly close fitting.

The building was assessed as offering a moderate to high level of bat roost potential.

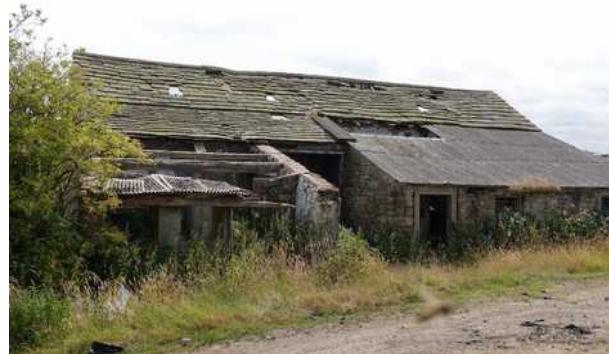
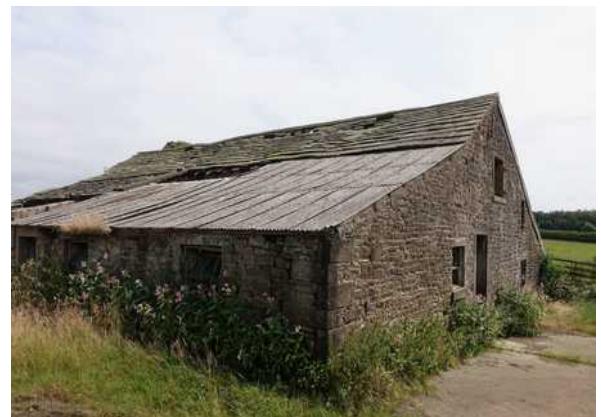
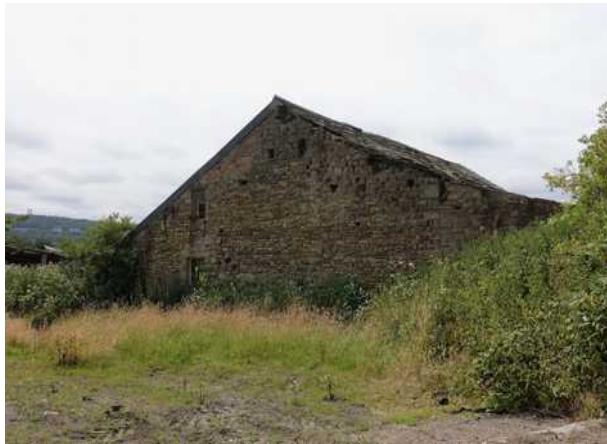
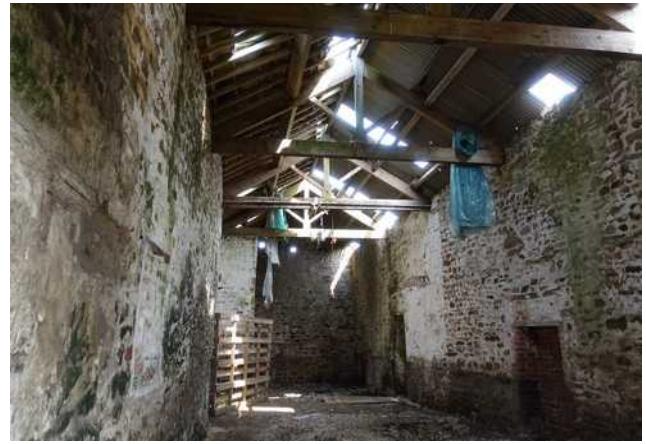
The separate barn is a two storey traditional stone built building with a double pitch stone slate and corrugated fibreboard roof, a single storey lean-to is present on the northern facade with a single pitch corrugated fibreboard roof. External stone walls have gaps and crevices present. The main roof is unlined and roof lights allow light penetration to the interior, the lean to roof is unlined to the interior. Roof slates are in poor condition with areas of lifted, missing and slipped slates allowing weather and light penetration to the interior.

The building was assessed as offering a moderate level of bat roost potential.

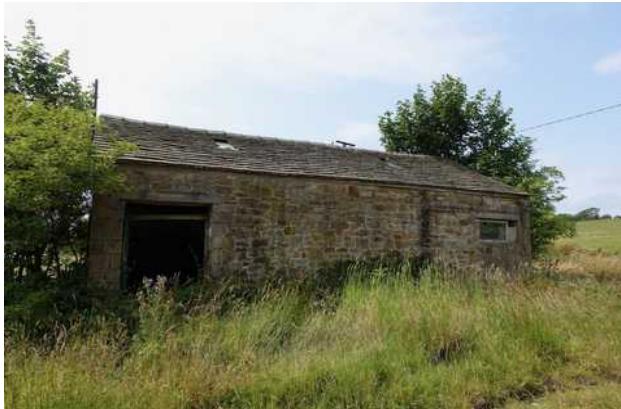
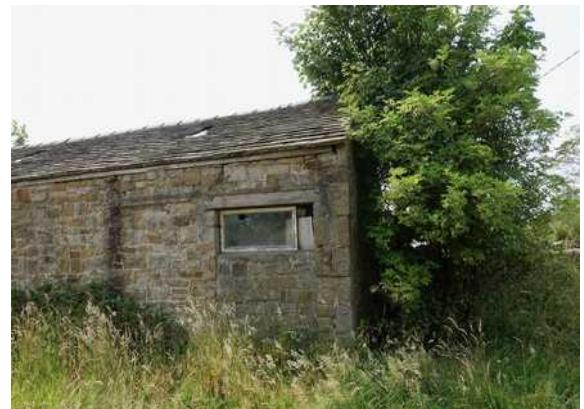
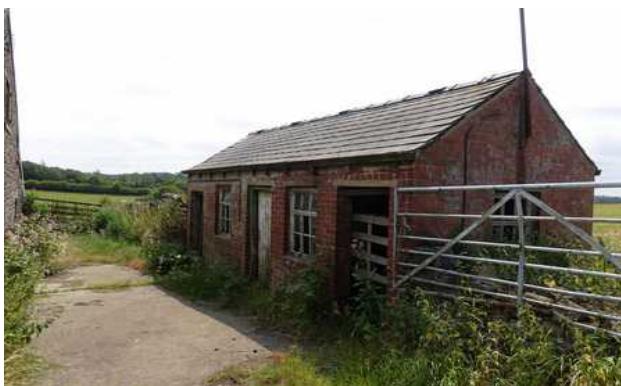
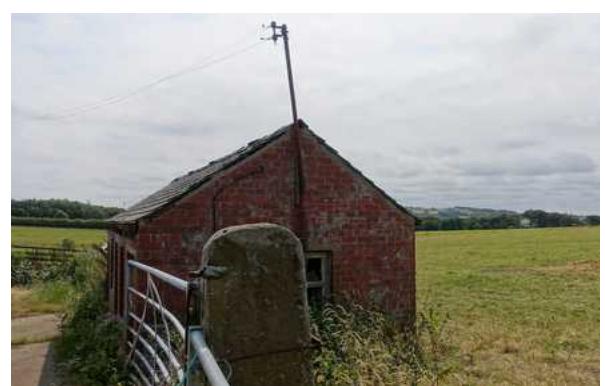
Two further single storey outbuildings are present. A stone outbuilding with double pitch slate roof, and a brick built outbuilding with double pitch slate roof. Both buildings were assessed as offering low bat roost potential.
