HERITAGE STATEMENT

PROPOSED REFURBISHMENT OF EXISTING HOUSE AND CONVERSION OF EXISTING BARN
AT
LOWER REAPS FARM
WHINNEY LANE
MELLOR
LANCASHIRE
BB2 7EL
NGR: SD 66119 30211

Project Ref- 6590 Document Ref- HS-1.01

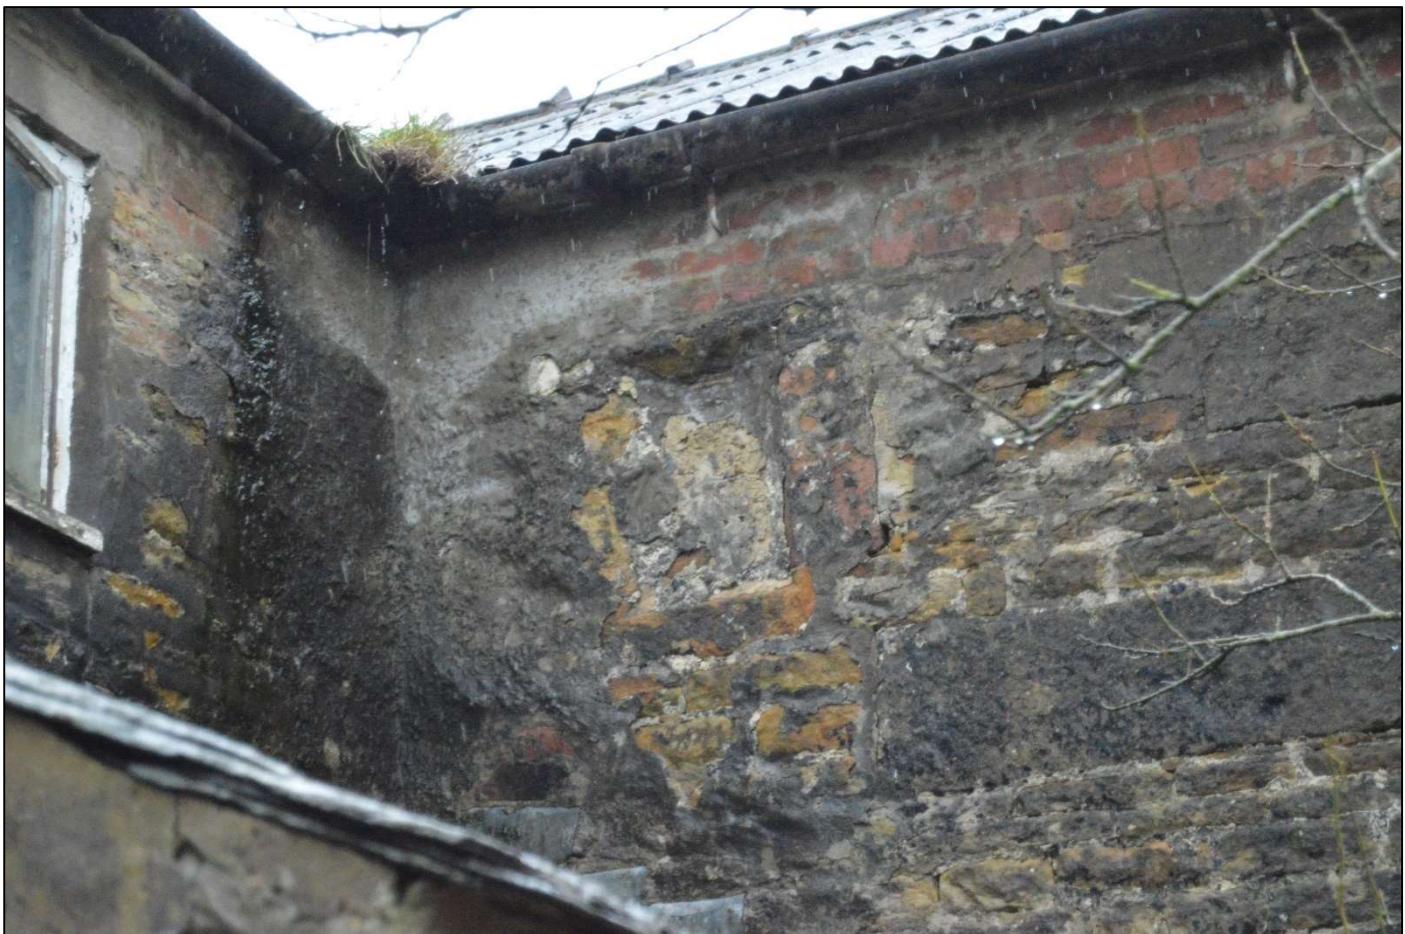
PL04: View of blocked window to the first floor of the west elevation of the cross wing.

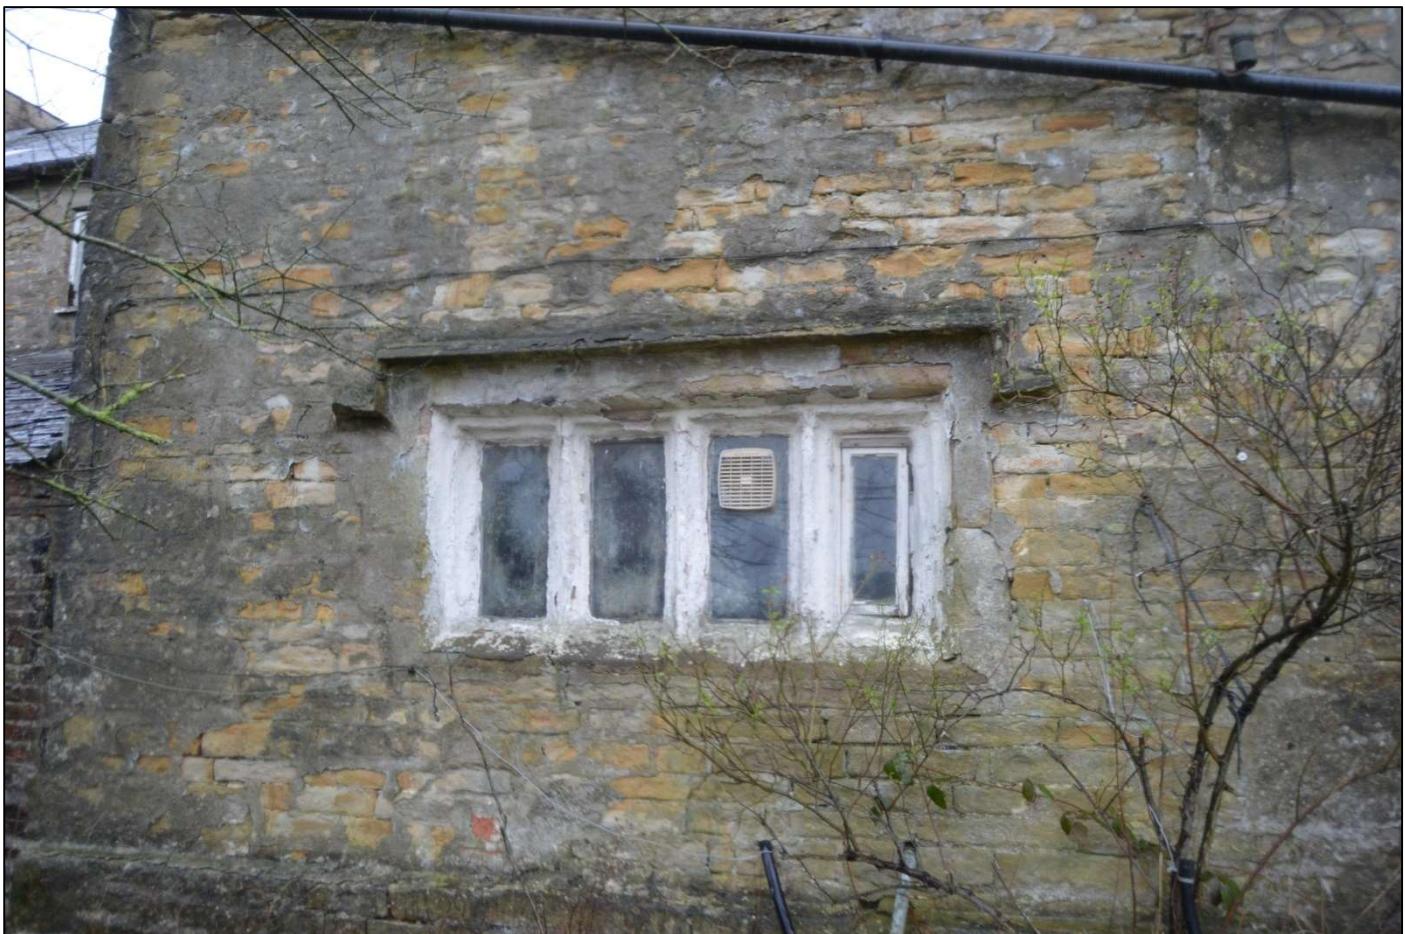
PL06: View of the four-light, stone mullioned window to the ground floor of the cross wing.

The projecting gable end to the cross wing has a 17th century 4-light mullioned window to the ground floor and a similar 3-light mullioned window to the first floor, both with hollowed chamfered mullions, surrounds, with outer chamfer and stone hoods over. Adjacent to the porch, are three boarded up windows to the ground floor. Past photographs of the building show that the eastern window once had a 6-light sash window, probably early 19th century in date and likely formed following the erection of the porch and blocking up of the mullioned window within. The remaining two windows once had 4-light sash windows. These historic windows have been removed and replaced with modern timber casement windows. A modern 4-light timber casement window is situated above the lean-to porch, with a further window, also of four lights, is present to the first floor to the west end of the farmhouse's front

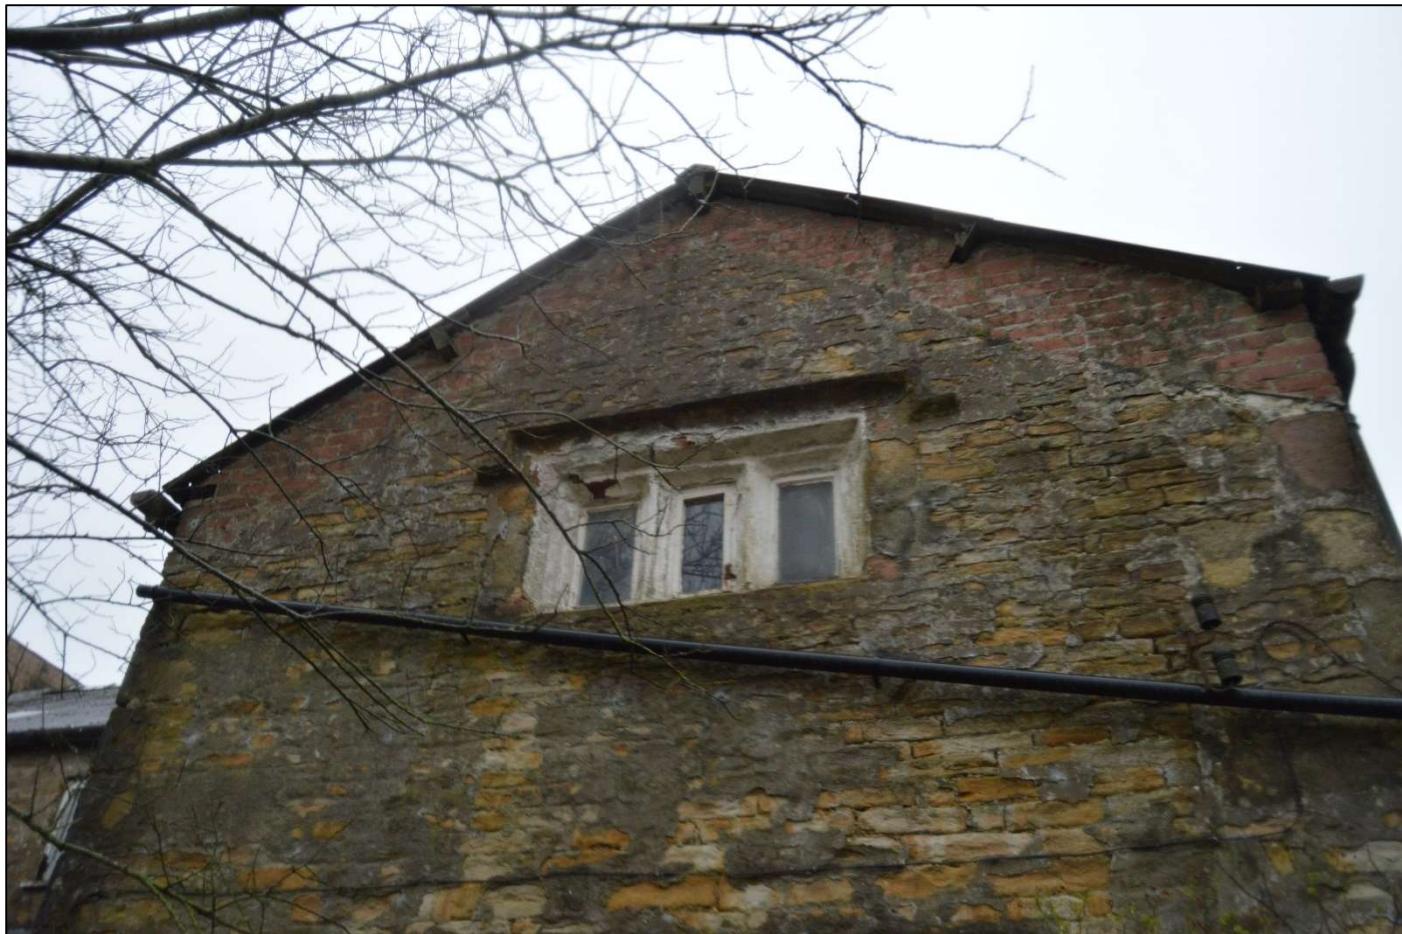
PL07: View of the three-light, stone mullioned window to the first floor of the cross wing.

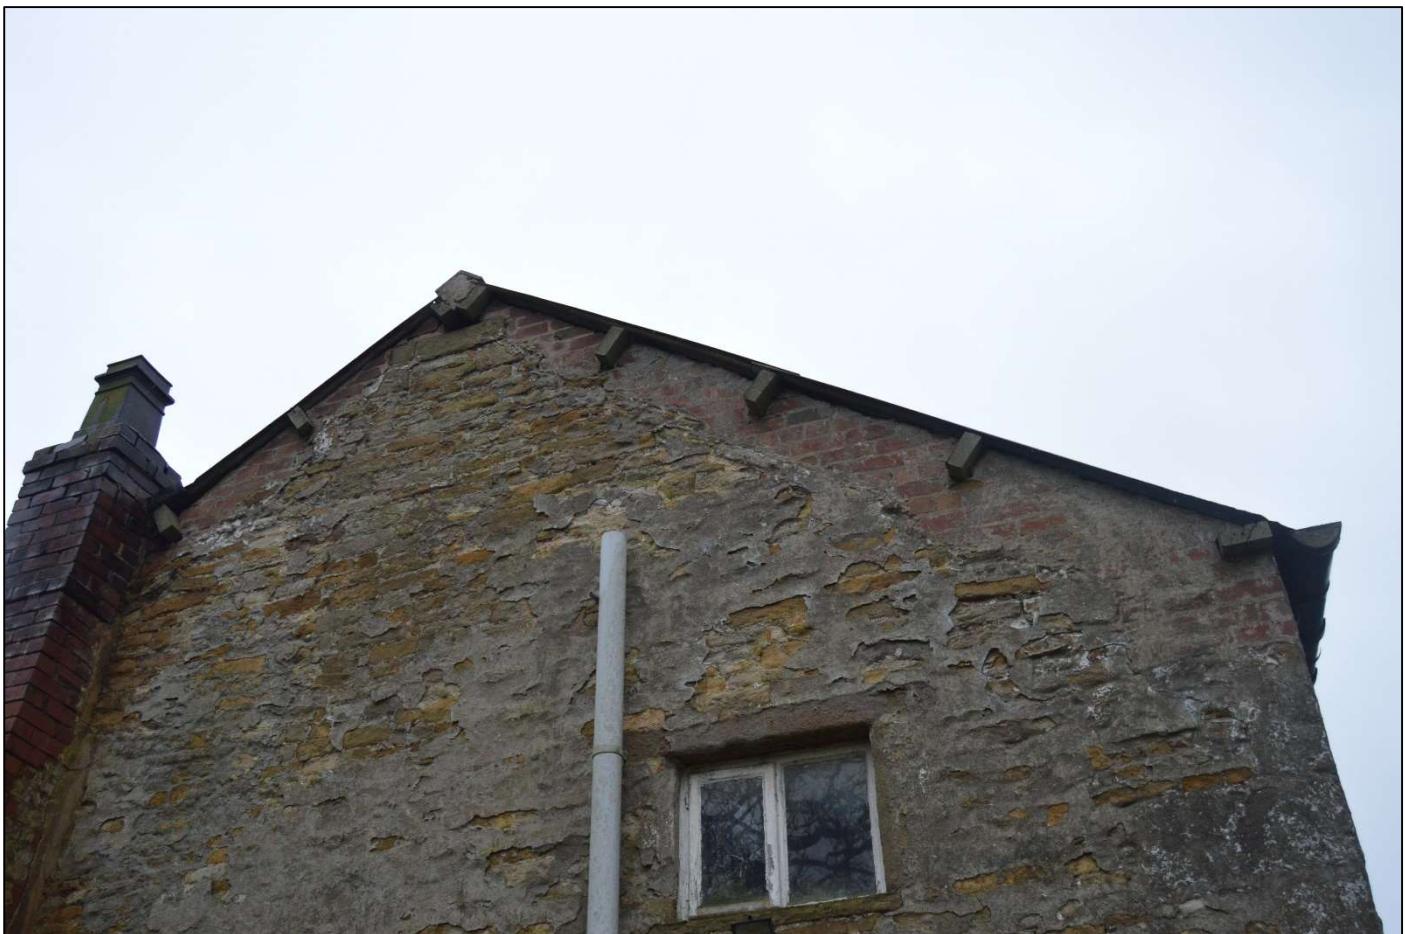
PL10: View of raised roof and old roofline to the east gable end.

The farmhouse is three units in length and is one unit deep, including a projecting cross wing to the east end of the building. A stable provides a fourth unit to the building to the west end. The building is constructed from local sandstone, which has been roughly dressed and the roof covering is of profiled sheet roofing. A full height brickwork gable stack is located to the east gable end, with a further stack located centrally along the length of the building at ridge level and denotes the extent of the original small 17th century farmhouse, which is of two storeys in height but was slightly lower in height than the present eaves. The west unit of the house and the former stable are later additions, probably dating from the 19th century, with the stable being later than the west unit. Lines of dichotomy, formed by stone quoins, to both the front and rear elevations, denote the phases of construction. The front porch to the 17th century house is likely an early 19th century addition and the front south elevation of the porch has been rebuilt in the 20th century in facing brickwork. The roof structure to the farmhouse and stable has been entirely replaced in the 20th century, an alteration which was accompanied by the raising of the eaves using facing brickwork.

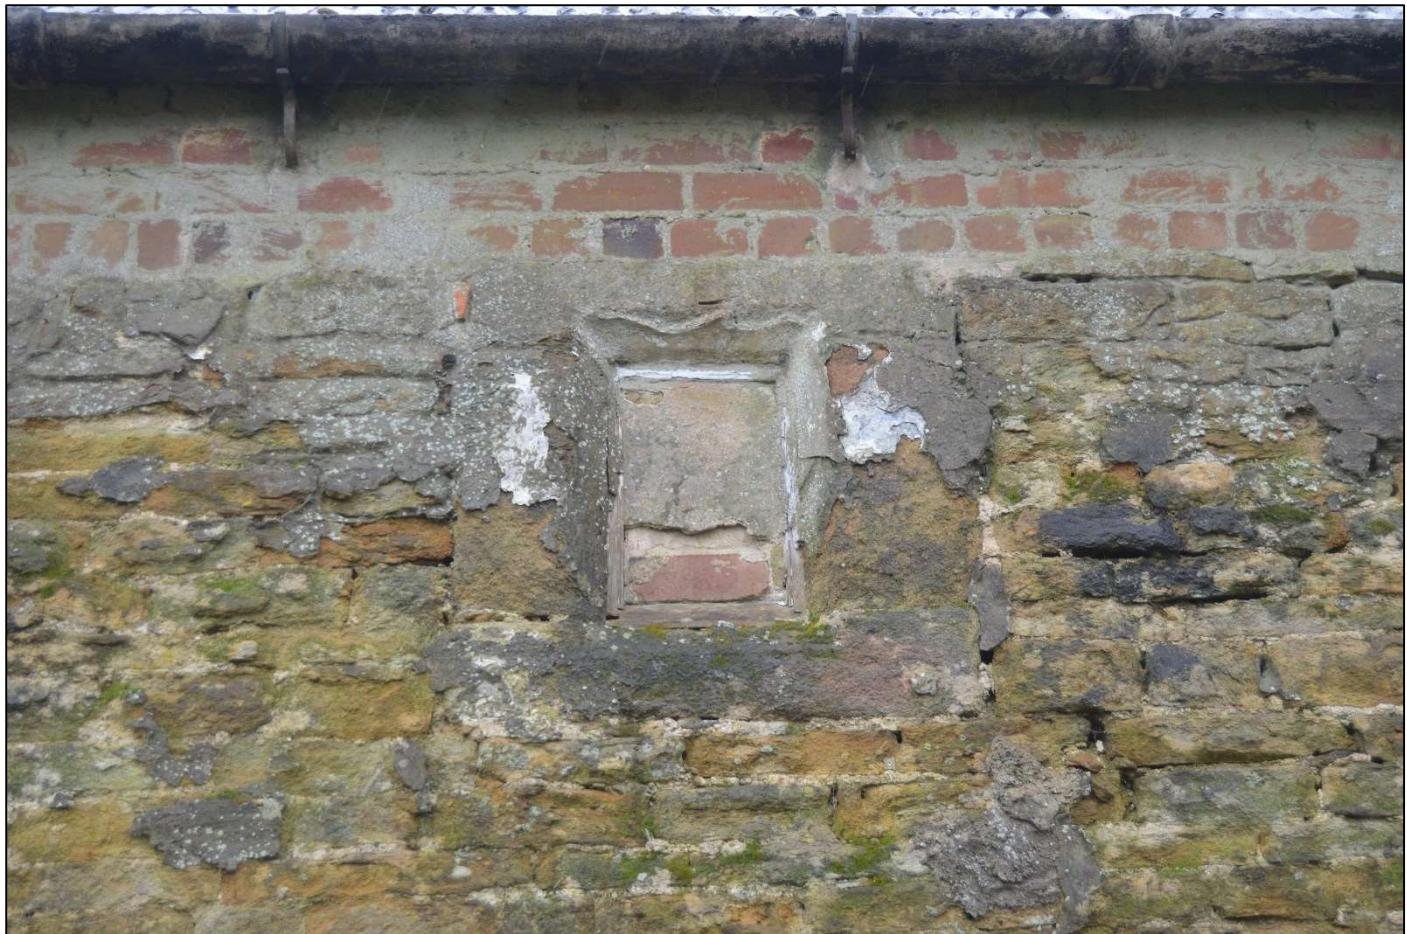
PL15: View of blocked up former staircase window to the first floor of the rear north elevation.

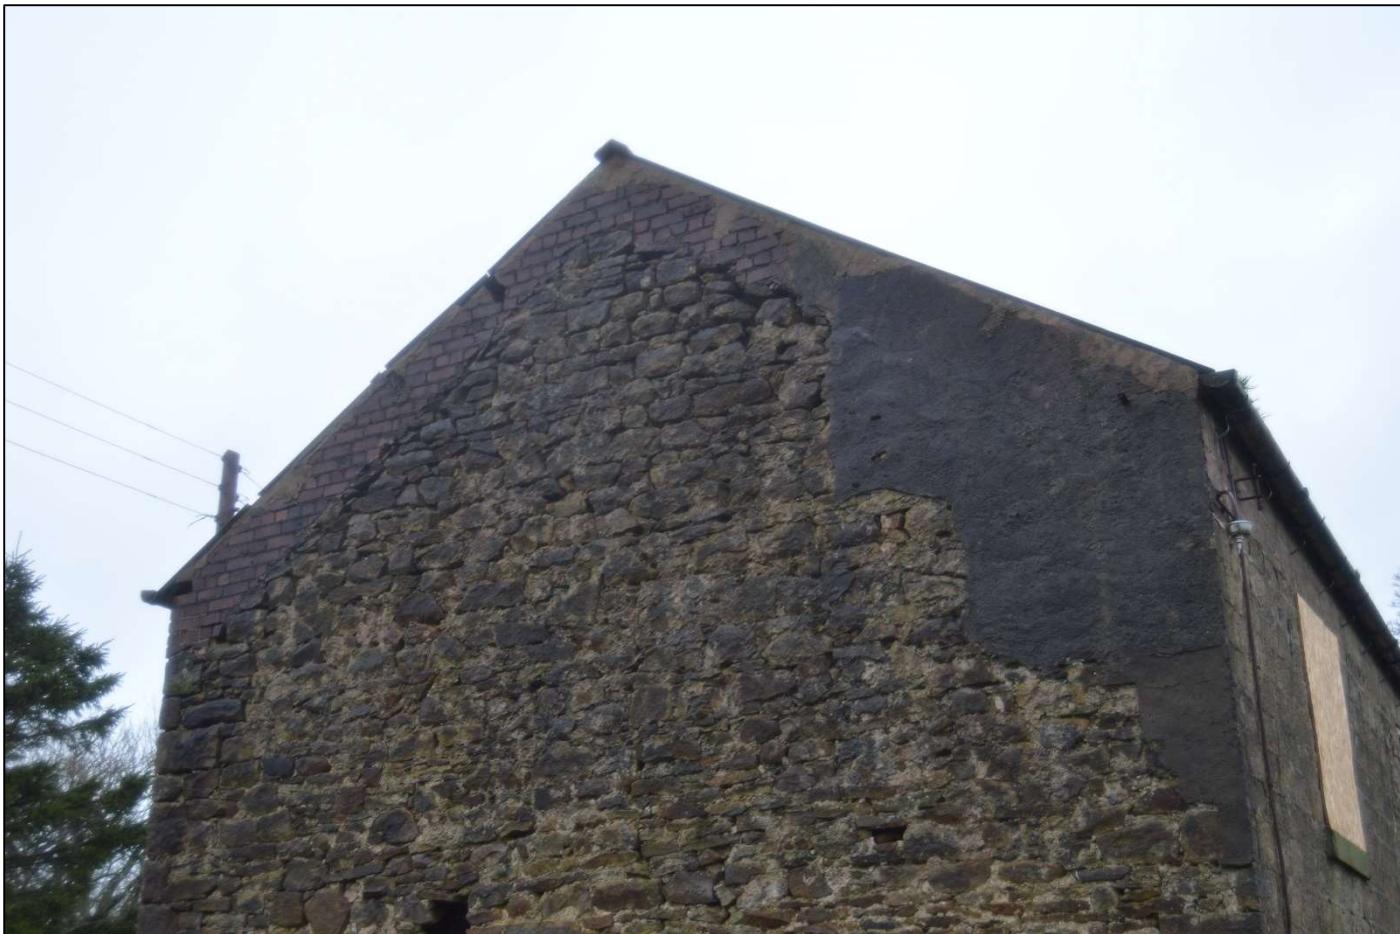
PL17: View of raised roof and old roofline to the west gable end elevation.

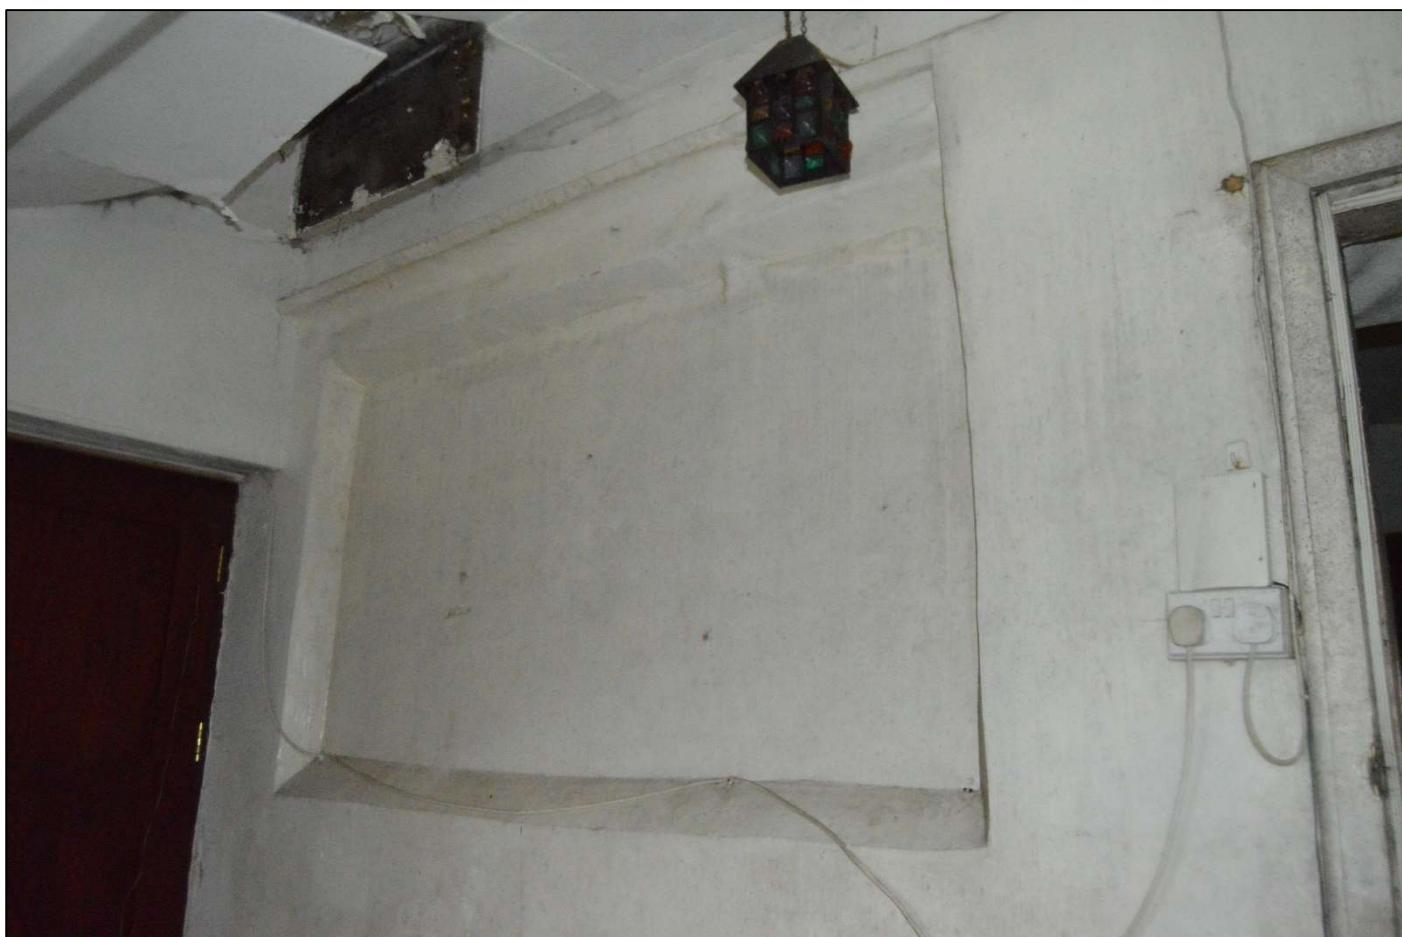
PL25: View of blocked former mullioned window from within the front south elevation lean-to.

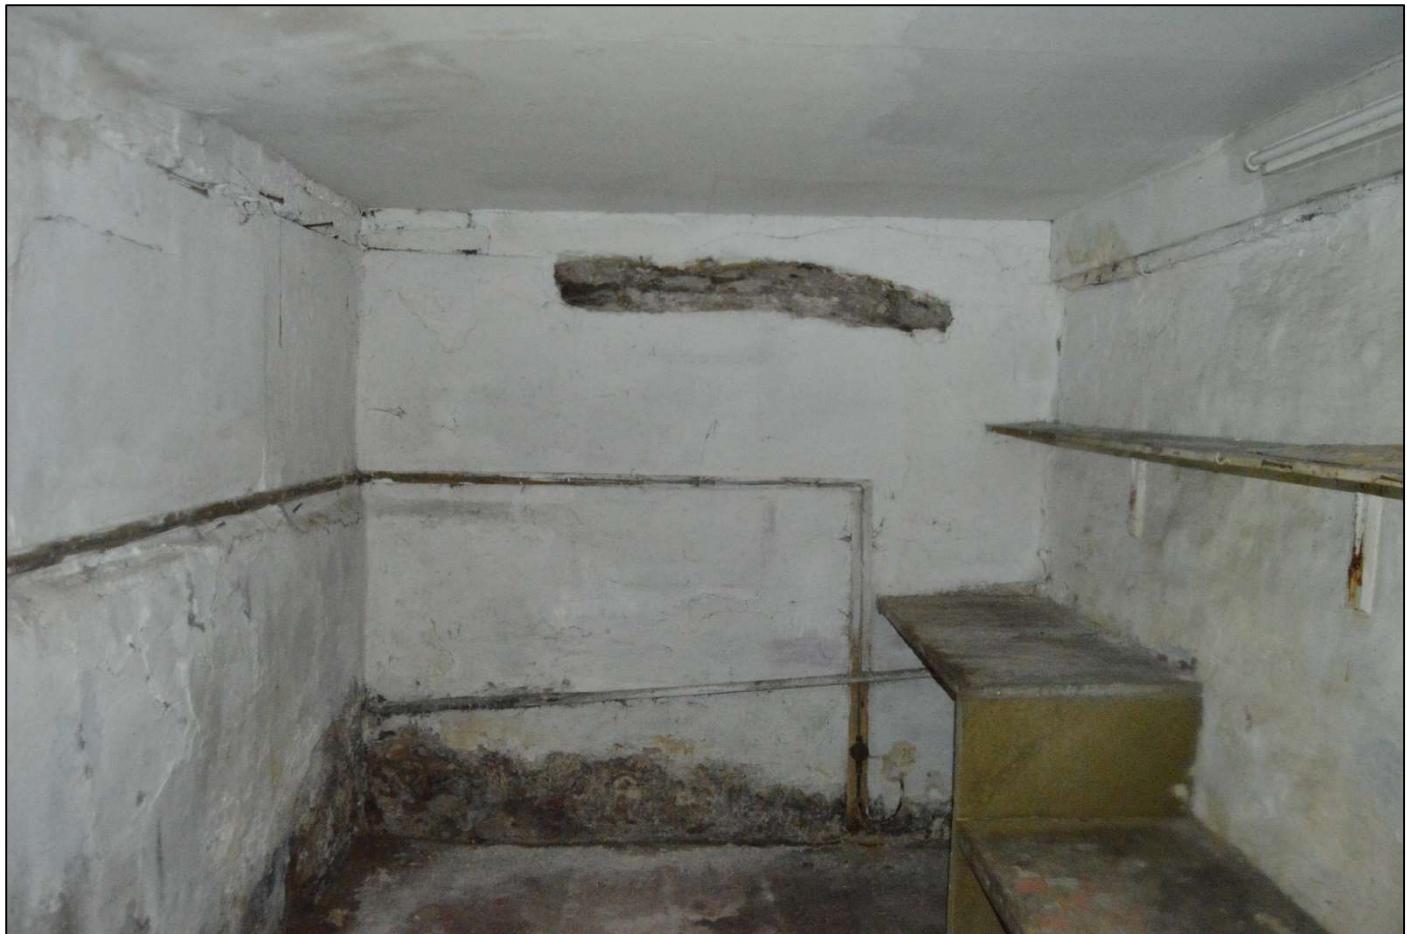
PL26: View east within the rear ground floor unit to the cross wing (note the timber lintel to the blocked window).

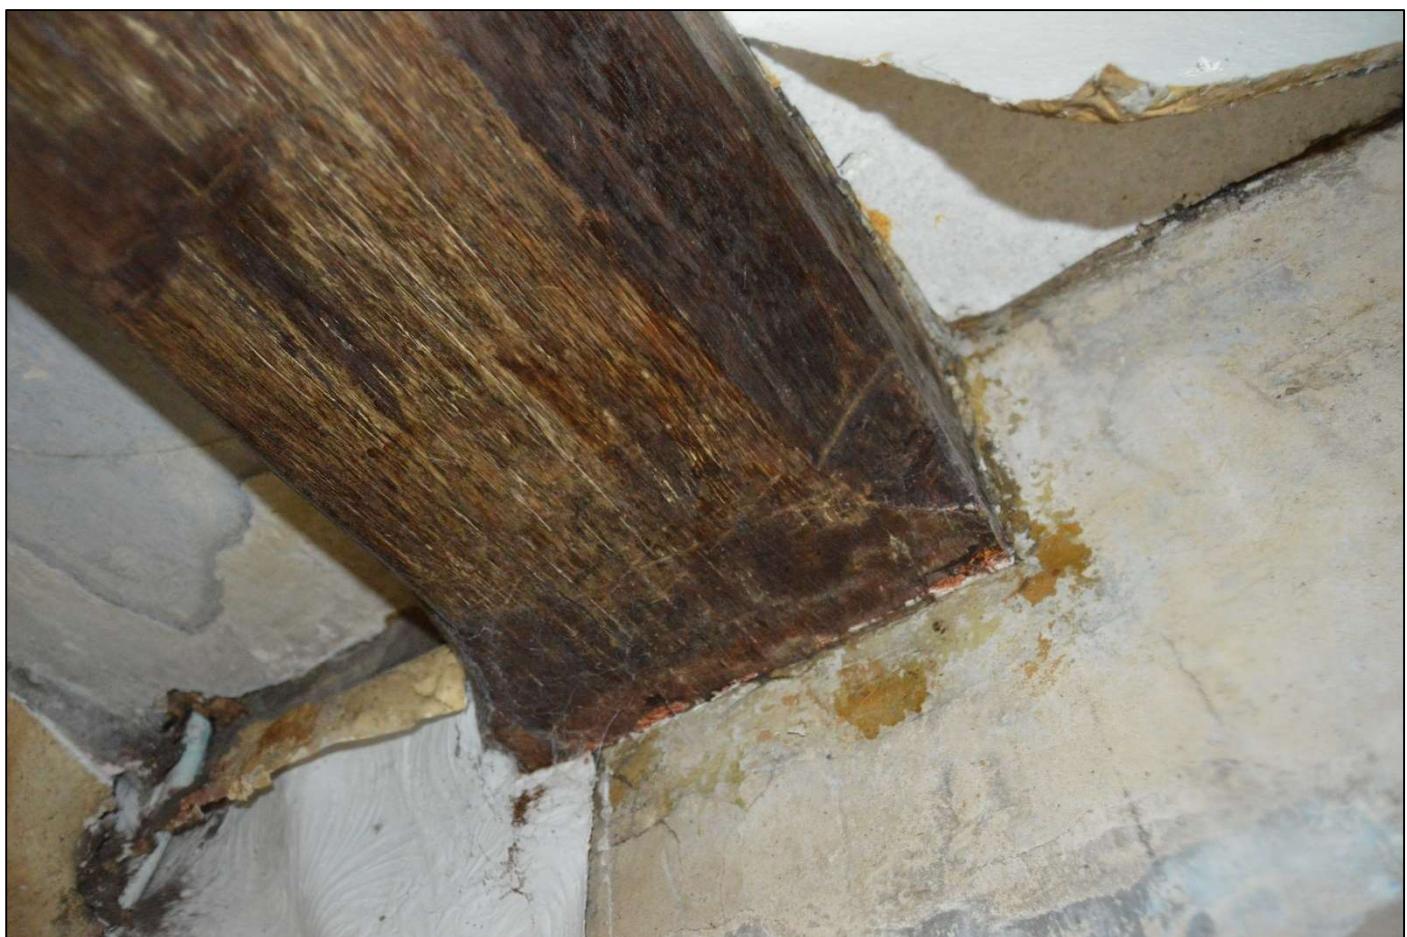
PL31: View of 17th century floor beam within the central ground floor unit, with chamfers and stops.

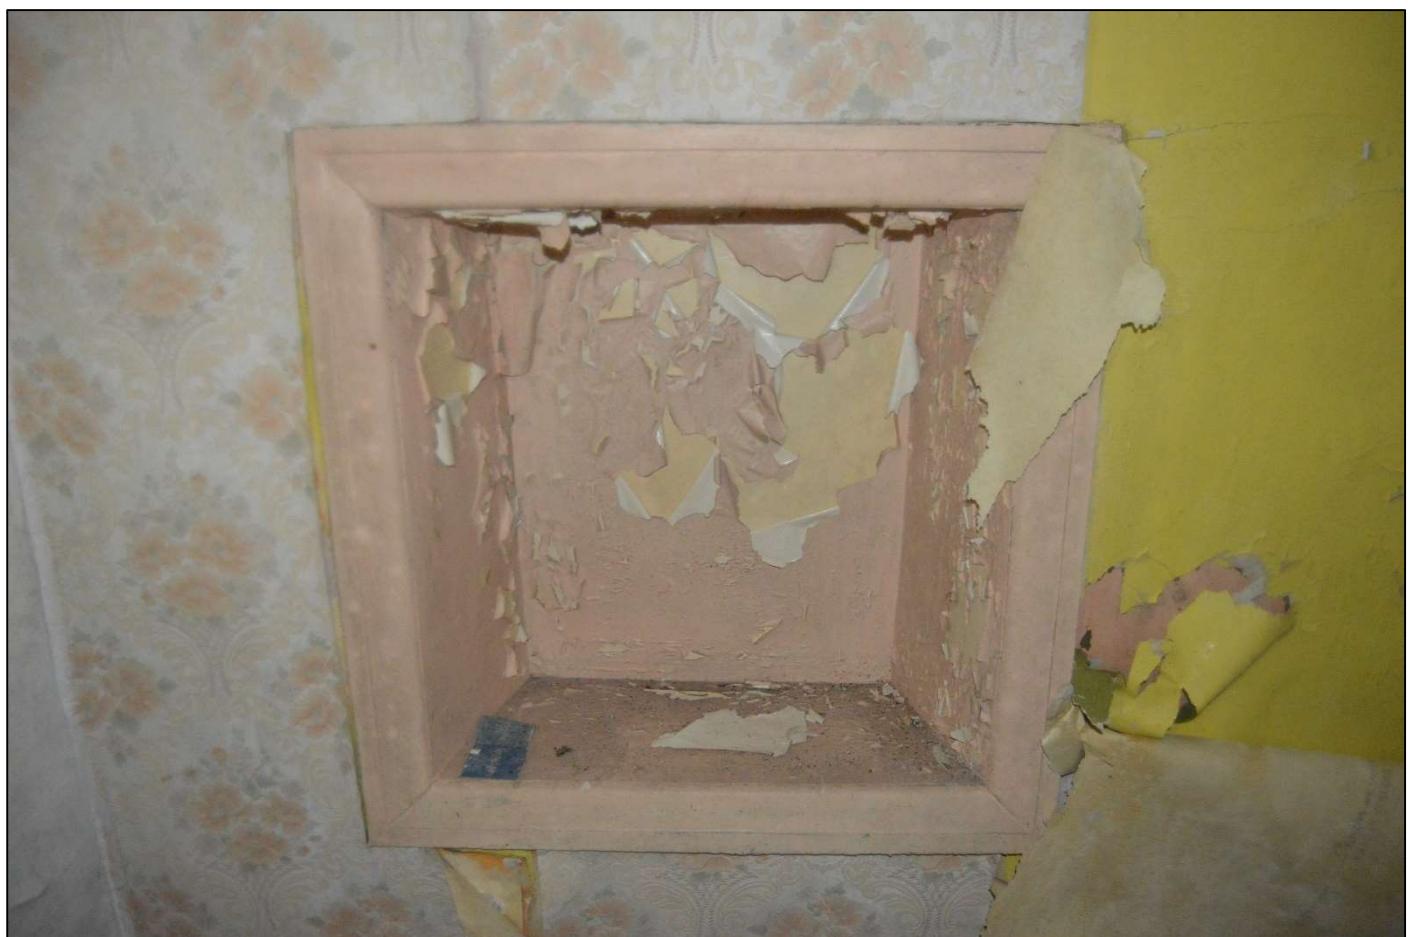
PL36: View of blocked possible former staircase window to the first-floor landing to the rear of the cross wing.

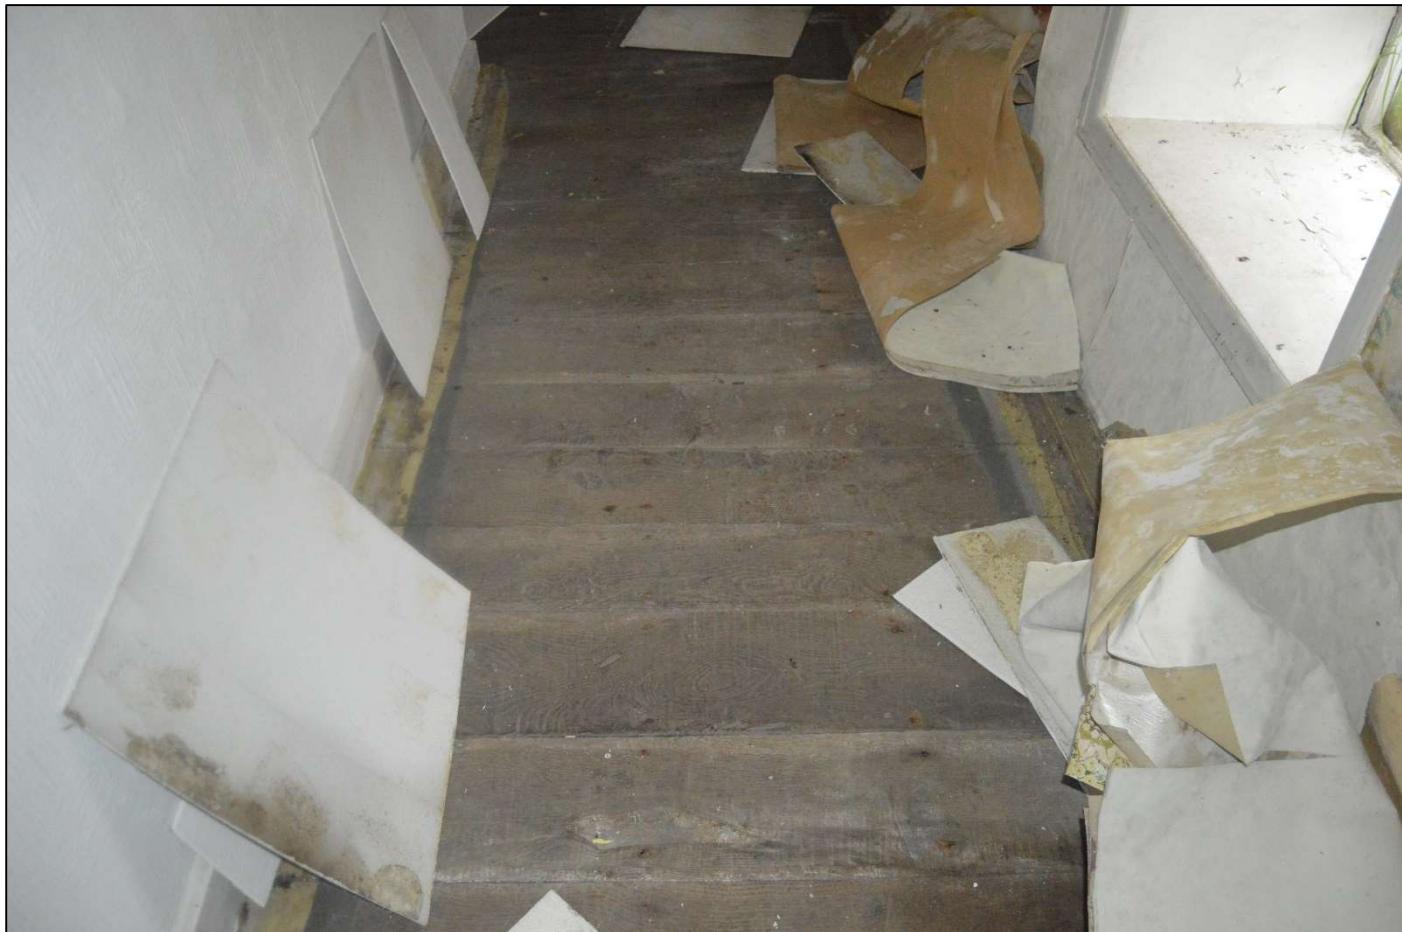
PL38: View of the timber floorboards to the corridor / landing to the rear of the building.

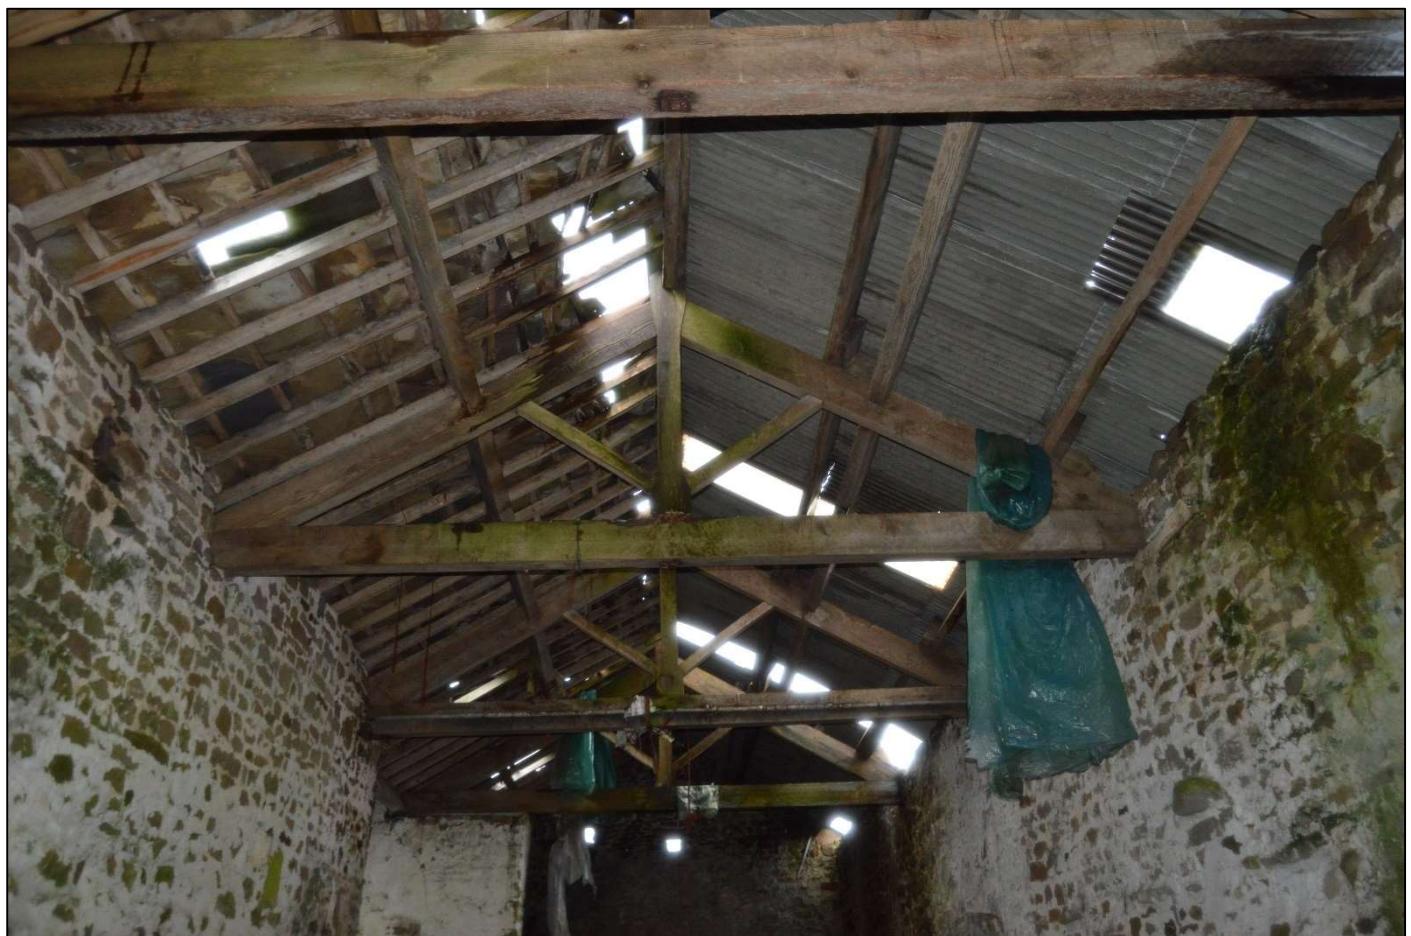
PL60: View of the roof structure over the main core of the barn.

The original five bay combination barn, now forms one single space. The presence of a forking hole present to the west gable end would suggest that a hayloft would be present to the west end of the barn, however none is present and there is no physical evidence, i.e., joist sockets, to suggest one was ever here which might mean that the sockets could have been blocked in, likely in the 20th century. A blocked window and door are present to the west side of the north wall of the barn (seen internally), with two opposing blocked up windows noted to the south wall opposite. A brick recess lies adjacent to the blocked windows in the south wall and appears to be an inserted door opening, with brick jambs which was also subsequently blocked-up. The roof structure is comprised of 4no kingpost roof trusses of sawn timber and of 19th century date and bear carpenters' assembly marks. The roof structure to the rear south roof slope is somewhat piecemeal, comprising of varying rows of sawn timber purlins onto which the profiled sheet roofing is fixed to. The north slope has a central row of sawn timber purlins, with common timber rafters and battens over, with a sandstone slate roof covering.

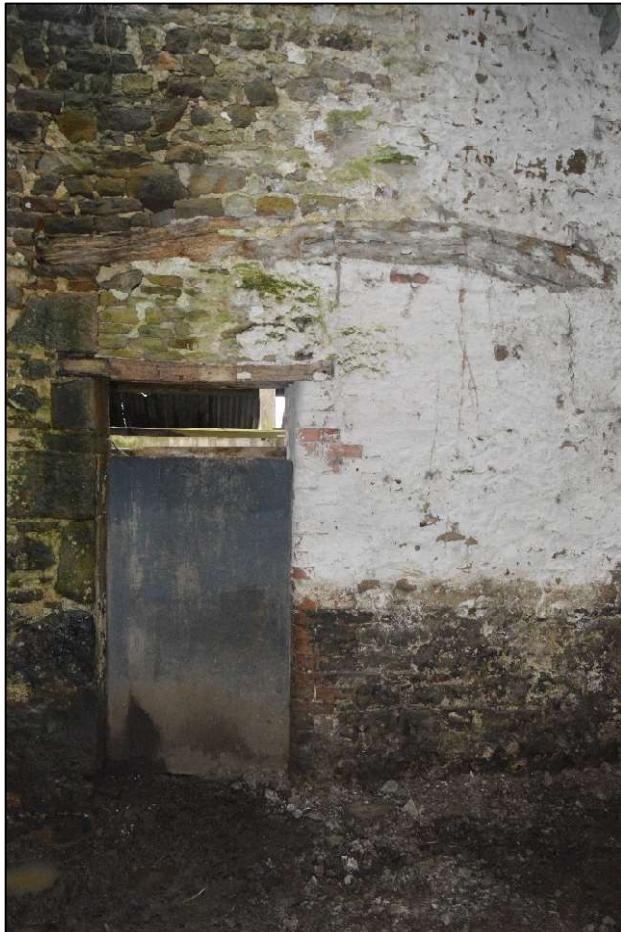
PL61: View of the opposing doorway (now blocked up) opposite the cart entry porch.

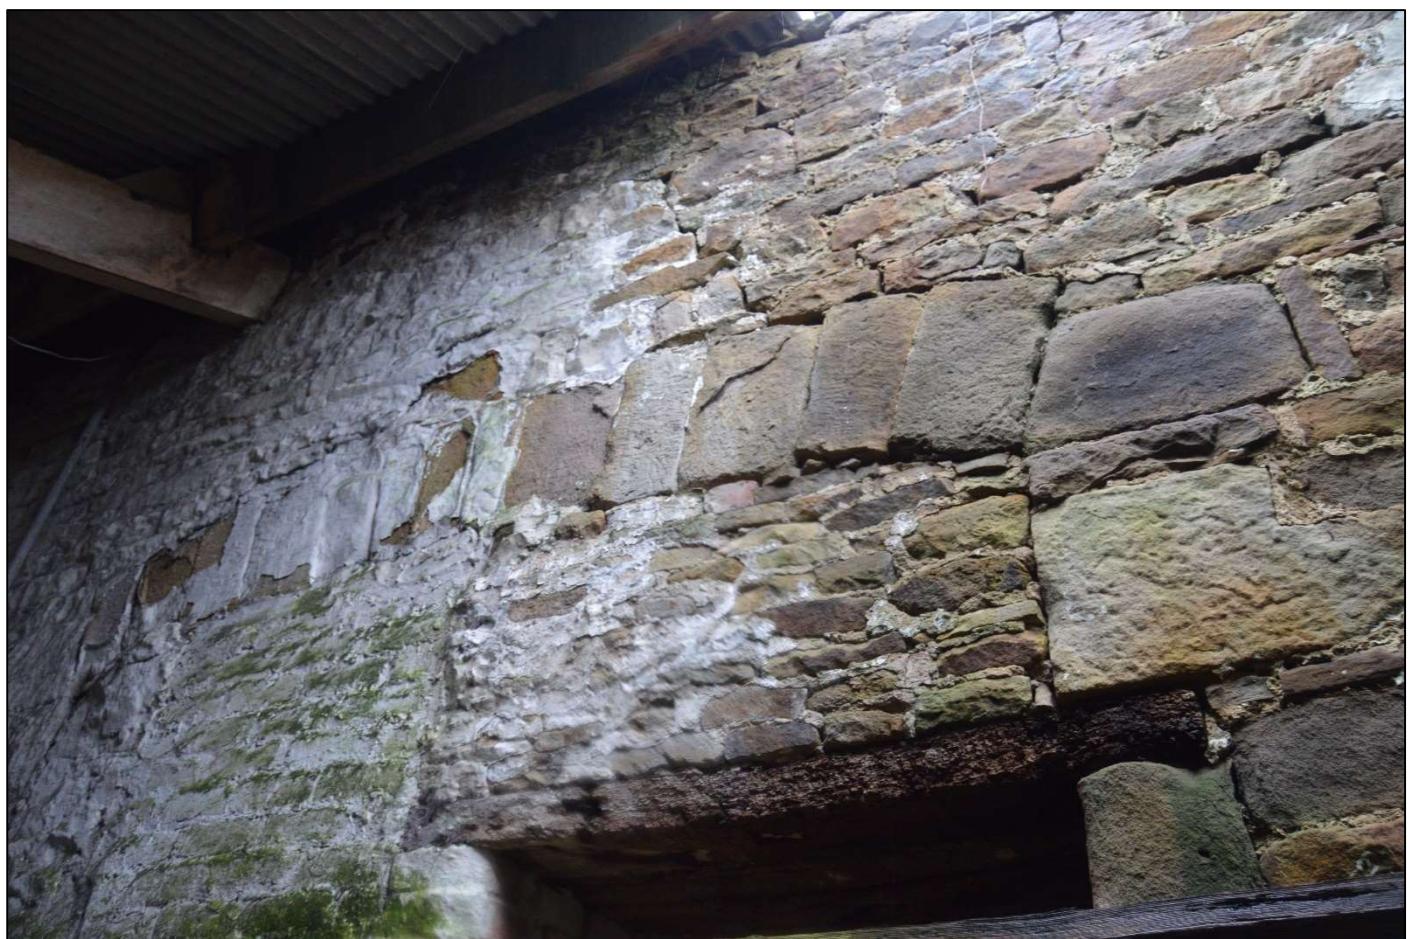
PL62: View of stone voussoirs to the blocked-up opening viewed from within the south shippion.

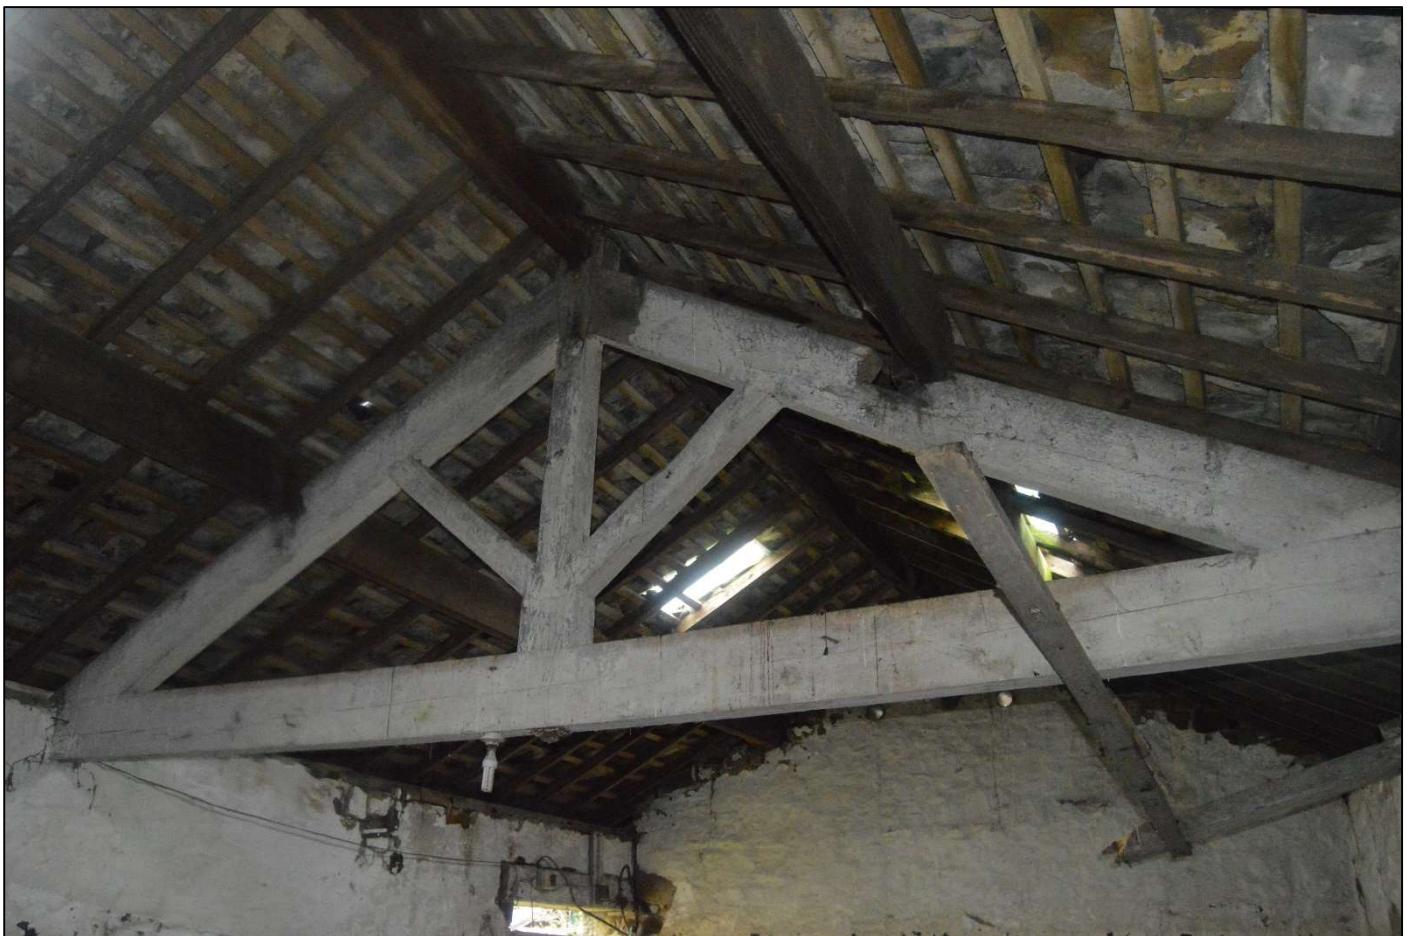
PL67: View of the roof structure to the stone outbuilding.
