Bat Survey Report

Hodder Court, Clitheroe, Lancashire, BB7 9PP

Report title	Bat Survey Report
Revision version	01
Site address	Flat 3, Hodder Court, Clitheroe, Lancashire, BB7 9PP
Grid reference	SD 702 389
Report composed by	Miranda Cowan Ecology Ltd. (MCIEEM, Tech ArbA)
Client	Julie Booth
Date	31 st October 2022

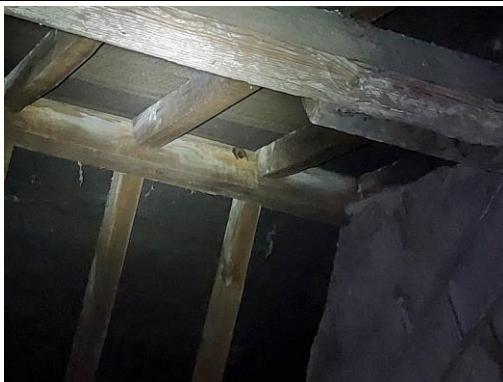
Appendix C details full findings from the PRA with the data summarised below. The overall key finding from the PRA related to the presence of two roosting common pipistrelle bats, both located on the main roof wooden ridge beam. Multiple common pipistrelle droppings were also located on boarding throughout the floor of the loft. The droppings were small (2mm wide x 8mm length) and disintegrated to dust upon touch.

<i>Plate 1:</i> Roosting common pipistrelle on main ridge beam.	<i>Plate 2:</i> Accumulations of common pipistrelle bat droppings

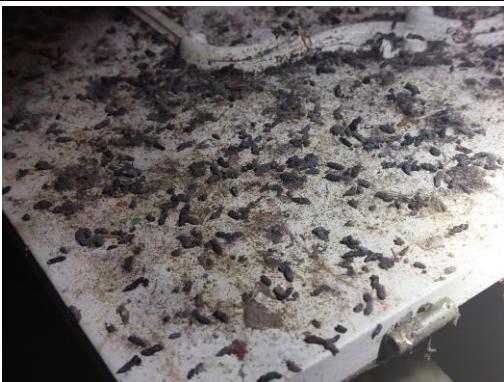
The PRA completed on the 14th July 2022 confirmed two individual common pipistrelle bats to be roosting within the loft void of Flat 3, Hodder Court. Abundant common pipistrelle bat droppings were also located across the floor of the attic space, reflecting a long-term established roost, indicative of a breeding site.

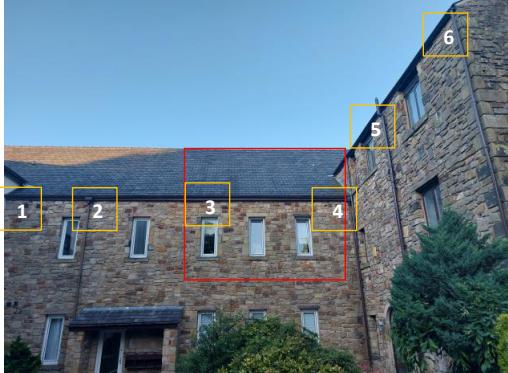
Plates 1 and 2 highlight the locations for where there are gaps beneath the fascia boarding, with PRF 3 being associated with Flat 3. PRF 2 is behind a drainpipe, above the communal staircase and PRF 7 and 8 are to the rear of the building. The gaps under the fascia boarding were circa. 5cm and there from ground level there were gaps in the brick within PRF 2 and 3.

Plate 3: Front view of Hodder's Court, extent of Flat 2.	Plate 4: Rear view of Hodder's Court, extent of Flat 2

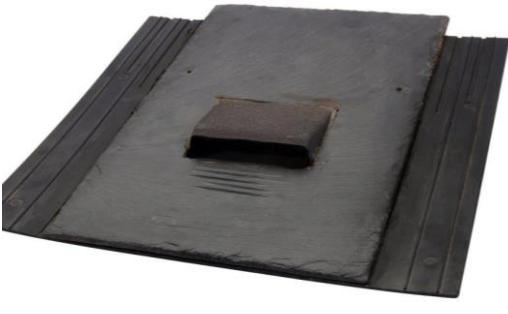
Bat access slate	1FF Schwegler Bat Box

Bat access tiles and bat boxes can be sourced from <https://www.nhbs.com/>, where there is a selection of specifications to meet with the requirement of construction.

- 1) To retain the top section of the loft void for bats, which includes the main support beam that common pipistrelle was recorded as roosting on.
- 2) To compensate for loss of PRF (fascia boarding), the proposal should include four bat tiles in the top roof void section. Two should be on the west side of the roof and two on the east.

- 5) Alternative roost locations, in the form of bat boxes should be positioned on trees to compensate for loss and reduction of roosting opportunities during and post works. The bat boxes are to be installed prior to the start of the works, with their number and location informed by the ecologist and agreed under Hodder Court ownership. The provision of bat boxes will need to be illustrated on the design plan.

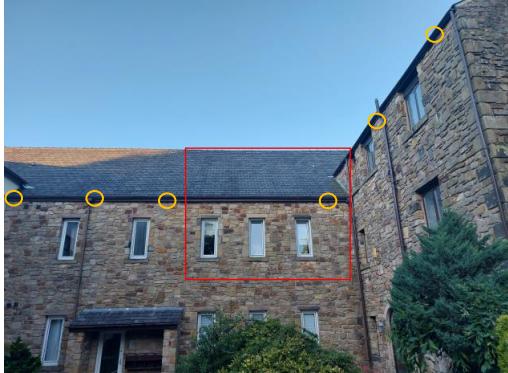
Site: Hodder Court	Structure Ref / OS Ref: SD 702 389	Date: 14 th July 2022		
Surveyor: Miranda Cowan Ecology Ltd.	Weather: Dry conditions, good visibility			
<p>Structure Description: A complex for flats, with the front of Flat 3 being west facing with a courtyard, and the rear of the Flat 3 east facing and adjoined by a steep sloping area of amenity grass / garden. Flat 3 front and rear aspects are shown as Plate 1 and 5. The building is built from traditional local stone, which is fully and neatly pointed. The entirety of Hodder Court has a slate roof, with all individual tiles sitting flush. All stone surroundings to the windows are also neatly flush. Wooden fascia boarding (Plate 2) spans across both the full length of both the front and rear facing aspect of Hodder Court. The property to the right of the image in Plate 1 relates to a previous EPSL as identified on magic.</p>				
<p>Note of PRF: The fascia boarding at the front and rear of Flat 3, and also along the wider extent to the front and rear property has notable gaps beneath, see marked orange circles for location of gaps under fascia boarding (Plate 1 and 2).</p>

<p>Resulting Value: Confirmed common pipistrelle bat roost.</p>				
<p>Additional Survey Requirements: Three activity surveys.</p>				
<p>Plate 1: Front view of Hodder's Court, extent of Flat 2.</p>

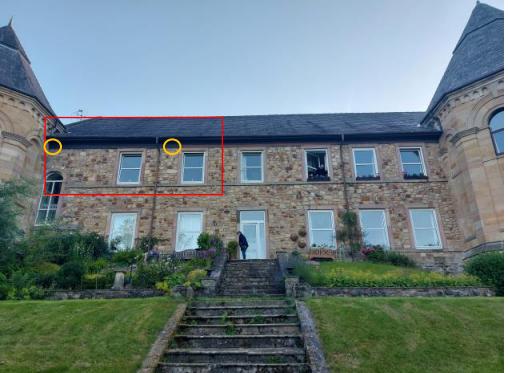
<p>Plate 5: Rear view of Hodder's Court, extent of Flat 2.</p>

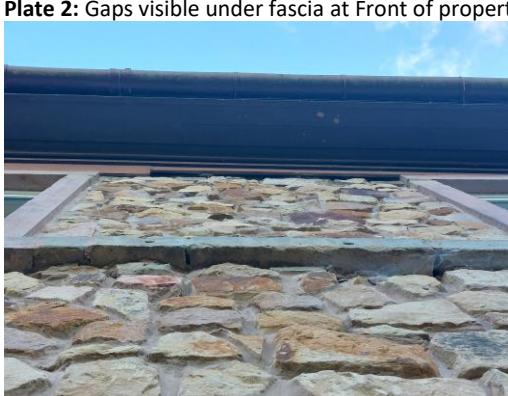
<p>Plate 2: Gaps visible under fascia at Front of property.</p>

Once the soft demolitions works are complete and all bats are safely removed, the PRF's linked to Flat 3, including gaps between adjoining loft voids will need to be temporarily closed off to prevent bats re-entering the loft void as the works commence. Bats will still have access to other loft sections of Hodder Court and there will be provision of external bat boxes.

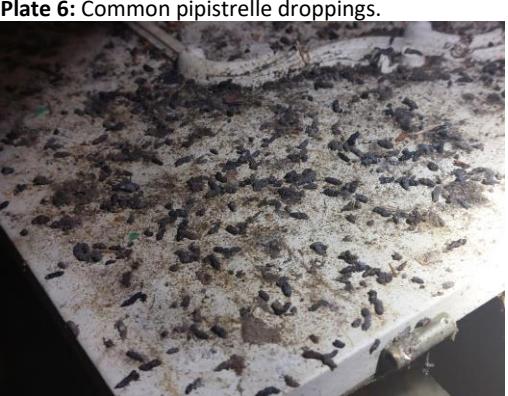
<p>Plate 6: Common pipistrelle droppings.</p>

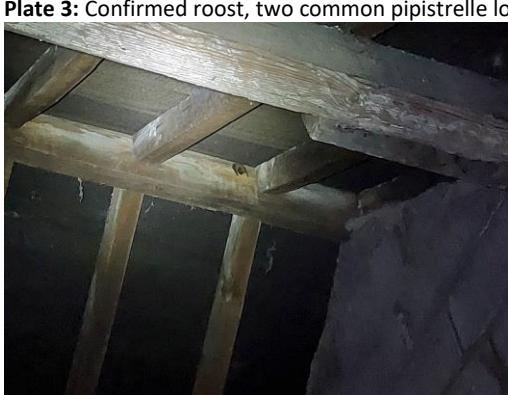
<p>Plate 3: Confirmed roost, two common pipistrelle located</p>

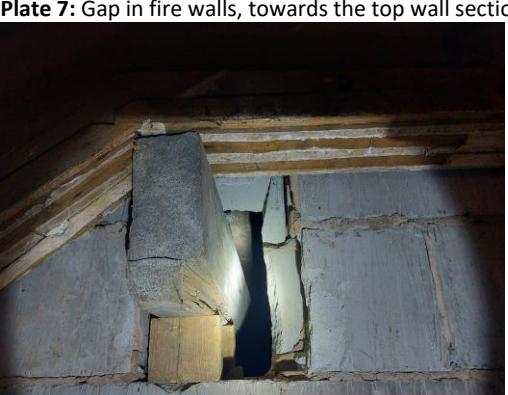
Given that common pipistrelle was observed emerging from all PRF's, it is concluded that the bat roost spans throughout the full extents of loft avoids above different occupied flats. Internal bat passage between each loft void is likely to be via notable gaps in the upper sections of the fire walls, where the central ridge beam spans through. These gaps equate to the size of a single breeze block.

<p>Plate 7: Gap in fire walls, towards the top wall section.</p>

- 3) Access should be maintained for bats throughout the entirety of the Hodder Court's loft voids, although the method for achieving this will need to balance with fire safety risks.

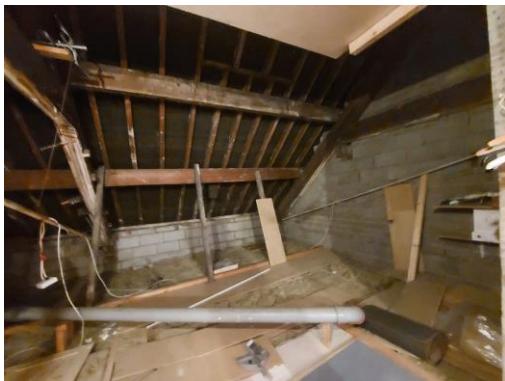
Where there is a low wall along the length of the lower sloping roof section (Plate 4, **Appendix C**), close to the overhang, there is potential for bats to be roosting behind the wall, which extends down to the fascia boarding for where bats can access and egress.

Plate 4: View of loft void, fir wall and low wall along lower roof section.

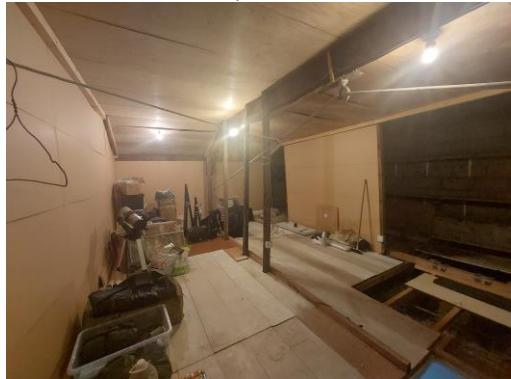
The loft void is a used space for storage and has lighting throughout. The floor is lined with insulation and is partially boarded. Internal fire walls are built from breeze blocks, with gaps in the brickwork where the central ridge beam traverses through to other loft voids above separate flats. Breeze blocks are also built around the lower section of the sloping roof, behind which area gaps to facilitate bat migrating towards openings beneath the roof overhang and fascia boarding.

Plate 8: Part lined loft space.
