**BAT SURVEY AT -  
MEADOWCROFT  
LITTLEMOOR ROAD  
CLITHEROE**

**DATE AND TIME OF VISIT  
12<sup>th</sup> Jan 2023 2.15 pm**

**REFERENCE. Mr and Mrs Clarke**

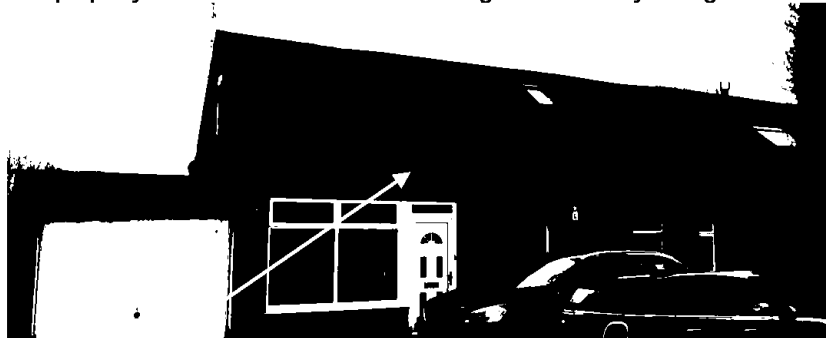
Disruption to section of the front elevation roof pitch where the new porch roof will abut.

Section of roof being affected by the extension.
