# **Post-Excavation Assessment for Archaeological Monitoring, Glebe Barn, Gisburn, Lancashire**

**Client: Andrew Weir**

Project: The Glebe Barn, Gisburn

Date: September 2022

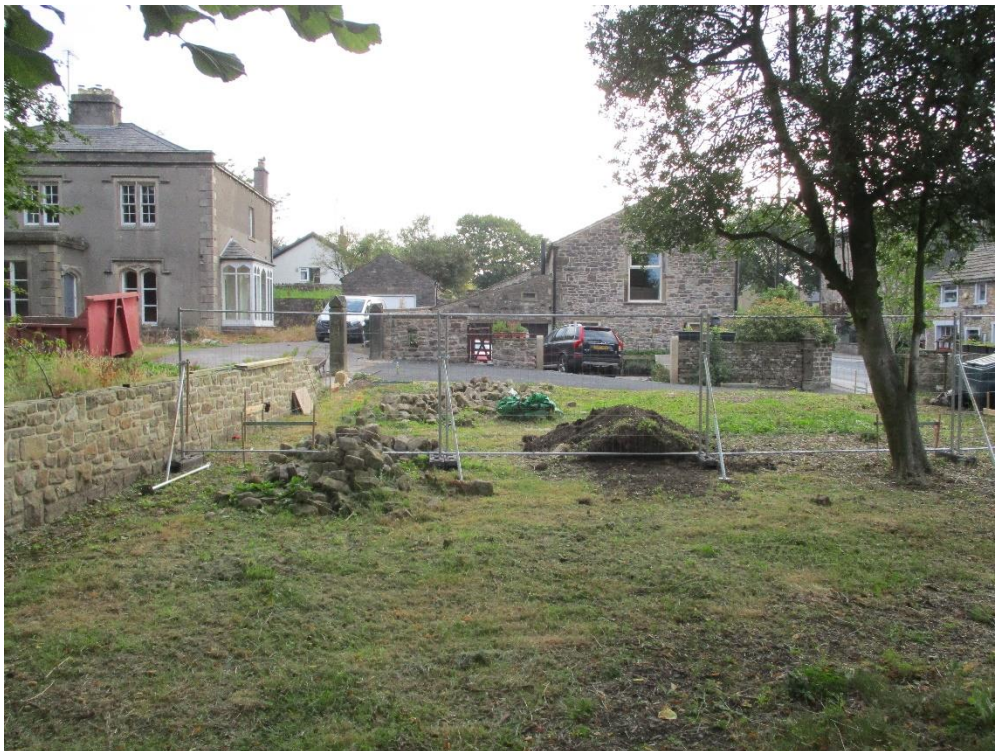
5.2.1 Topsoil stripping was required on an area measuring 9m in length (north to south) by 7m in width (east to west) in plan (Figure 1). This area covered the entire development and was for the foundation trenches.

*Figure 1: General view of the Site prior to works; looking east.*

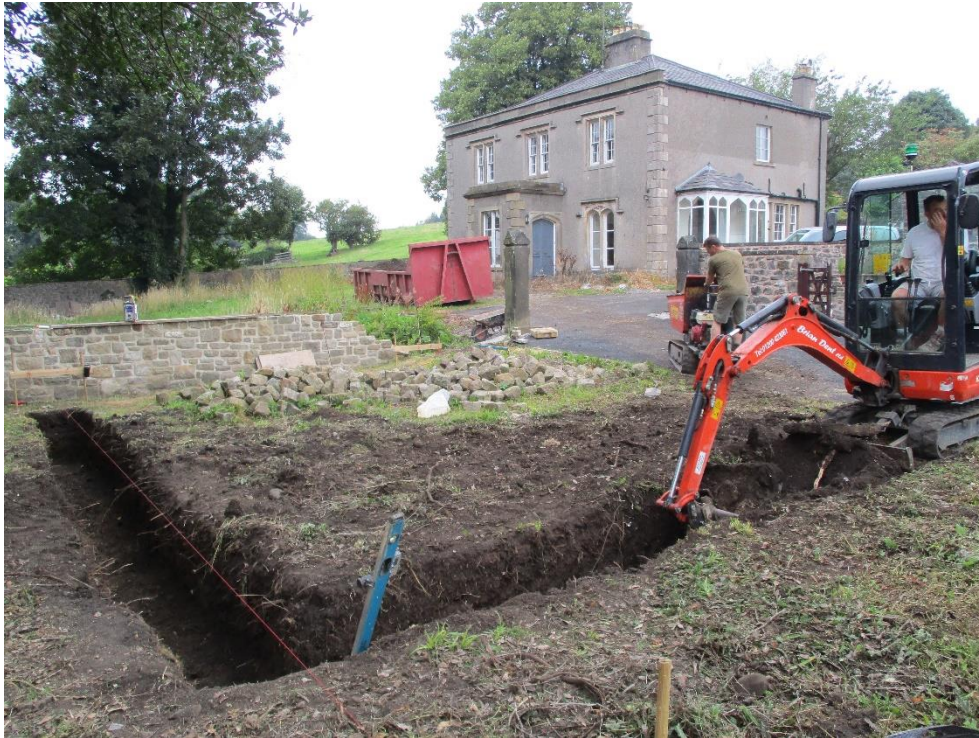
5.2.3 The topsoil overlay deposits of mid-grey-brown clay-silt with occasional rounded pebbles mixed with yellow brown clay, which has been interpreted as pockets of redeposited natural (102). Occasional flecks of lime mortar were recorded up to 50mm in size. Context (102) was 0.1-0.4m thick and widespread across the Site but did thin out from south to north. Likely a modern deposit resulting from the levelling of the Site.

*Figure 2: General view during excavation of trenches. Looking north east towards the Vicarage.*

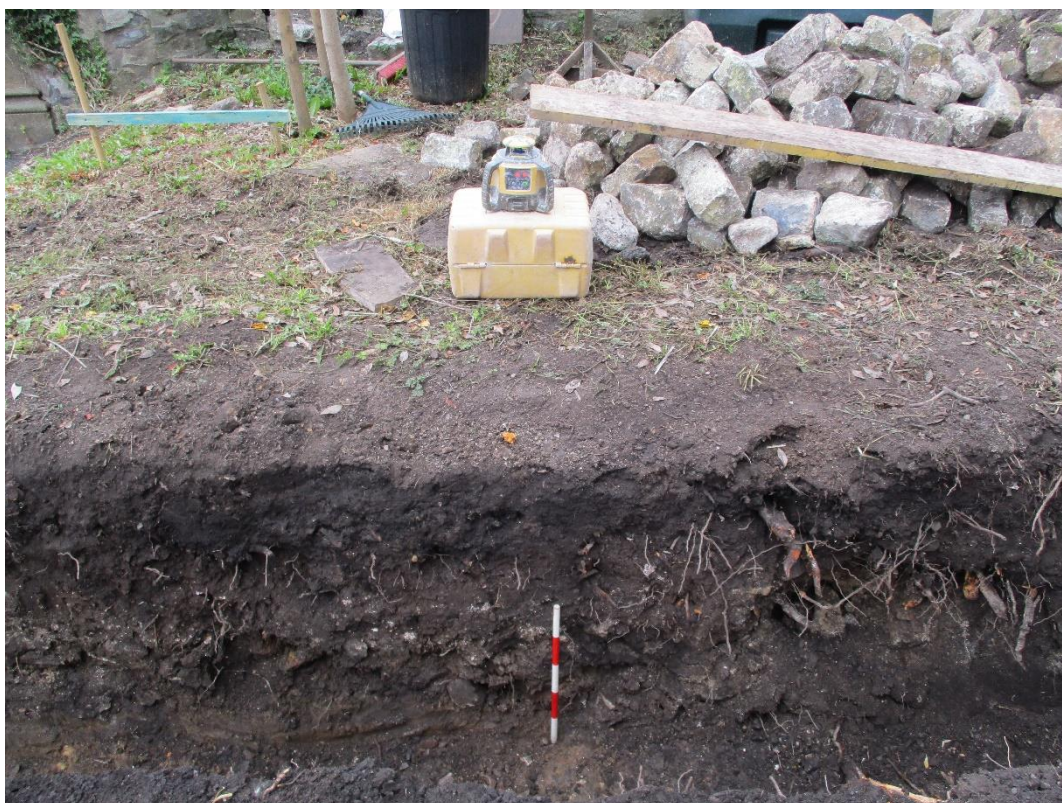
- 5.2.4 Context (102) sealed deposit (103) a loose layer of mostly sandy, yellow-white lime mortar and small fragments of yellow/grey sandstone rubble, which had fragments of a generally angular shape. Rare fragments of modern grey roofing slate and red brick were encountered. The deposit thins from east to west and south to north.

- 5.2.5 Context (104) lies below context (103) and above the natural bedrock (101) and is comprised of mid-brown soft silt-clay with occasional rounded pebbles. This deposit has been interpreted as the remnants of a buried topsoil horizon that was sealed beneath later dumped levelling deposits.

- 5.2.6 Context (101) is the natural and comprised yellow-brown, stiff clay with approximately 15% being stone inclusions of mostly rounded pebbles. The deposit represents natural superficial / drift geology.

*Figure 3: North facing section view (see Drawing 2) showing stratigraphic sequence (Contexts 100-104). 0.5m scale bar.*

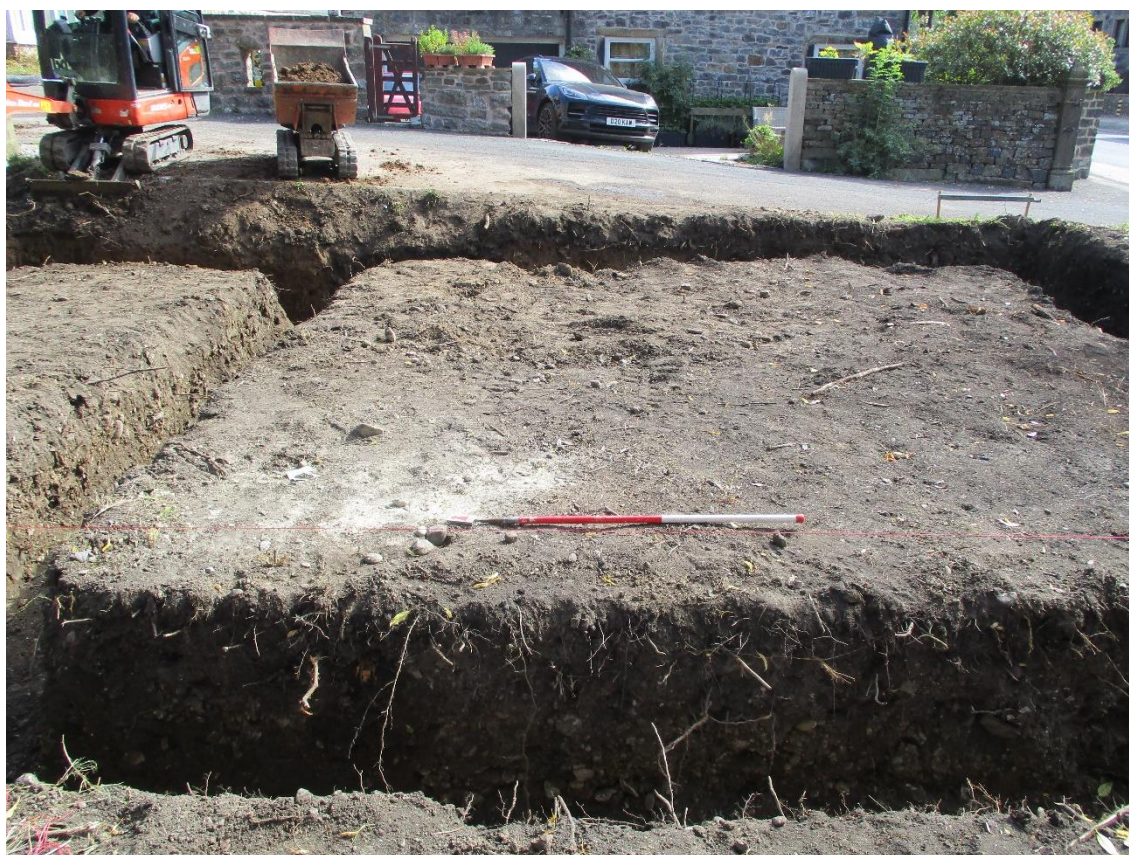
- 5.2.7 No archaeological finds, features or deposits were recorded in the excavated foundation trenches.

*Figure 4: View of fully excavated plot - west to east. 1m scale bar.*
