Bomber Farm, Gisburn

BAT AND BARN OWL REPORT

FINAL REPORT

Date: 25.11.2022

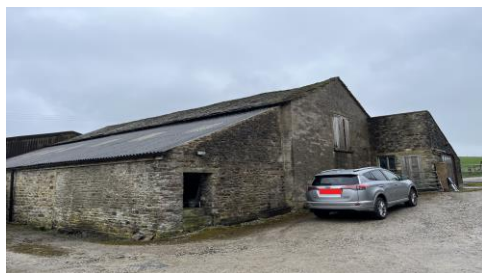
Photograph 1: Western and northern elevations of the stone barn.

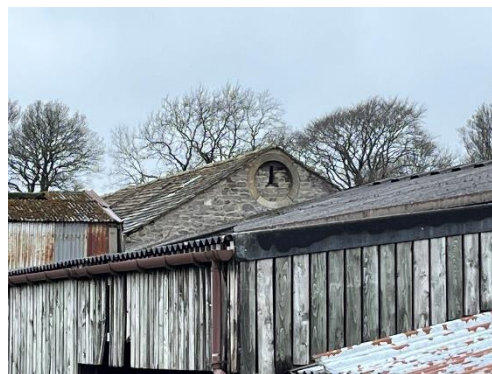
Photograph 2: Eastern elevation of the stone barn showing ventilation hole.

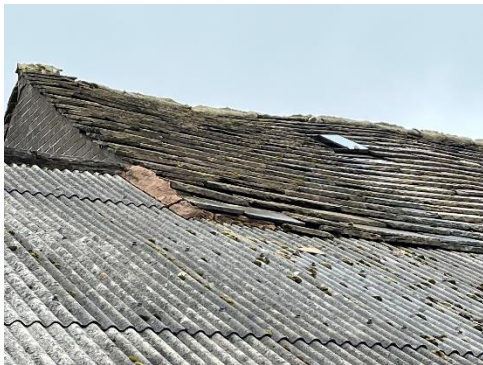
- 3.7 The stone-tiled pitched roof is overall in moderate-poor condition, with some missing, lifted, broken and slipped tiles (Photograph 3). Gaps were also noted at the following locations: beneath the ridge tiles where mortar is missing; surrounding a series of skylights; beneath the lowest row of roof tiles (Photograph 3); and between and beneath the edge tiles on both gable ends (where mortar is crumbling/missing; Photograph 4). The aforementioned features may provide potential roosting features for crevice dwelling bats, and/or ingress opportunities into the internal space. A gap is also present beneath the corrugated roof sheets and beneath the lowest row of stone roof tiles on the northern elevation (Photograph 5). These gaps lead to stone elevations, where potential roosting features suitable for crevice dwelling bats may be present and/or ingress opportunities into the internal space.

Photograph 3: Example of missing, lifted, broken and slipped tiles; gaps beneath ridge tiles; gaps surrounding skylights; and gaps beneath the lowest row of roof tiles.

- Installation of Morris bat slates on the roof pitches to replace lifted tiles and provide access points to the space between the slates and roof liner;

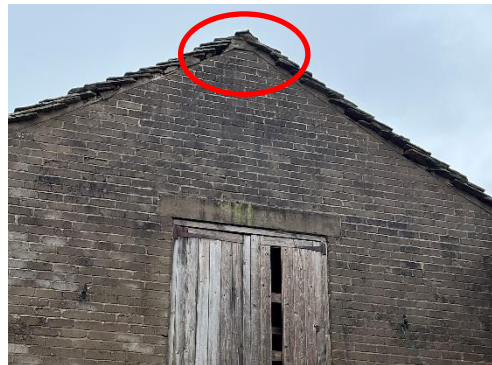
Photograph 4: Example of gaps between and beneath the edge tiles on the gable end. Loading door present on the second floor of the western elevation.

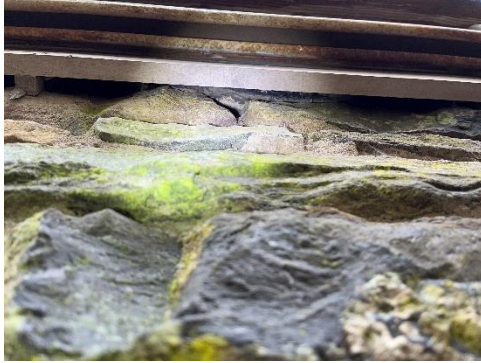
- 3.9 A narrow gap, ranging from approximately 1 cm to 4 cm, is present between the timber track of the sliding door (on the western elevation) and the stone which sits behind (Photograph 6), offering a potential roosting feature for crevice dwellings bats. A timber fascia board present along the northern elevation results in a narrow gap, ranging from

Photograph 6: Narrow gap, ranging from approximately 1 cm to 4 cm, between the timber track of the sliding door and the stone elevation.

- If the dismantling of known or potential roost sites is required:
 - Any dismantling of known or potential roost sites (including within stone/brick/breezeblocks and of the fascia board and timber board behind sliding door) will be conducted under the supervision of an ecologist licenced to handle bats. The ecologist will first inspect relevant areas of the buildings for bats before works commence. Any bats found will be captured by the bat-licenced ecologist by hand (using gloves) or a static net, placed into a cloth bag and relocated to a pre-installed bat box;

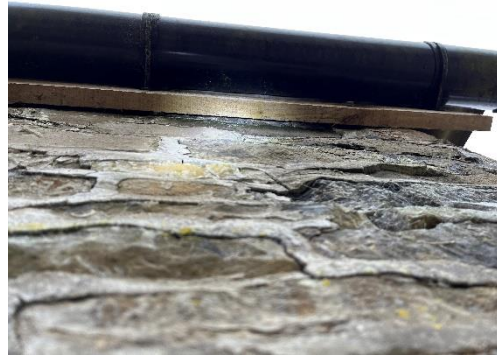
0 cm to approximately 3 cm, between the timber and the stone which sits behind (Photograph 7), offering a suitable roosting feature for crevice dwelling bats; a small number of bat droppings were recorded immediately beneath this fascia board, slightly east of the small hatch, indicating the presence of a bat roost (see Appendix D for more information). No fascia board is present along the southern elevation.

Photograph 7: Example of narrow gap, ranging from 0 cm to approximately 3 cm, between the timber fascia board and the stone elevation.

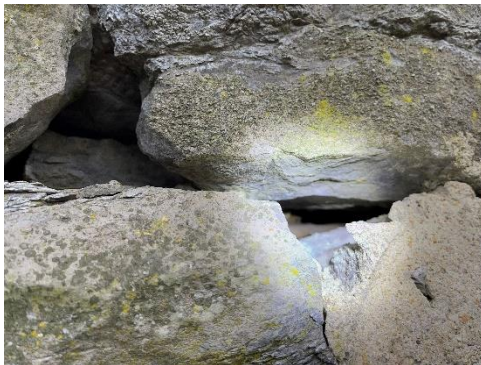
Photograph 8: Example of crevices present within the stonework of the external elevations.

- 3.10 Numerous cracks and crevices are present throughout the stonework of the northern, southern and western external elevations of the stone barn as a result of missing mortar (see Photograph 8 for example). A high number of these crevices appear to lead upwards into cavities within the stonework. These features may provide potential roosting features for crevice dwelling bats. A gap is also present within the section of breeze block along the southern elevation, which may provide potential roosting features for crevice dwelling bats, and/or ingress opportunities into the internal space. No crevices were noted within the brickwork of the western elevation or within the stonework of the eastern elevation.

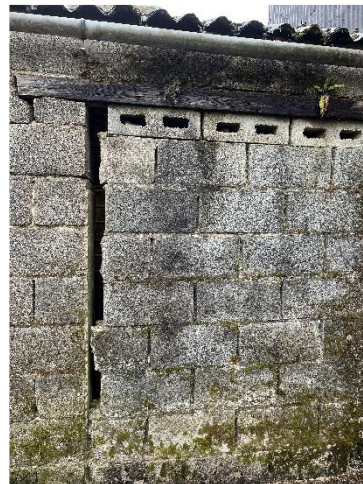
Photograph 9: Narrow gap within the breezeblocks.

- Thirteen common pipistrelle re-entries into crevice within a section of breezeblock as a result of missing mortar within an internal wall. Social calling was recorded, together with bats emerging, re-entering and re-emerging during the survey, suggesting the presence of young bats (Roost D).

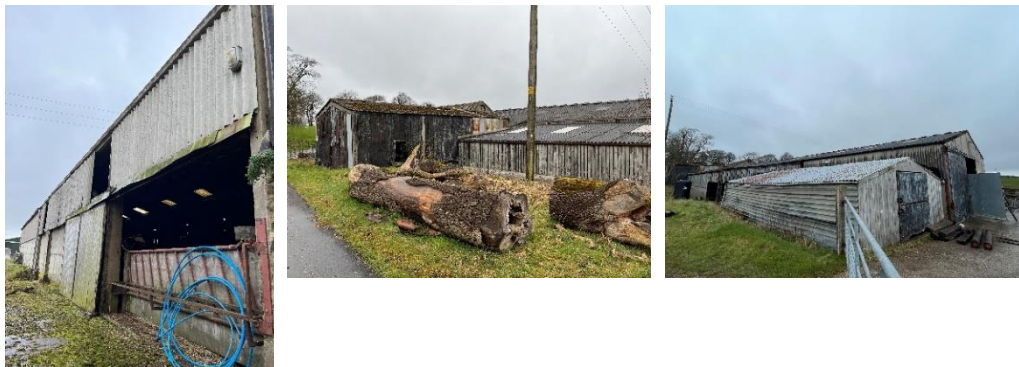
- 3.11 The eastern two-thirds of the barn is an amalgamation of extensions to the stone barn, constructed from a combination of large concrete blocks, corrugated sheets and timber

cladding. This section is considered unsuitable for use by roosting bats due to the lack of potential roosting features: the smooth nature of the corrugated sheets limit the ability for bats to grip; the thermodynamic properties of the corrugated sheets result in temperature fluctuations; no crevices are present within the large concrete blocks; and the timber cladding is only a single layer which does not overlap and therefore provides no suitable crevices. A series of large barn doors together with gaps between the timber beams/corrugated sheets are present across this section of the barn, allowing access for wildlife into the internal space.

Photographs 10 - 12: External elevations of the eastern two-thirds of the barn which are constructed of large concrete blocks, corrugated sheets and timber cladding.

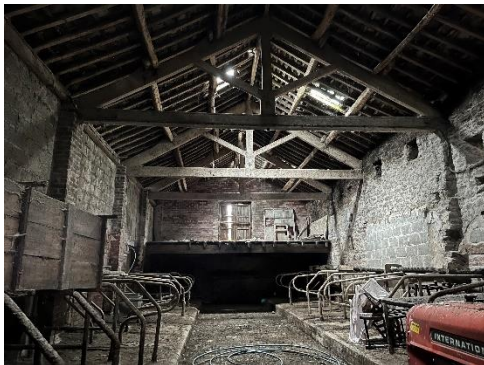
- 3.13 No loft space is present within the barn. Numerous areas of light ingress were noted across the roof, mainly due to the presence of skylights, but also as a result of missing, lifted, broken and slipped tiles and the lack of roof lining (Photograph 13). The exposed timber beams could provide roosting opportunities for void-dwelling bats, however the likelihood of such species using this barn as a day roost is considered unlikely due to the bright nature of the internal space. Gaps between the timber beams and the stone tiles may be used by crevice dwelling bats.

Photograph 13: View of the internal space (central section), showing numerous areas of light ingress due to the state of the roof and skylights. Ledge on the first floor towards the west of the barn.

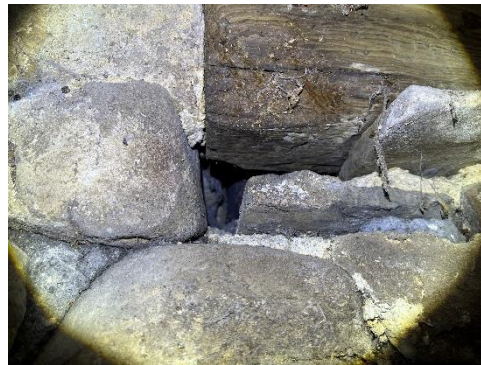
Photograph 14: Example of cracks and crevices present throughout the internal elevations.

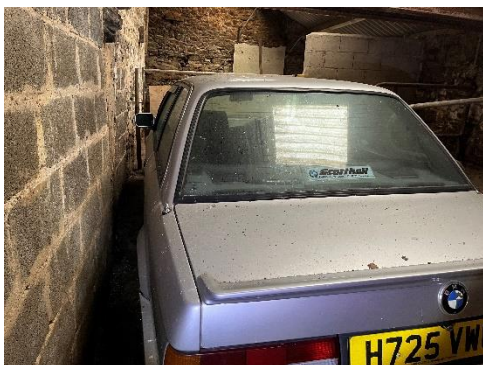
- 3.14 A collection of bat droppings and urination stains were recorded on the roof/windows of a car which was stored within the northern section of the stone barn (Photograph 15). The ceiling of this section is composed of corrugated sheets, which is not considered suitable for use by roosting bats. As such, it is considered likely that these droppings/urination stains are either from bats foraging within the internal space and/or from bats which are roosting within crevices within the stonework. A small collection of old bat droppings were also noted within a sink present towards the south-western corner of the barn; again, it is uncertain if these are from foraging within the internal space and/or from bats which are roosting within crevices within the stonework.

Photograph 15: Collection of bat droppings and urination stains present on a car stored within the barn.

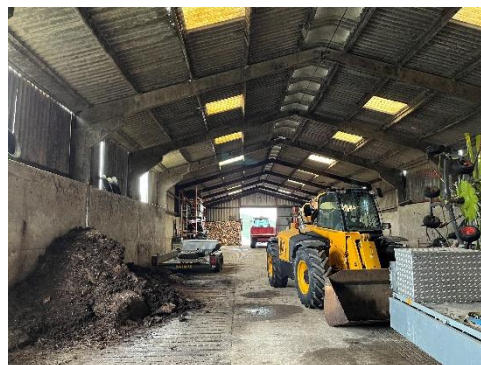
Photograph 16: View of the internal space of the corrugated/timber barn.

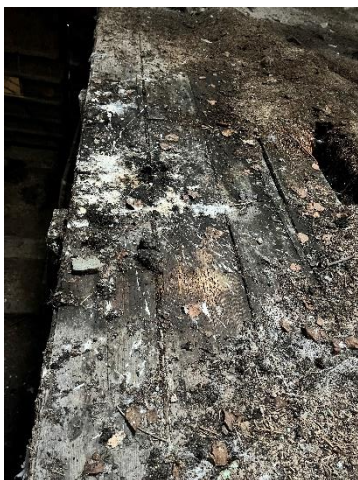
- 3.27 Extensive evidence of roosting barn owl was noted during the building inspection within the first floor space located towards the west of the stone barn. Here owl pellets, owl droppings and barn owl feathers were noted (Photograph 17). Owl pellets and droppings were also noted on the ground floor of the barn (Photograph 18), where a second floor is not present, but the timber roof beams provide suitable perching locations. Fresh pellets, along with numerous old pellets were recorded, indicating long-term use of the barn.

Photograph 17: Owl pellets, owl dropping and barn owl feathers were noted on the first floor space located towards the west of the stone barn.

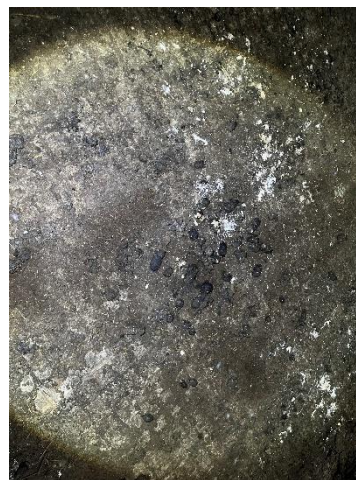
Photograph 18: Owl pellets and droppings located on the ground floor, beneath roof beams.

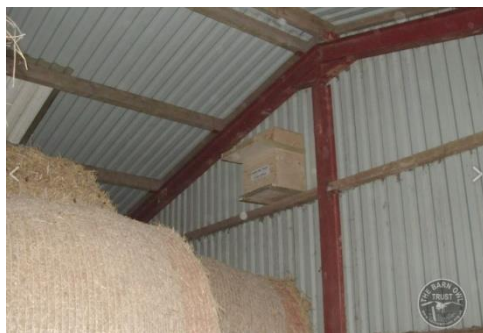
- 5.13 Where indoor boxes are provided in modern agricultural buildings, they are often installed on a gable wall, in view of an opening created in cladding (see photographs 19 and 20 below). Suitable boxes can be sourced from The Barn Owl Trust, and it is recommended to install the box and access point in advance of the development (and loss of their former roost/nest site), to encourage barn owls to discover it.

Photograph 19: Suitable barn owl box positioned in modern agricultural building

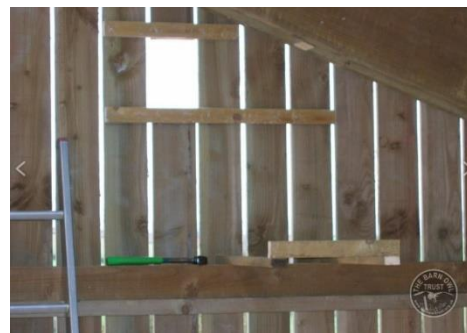
Photograph 20: Opening created for barn owls (with clear view of nest box)

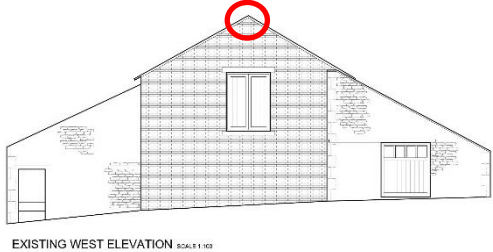
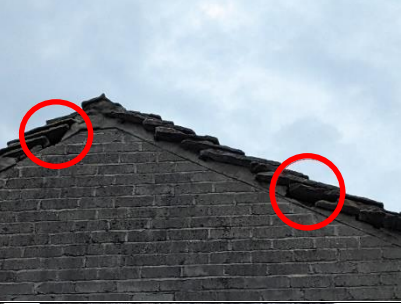
<p>EXISTING WEST ELEVATION SCALE 1:100</p>

- Four common pipistrelles re-entered into gaps beneath the ridge tiles where mortar is missing on the western gable end (roost A);
 - One common pipistrelle re-entry into a gap behind the timber track of the sliding door on the western elevation, however the thermal imaging camera shows the bats almost immediately fly out and leave. Inspection of the crevice

Roost Entrance ID	Description	Location	Photograph
A	<p>Common pipistrelle roost beneath the ridge tiles where mortar is missing on the western gable end.</p> <p>Visit 1: None</p> <p>Visit 2: Four common pipistrelles re-entries</p> <p>Visit 3: One common pipistrelle emergence</p>

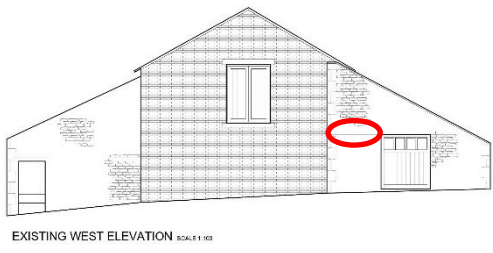
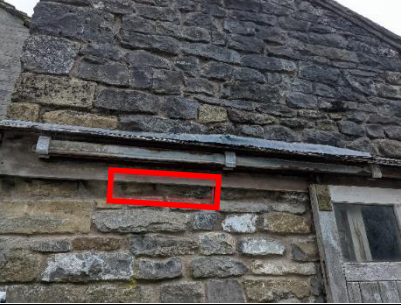
<p>EXISTING WEST ELEVATION SCALE 1:100</p>

B	<p>Common pipistrelle roost behind timber track of the sliding door on the western elevation.</p> <p>Visit 1: None</p> <p>Visit 2: One common pipistrelle re-entry, however the thermal imaging camera shows the bats almost immediately fly out and leave.</p> <p>Visit 3: None</p>

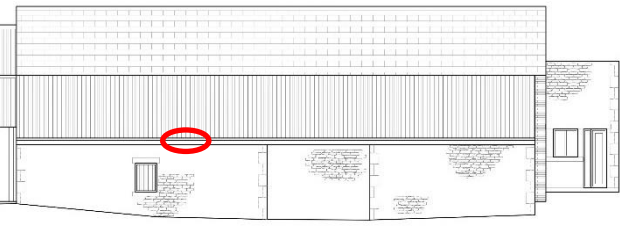
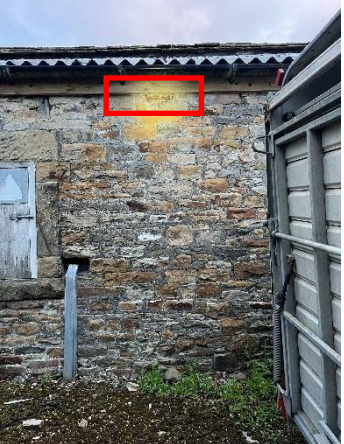
C	<p>Roost (likely common pipistrelle) behind fascia board along the northern elevation of the barn.</p> <p>Visit 1: None</p> <p>Visit 2: None</p> <p>Visit 3: One individual present prior to the start of survey (<i>Pipistrelle</i> sp.).</p>

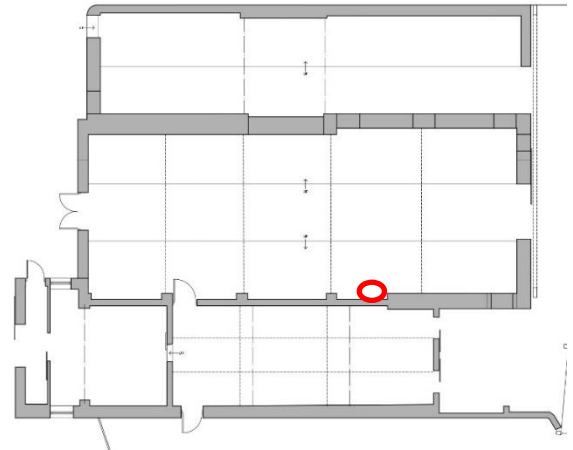
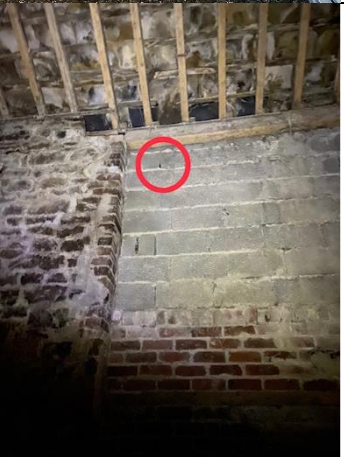
D	<p>Crevice within breezeblock in internal space of barn, towards the south.</p> <p>Visit 1: None</p> <p>Visit 2: Thirteen common pipistrelle re-entries. Social calling recorded, together with bats emerging, re-entering and re-emerging during the survey, suggesting the presence of young.</p> <p>Visit 3: None</p>
