BOW20/341 Phynis Farmhouse: Bat Update Survey

Bowland Ecology Ltd. was commissioned by United Utilities (UU) to update the bat surveys of Phynis Farm, Slaidburn (central NGR: SD 71403 54405). The survey is to inform a planning application to convert three stone barns surrounding the farm yard to residential accommodation. The aim of the bat survey was to update previous surveys of the site undertaken in 2020 and 2014. The survey included an external inspection of the buildings, searching for signs of roosting bats and one emergence and activity survey aimed to identify any bat roosts within the buildings and characterise the size and nature of the roosts, if present. This advice note identifies potential ecological constraints, legal obligations (Appendix A) and mitigation measures with respect to the proposed works. The survey included the three barns and excluded the farmhouse, since work to renovate the house has recently been completed.

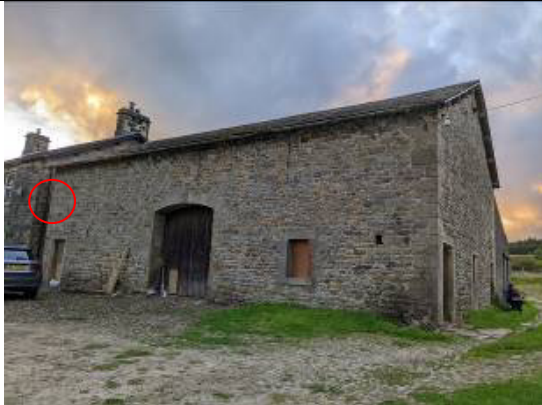
Photograph 1: South-eastern and south-western elevations of Barn 1. Circled is the location of the roost entrance where 1 common pipistrelle bat emerged.

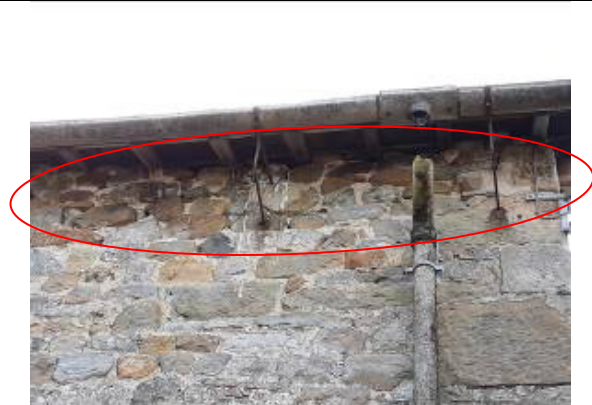
Photograph 2: Example of gaps in mortar work between the stones and access beneath the eaves (circled).

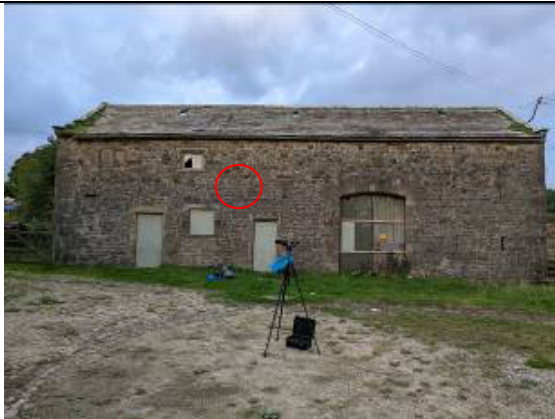
Photograph 3: South western elevation of Barn 2, highlighting the gaps in the stone work above the infilled ventilation slot where one bat emerged.

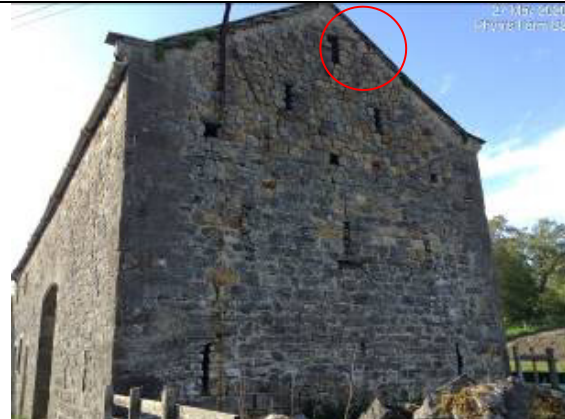
Photograph 4: Ventilation slots and holes in the south eastern gable of Barn 2. Circled is the location of the roost entrance where 6 soprano pipistrelle bats emerged.

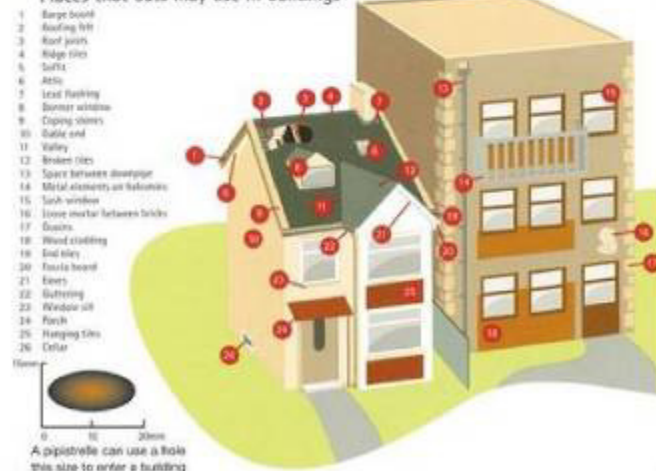
Places that bats may use in buildings

Schematic from www.bats.org.uk

- The top of gable end or dividing wall;
- The top of chimney breasts;
- Ridge and hip beams and other roof beams;
- Mortise and tension joints;
- All beams/ceilings/pipework (free hanging bats);
- The junction of roof timbers, especially where ridge and hip beams meet;
- Behind purlins;
- Between tiles and the roof lining;
- Under flat felt roofs;
- Under barge boards;
- In cavity walls;
- In cracks in stone or concrete;
- Behind peeling paint/wall coverings;
- Gaps behind window and door frames;
- Between window panes and timber boarding.
- In trees (cracks/holes/ivy cladding).
