BAT, BARN OWL & NESTING BIRD SURVEY AT

Tan Yard Farm, Ribchester

It is understood that the barns at Tan Yard Farm, Ribchester, will be converted to form residential accommodation.

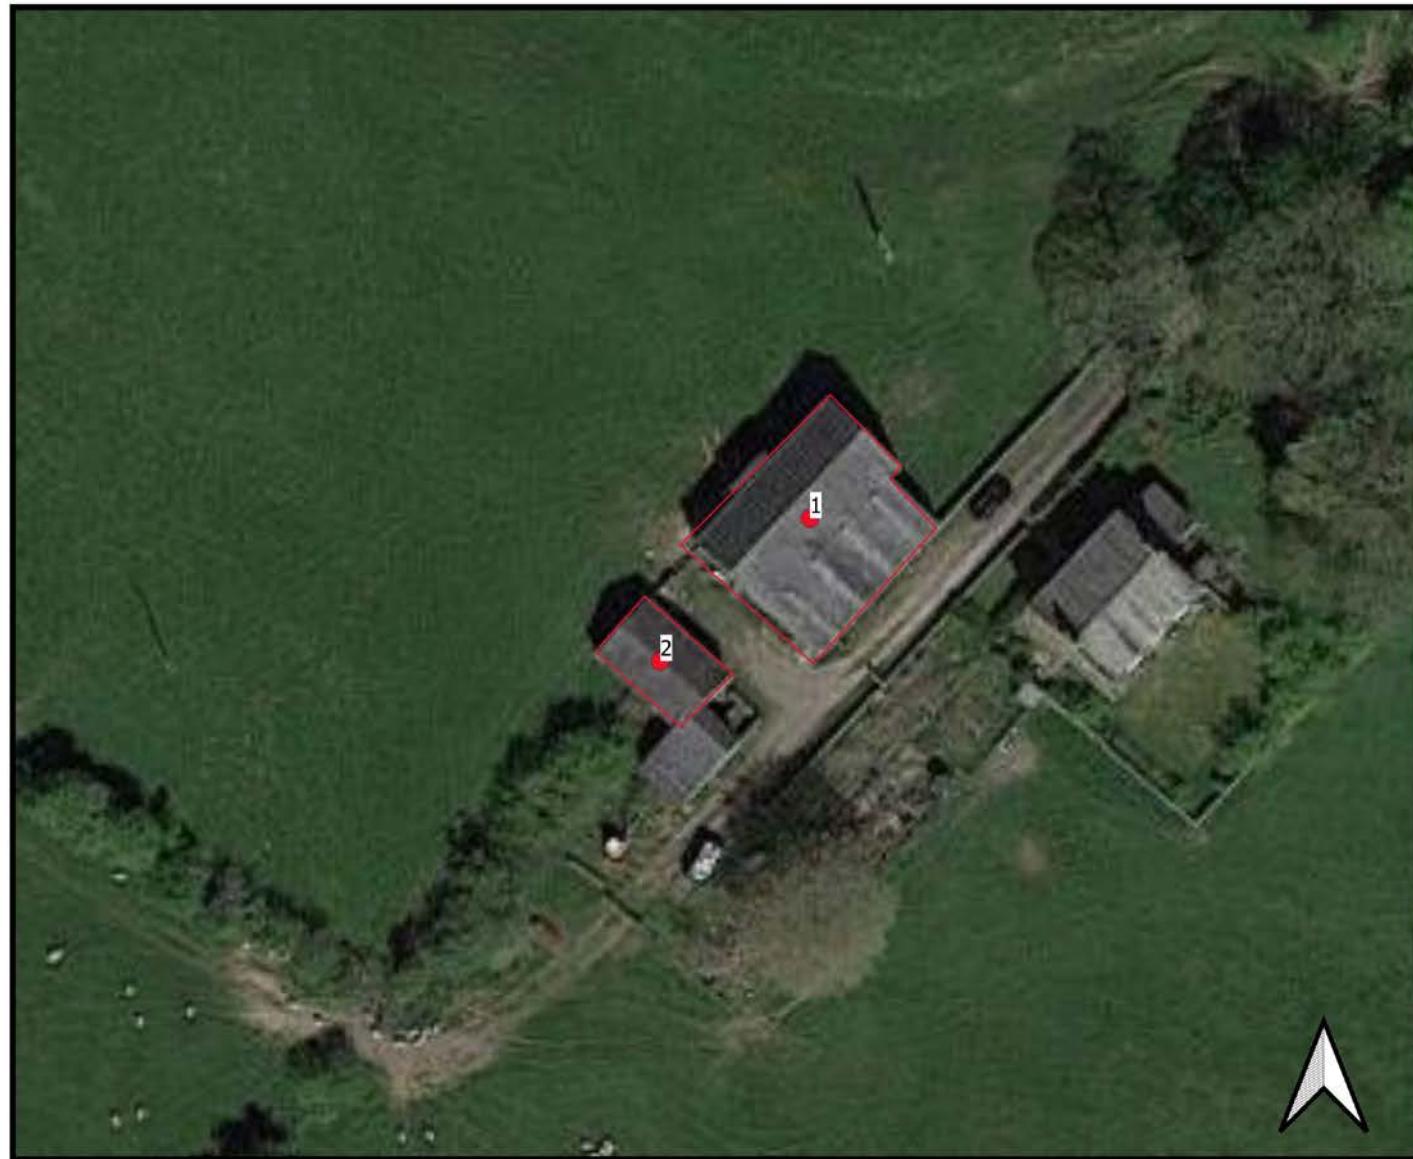
Figure 2
Site Boundary

■ Site Boundary
● Building Number

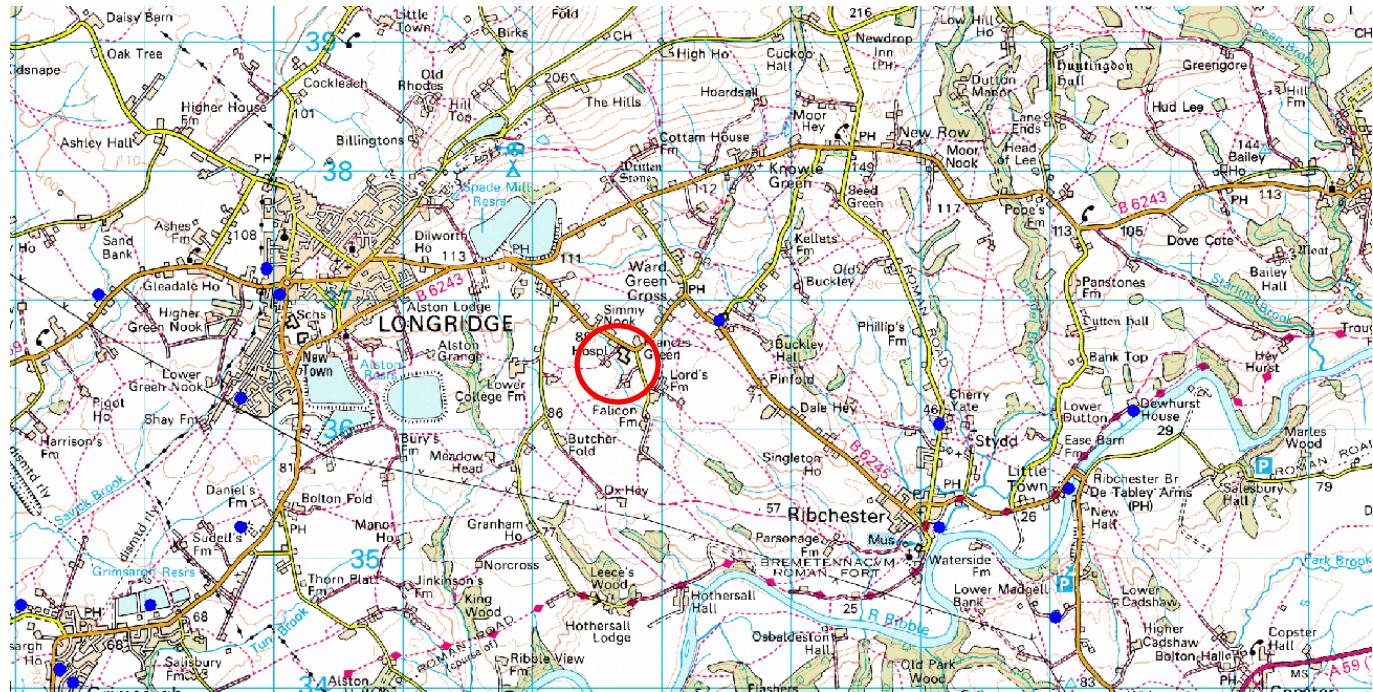
Figure 4 Bat records shown in blue, site location circled red.

A search of the Envirotech dataset returned two records of two bat species within 2km but no records for the site.

Records are shown on Figure 4.

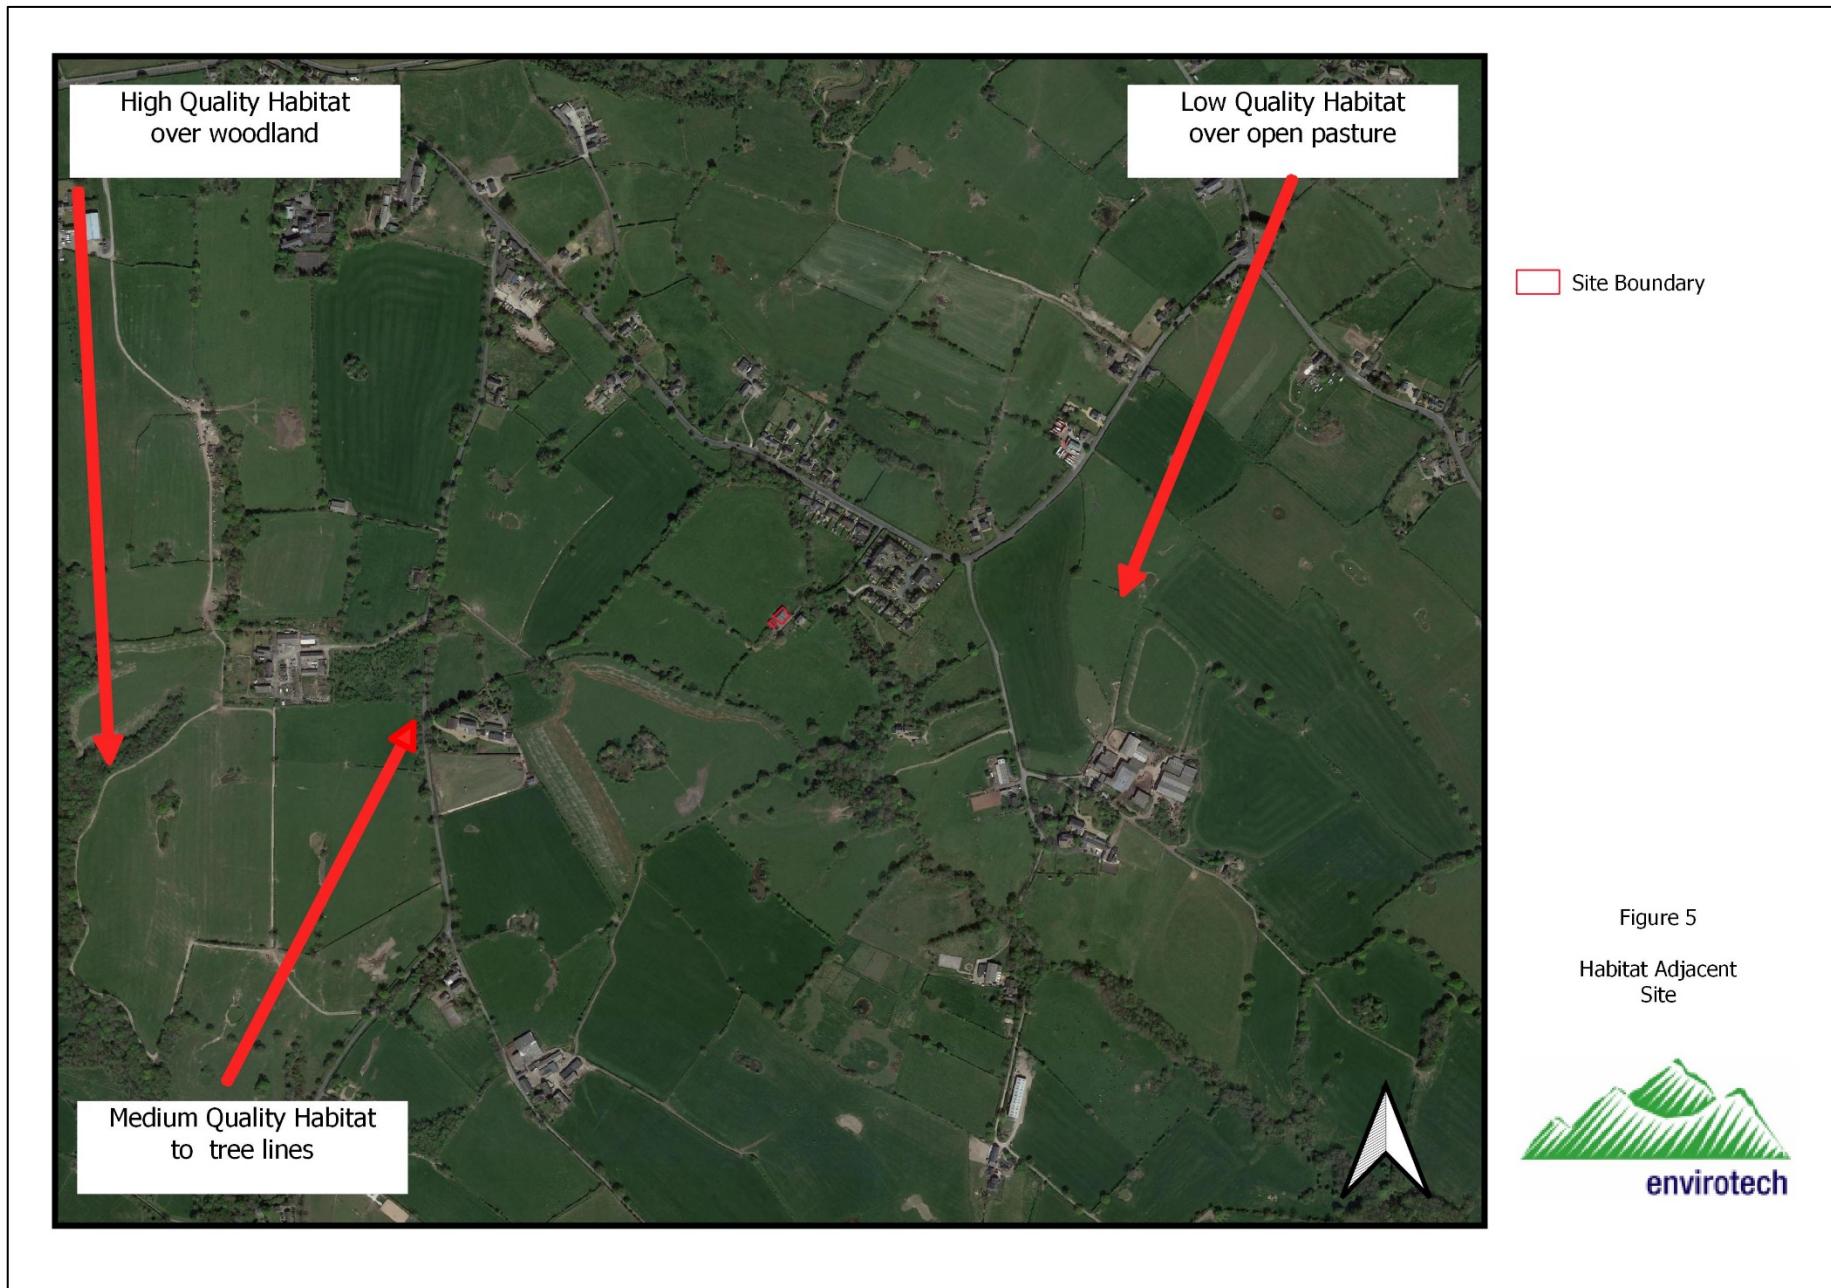
The habitat at and adjacent to the site was assessed from satellite imagery this was then ground truthed, Figure 5.

The habitat on and adjacent to the site identified from satellite images was ground truthed. Details of the habitats found on and adjacent to the site are detailed in Figure 5.

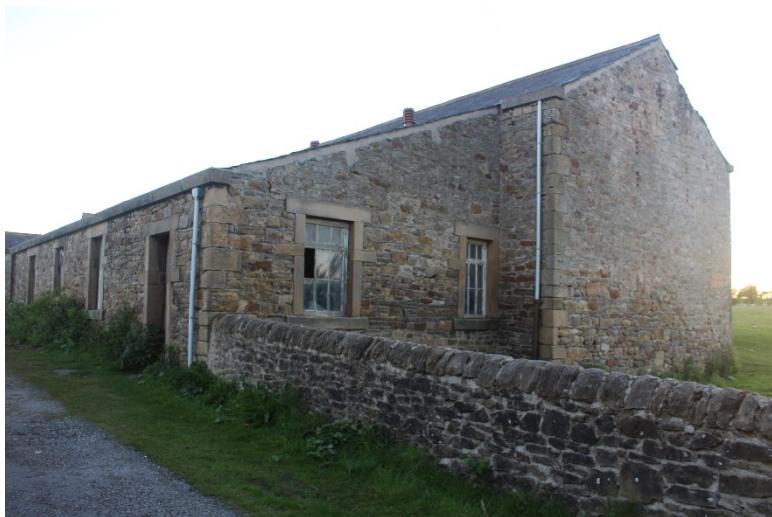
<p>Building 1</p> <p>Well sealed walls and roof coverings generally in good order</p>

The walls of the building are made from natural stone and are in excellent condition. There are no structural gaps or cracks, the pointing between the dressed stone is in excellent condition.

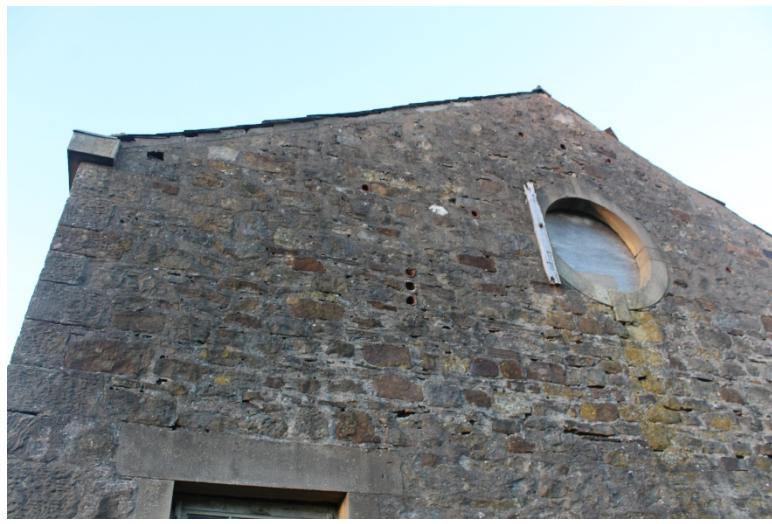
<p>Roof verges are well sealed</p>

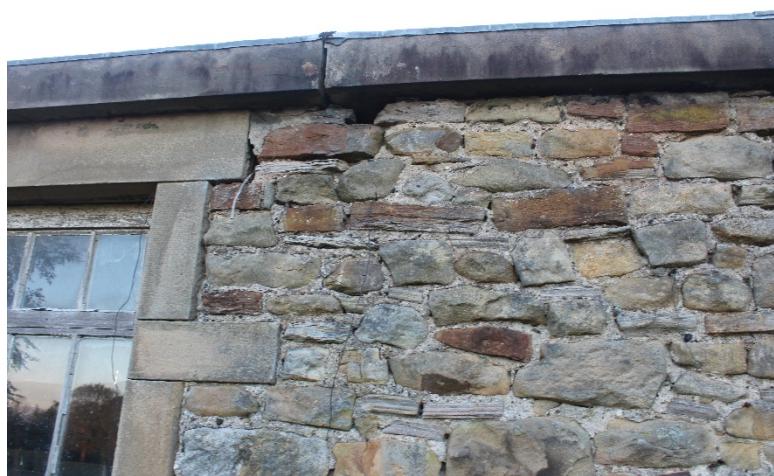
Occasional crevice's at the eaves

The roof of the building is made from slate and is unlined. There were occasional raised slates on both roof pitches, as well as ridgeline gaps where the mortar was missing. The full extent of the gaps could be seen from the ground with close focus binoculars and a 1,000,000 candle power torch. No indications of use by bats could be found. As the roof is unlined any use of the roof would also result in droppings being deposited internally.

6. Remove all roof coverings by hand only.
7. Retain at least 8 gaps along the eaves lines of the buildings which allow access to the wall tops under the eaves during any re-roofing which is undertaken. A plan for these type of roost is shown on Figure 7. These potential roost sites will be a significant improvement on existing site conditions.

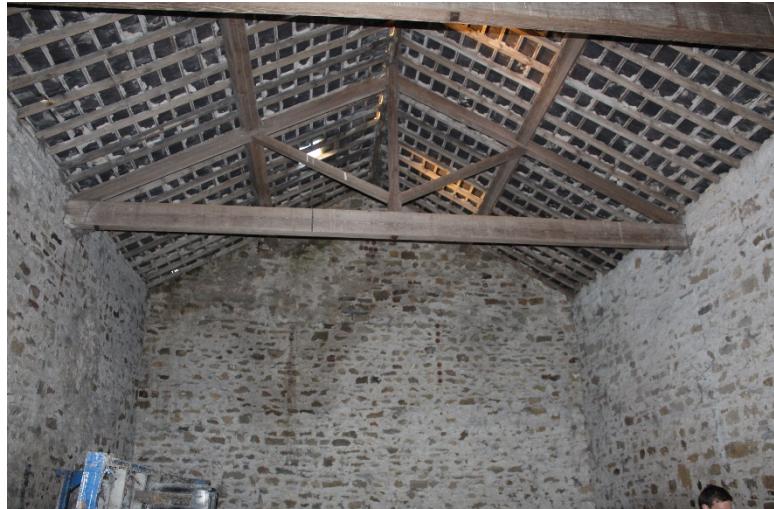
Roof is unlined and vaulted

Timber frame in good order

Walls well sealed

The timber beams in the roof were found to be in excellent condition with no rot, splits or gaps suitable for roosting or hibernating bats. There was a good covering of cobwebs under the roof and spanning the internal space.

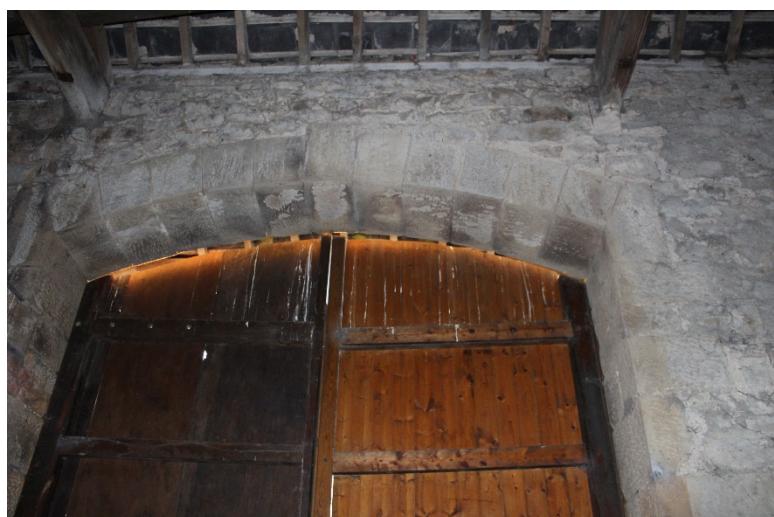
Small amounts of white wash to top of barn doors from Barn owl

No indications of use of the site by bats were found during the survey. A single female Barn Owl (*Tyto alba*) and nesting Feral Pigeons (*Columba livia domestica*) were recorded on site.

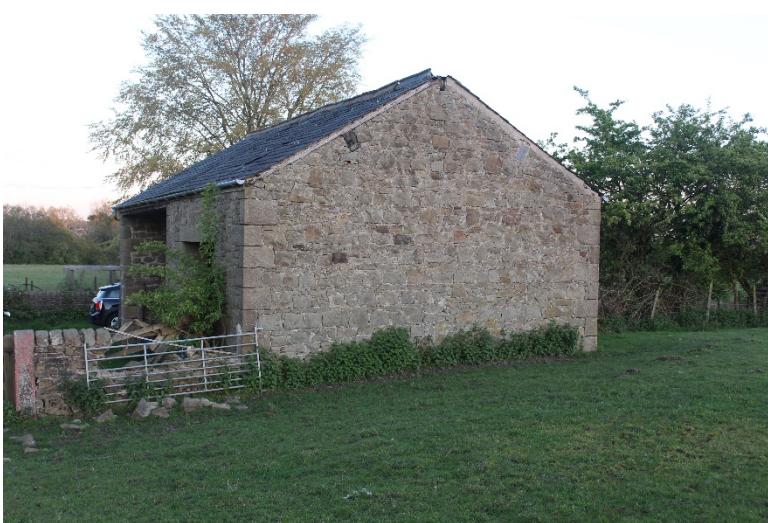
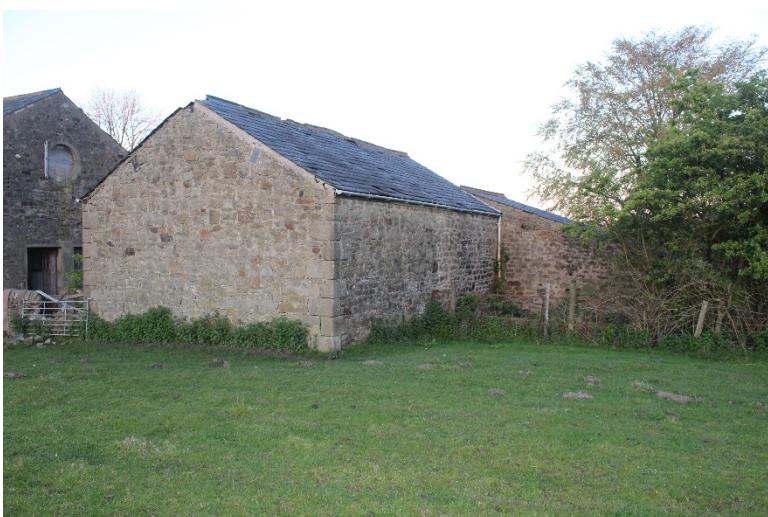
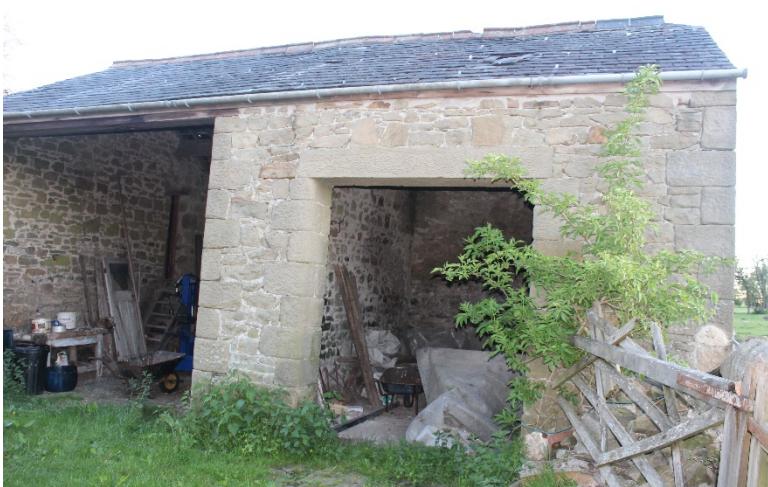
Building 2

Well sealed external walls

Roof recently replaced

Roof verges well sealed

The walls of the building are made from natural stone and are in excellent condition. There are no structural gaps or cracks, the pointing between the dressed stone is in excellent condition.

The building has been repaired in the recent past so is in good order.

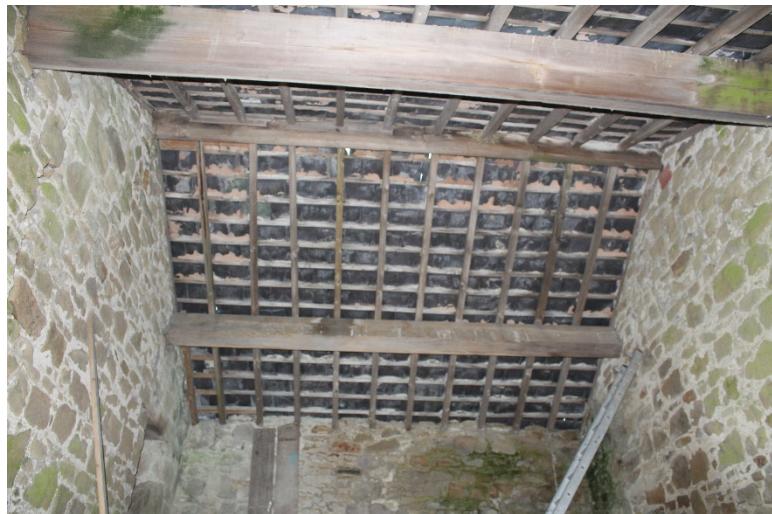
Internal walls are well sealed

Roof is unlined

The timber beams in the roof were found to be in excellent condition with no rot, splits or gaps suitable for roosting or hibernating bats. There was a good covering of cobwebs under the roof and spanning the internal space. No indications of use by bats could be found.
